Sahbi TAMBOURA, Abir ABDESSALEM, Hachmi BEN DALY, Abbas TCHARKHTCHI, Joseph FITOUSSI - On the mechanical properties and damage mechanisms of short fibers reinforced composite submitted to hydrothermal aging: Application to sheet molding compound composite - Engineering Failure Analysis - Vol. 131, p.105806 - 2021

# On the mechanical properties and damage mechanisms of short fibers reinforced composite submitted to hydrothermal aging: Application to sheet molding compound composite

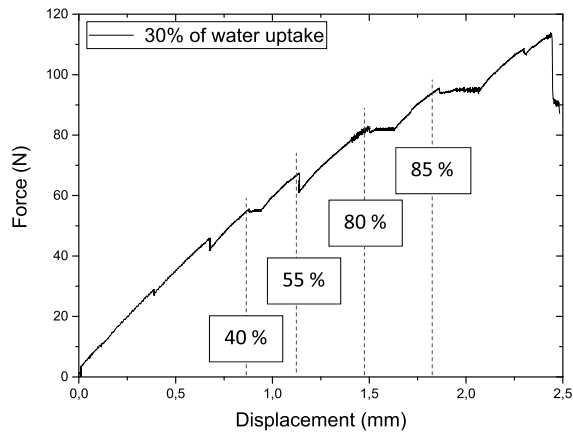
Fig. 9. In-situ three bending curve of SMC composite aged at 50 °C after 30% of water uptake.

In situ three points bending tests were performed while maintaining the same procedure for all the studied specimens. Here, we only discuss the results obtained on unaged samples and aged at 50 °C after 15% and 30% of water uptake. Fig. 9 represents the force/displacement curve of an aged specimen taken after 30% of water uptake at 50 °C. The same trends were obtained on all the studied samples. The curve shows clearly the interruption of the crosshead displacement needed to take photos of damage initiation and propagation. One can observe that the interruption stages are not enough long to produce significant relaxation of the matrix.
