Samuel RODRIGUEZ, Victor GAYOUX, Eric DUCASSE, Michel CASTAINGS, Nicolas PATTEEUW - Ultrasonic imaging of buried defects in rails - NDT&E International - Vol. 133, p.102737 - 2023

# Ultrasonic imaging of buried defects in rails

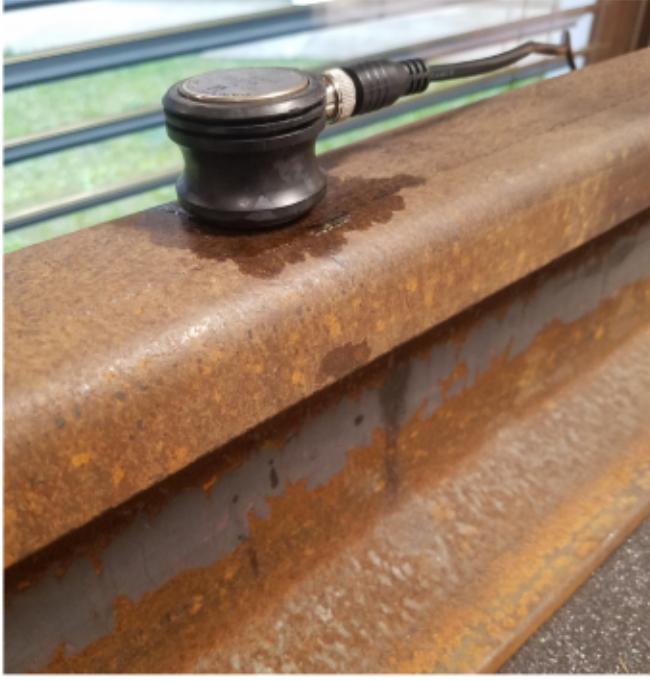
Fig. 2. The experimental apparatus for testing the numerical model.

To assess the model validity, comparisons with pulse-echo experiments are performed on a real rail sample inspected using a single one-inch piezoelectric transducer with successively out-of-plane and in-plane polarizations. The transducer is located at the center of the upper side of the rail head, as presented in Fig. 2.
