M.H. STAIA, Eli-Saul PUCHI-CABRERA, Alain IOST, E. CARRASQUERO, Y.Y. SANTANA, J.G. LA BARBERA-SOSA, Didier CHICOT, Adrien VAN GORP - Sliding wear of a-C:H coatings against alumina in corrosive media - Diamond and Related Materials n°38, p.139-147 - 2013

Sliding wear of a-C:H coatings against alumina in corrosive media

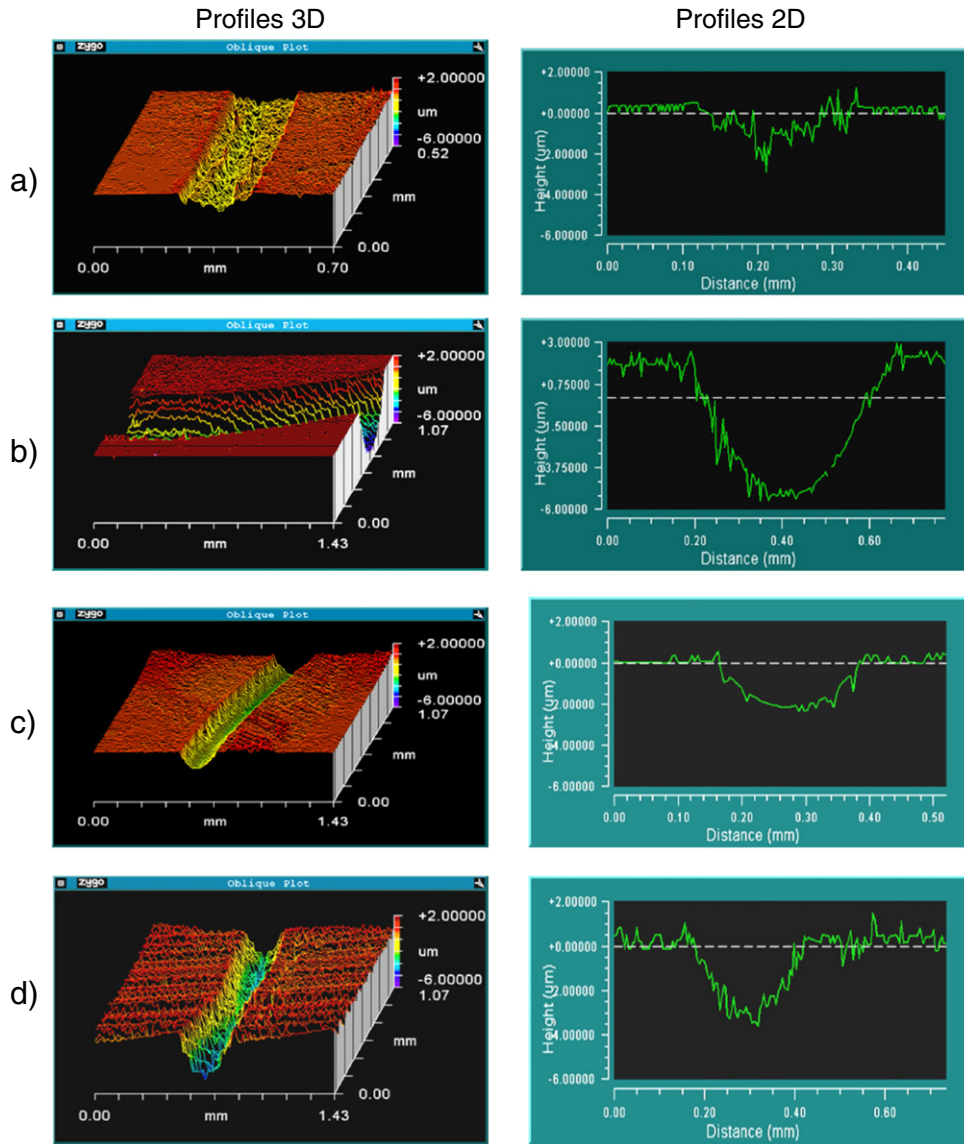
Fig. 6. Profiles of the wear tracks corresponding to the DLC coating tested in: (a) SBF solution at 2 N; (b) SBF solution at 5 N; (c) 3.5% NaCl solution at 2 N; (d) 3.5% NaCl solution at 5 N.

The 2D and 3D profiles obtained by means of the optical profilometer of the wear tracks for all the coated systems tested under the experimental setting described previously are shown in Fig. 6.

From Fig. 6 it can be clearly observed that when the normal load employed corresponds to the lower value of 2 N, the coatings are still present on the stainless steel substrate and, therefore, the value of the intrinsic rate constant can be calculated by dividing the wear volume by the product between normal load and the sliding distance (see Table 1).

However, the wear track profile corresponding to the sample tested in the SBF solution has an irregular shape, which makes the evaluation of the cross sectional area with the same precision as for the sample immersed in the NaCl solution difficult. Nevertheless, it was found that the value of the wear constant, k , was of approximately $2 \times 10^{-6} \text{ mm}^3/\text{Nm}$ and no significant differences were obtained between the wear rate of the DLC coating in 3.5% NaCl and the SBF solution, respectively.

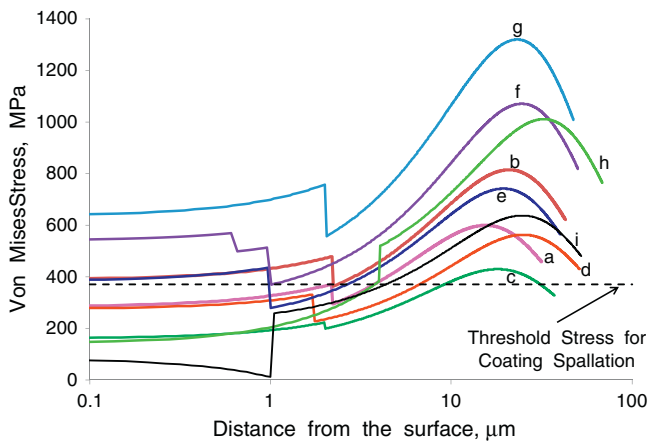
Fig. 7. Variation of the von Mises stress with the distance from the surface for the systems under study and for other DLC coated systems reported in the literature and described in Table 2.

However, it should also be borne in mind that below the coating, the existence of a 316L stainless steel layer could provide an elastic support to it. For example, for curves a and b in Fig. 7, corresponding to the tests conducted in the present research, it can be seen that when a normal load of 2 N is applied (curve a), the thickness of the elastic layer, of about 8.3 µm, is approximately 4 times the thickness of the coating and decreases to 5.5 µm for a load of 5 N (curve b). Consequently, it will be expected that plastic deformation of the substrate occurs at a distance from the surface greater than approximately 3 µm (curve f) and that during a wear test carried out in air, for both values of the applied load, no cracking will occur that could give rise to the coating detachment.

As can be seen in Fig. 7, the state of stress for the coated system under a load of 5 N (curve b) is more severe than in the case of a 2 N load (curve a). Therefore, it could be argued that its severity enhances the corrosive action of the solutions, similarly to the commonly observed stress corrosion-cracking phenomenon.
