Yessine AYED, Guénaël GERMAIN, Amine AMMAR, Benoit FURET - Degradation modes and tool wear mechanisms in finish and rough machining of Ti17 Titanium alloy under high-pressure water jet assistance - Wear - Vol. 305, n°1-2, p.228-237 - 2013

Degradation modes and tool wear mechanisms in finish and rough machining of Ti17 Titanium alloy under high-pressure water jet assistance

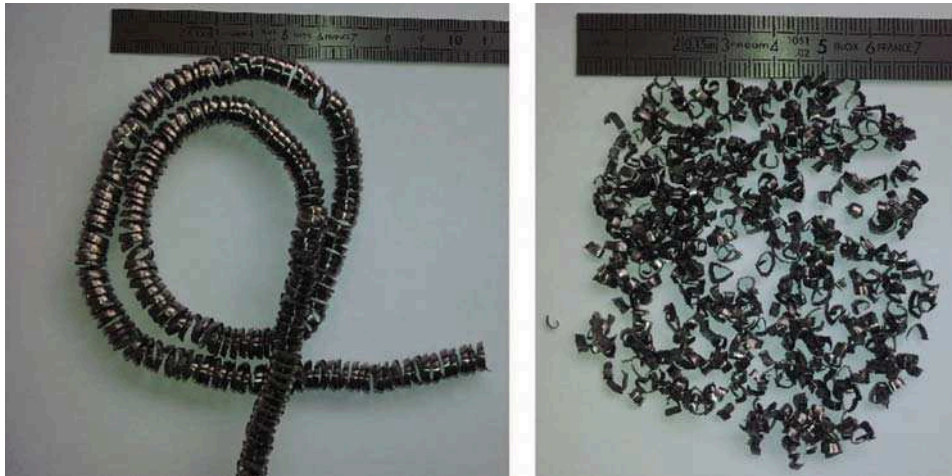
Fig. 2. Chip fragmentation at 100 bars (finishing condition).

Fig. 2 shows the morphology of the chips obtained when machining with conventional lubrication and with HPWJA at 100 bars, respectively. It can be seen that HPWJA ensures chip fragmentation.

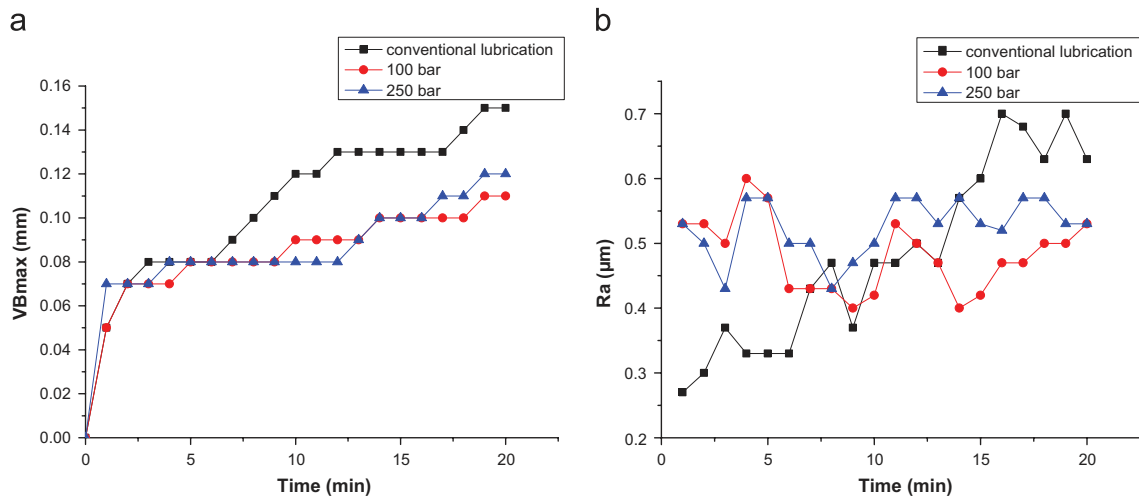
Fig. 3. (a) Flank wear (VB) and (b) surface roughness (R_a).

Fig. 3(a) shows the evolution of the flank wear criterion (VB) and (b) the evolution of the R_a criterion. For all the configurations, flank wear (VB) does not exceed 0.15 mm after 20 min of machining, but its evolution is slower with HPWJA. Indeed, in conventional lubrication after the running-in phase, flank wear increases linearly to 0.15 mm after 20 min.

However, for the HPWJA condition, after the running-in phase, the flank wear remains constant for a significant period. Indeed, in both assistance configurations (100 bars and 250 bars), flank wear remains constant at about 0.08 mm for approximately 6 min at a pressure of 100 bars and for about 9 min at a pressure of 250 bars. After this stable regime, flank wear increases in a way similar to conventional lubrication. Fig. 3(b) shows a significant variation of surface roughness. For conventional lubrication, the surface roughness tends to increase linearly as a function of machining time, going from $R_a = 0.25 \mu\text{m}$ to $R_a = 0.7 \mu\text{m}$ (i.e. R_a reaches three times its initial value). For tests with high-pressure water jet assistance, the initial surface roughness is higher, but its value remains globally constant (between $0.4 \mu\text{m}$ and $0.6 \mu\text{m}$ throughout the test). In addition, there is no marked tendency for the surface roughness to increase even at the end of the test. The surface roughness thus appears uninfluenced by flank wear.

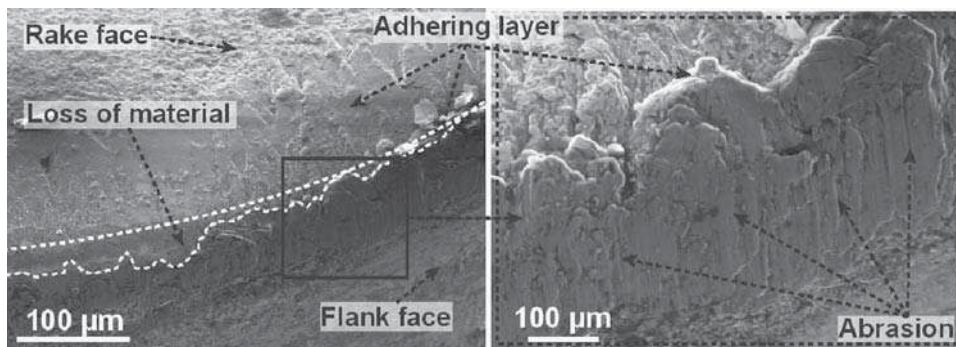
Fig. 4. SEM image of the tool rake/flank face after 20 min of machining in the finishing configuration with conventional lubrication.

Fig. 5. SEM image of the tool rake/flank face after 20 min of machining in the finishing configuration with 100 bars.

Fig. 6. SEM image of the tool rake/flank face after 20 min of machining in the finishing configuration with 250 bars.

Figs. 4–6 show the SEM images of the worn areas on the tool rake face and on the tool flank face for the three tests in the finishing condition. For conventional lubrication, significant flank wear at the nose radius (VBc) is observed. In addition, layers adhering to the rake face are noticed. During machining, the chip rubs on these adherent layers which appear to protect the rake face. However, when the formation of these layers reaches a stagnation level, they become instable and may be peeled-off

leading to wear by adhesion [10]. Alternatively, with HPWJA, a loss of material on the tool rake face and the formation of a crater can be seen. Damage in these areas is more important at a pressure of 250 bars. In this case, it seems that the most important wear mechanism is adhesion accompanied by abrasion and erosion.

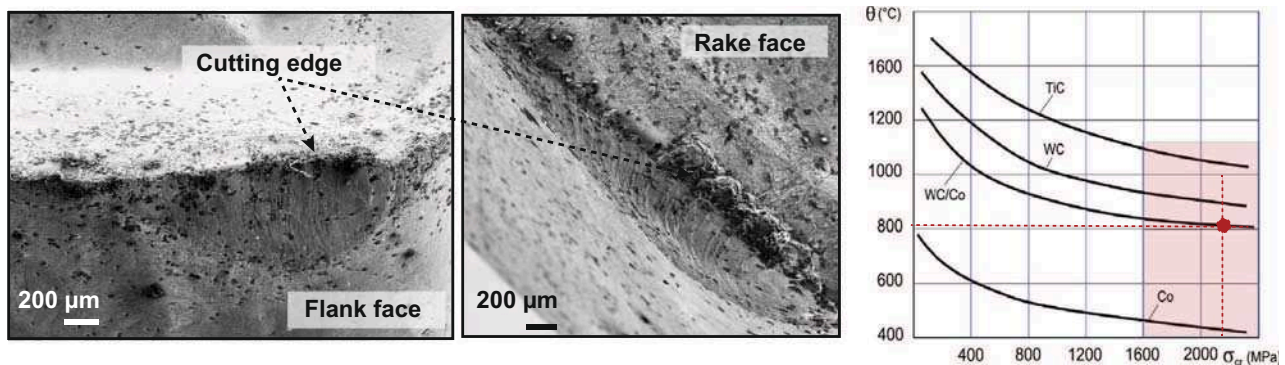
Fig. 8. (a) Image of the cutting edge after 75 s of roughing machining with conventional lubrication and (b) creep resistance [12].

pressure K_C (about 2100 MPa). Fig. 8(a) shows tool rake and flank faces after 75 s of roughing machining.

The measurement of the cutting force reveals that the average specific pressure is around 2100 MPa in conventional machining. Fig. 8(b) shows that, to avoid creep in the tool when exposed to a contact pressure of 2100 MPa, the cutting temperature must not exceed 900 °C for the WC and 800 °C for the WC/Co inserts. However, these temperatures correspond to those obtained when machining titanium [13–15]. This result confirms the degradation mode of the cutting edge by creep in conventional machining.
