Yessine AYED, Guénaël GERMAIN, Amine AMMAR, Benoit FURET - Degradation modes and tool wear mechanisms in finish and rough machining of Ti17 Titanium alloy under high-pressure water jet assistance - Wear - Vol. 305, n°1-2, p.228-237 - 2013

Degradation modes and tool wear mechanisms in finish and rough machining of Ti17 Titanium alloy under high-pressure water jet assistance

Y. Ayed^{a,*}, G. Germain^a, A. Ammar^a, B. Furet^b

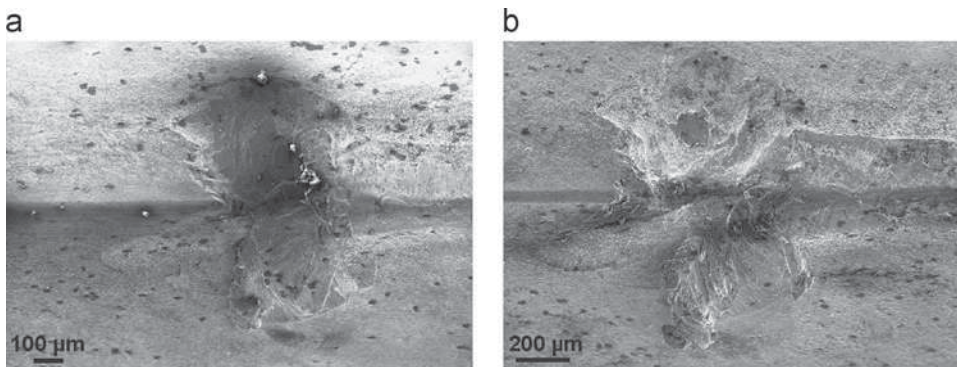
Fig. 12. Evolution of notch wear in roughing condition: (a) 4 min and (b) 5 min.

Fig. 12(a), taken after 4 min of machining, shows layers adhering to the notch. After 1 min of additional machining, the same notch is observed. Fig. 12(b) shows that the previously observed layers are pulled out, leaving a larger notch. Indeed, significant material loss was noted in the areas where material deposits were located. These observations confirm the wear mechanism by tearing-off of adhering layers.
