Vanessa RODRIGUEZ, Jacob SUKUMARAN, Yeczain PEREZ DELGADO, Mariana STAIA, Alain IOST, Patrick DE BAETS - Scratch evaluation on a high performance polymer - Mechanical Engineering Letters - Vol. 9, p.76-84 - 2013

Scratch evaluation on a high performance polymer

Vanessa RODRIGUEZ¹, Jacob SUKUMARAN¹,
Yeczain PEREZ DELGADO¹, Mariana STAIA¹, Alain IOST²,
Patrick DE BAETS¹

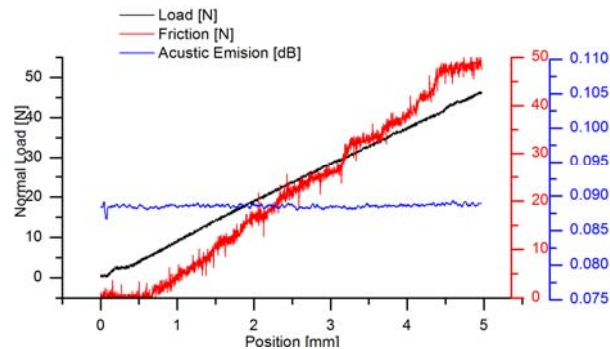
Figure 2. Typical course of the scratch loads versus scratch length measure in PEEK-E02 with a progressive load of 50N

Various properties were observed in this study such as penetration depth, tangential force, surface damage as a function of load, there are plotted in the figure 2 and 5 for the two PEEK filled with composites were shows the experimental results of scratching test. In both figure, it can be observed that the scratch force is increased as the load increased. From the Coulomb's law, it is evident that there is a linear relationship between scratch force and applied load. In previous investigations by Sujeet Sinha (Sinha and Lim 2006) finds that the scratch forces for all polymers that their investigated such as polypropylene,

The figure 2 is a typical testing curve for polymers under progressive load scratch test of the PEEK-E02 sample, where the tangential force curves show small magnitude of fluctuations at the beginning and at the middle of the test due to the inertial effects of instantaneously accelerating the scratch head to the designated scratch speed. But after this, the tangential force increase slightly and in a digressive manner to its final level, influences at the end by the movement of the indenter.
