# Comparison of damage behaviour of different plant fibre composites under laser impact loading

**Abstract** – The high strain rate behaviour of the eco-composites, when submitted to laser impact loading, is not well known yet. Crucial questions are still open: influence of plant fiber length and distribution on the composite impact behaviour, types of damage induced by impact loading, the way the failure occurs, etc. We present the very first results of a collaborative research involving the institutions PPRIME- Poitiers and PIMM-Paris, and IMP PAN-Gdansk-Poland. A comparison of laser shock induced damage is realised, based on observations of sample back faces for several types of eco-composites. Spallation, residual blister and inside delamination, depending on the fibre length in tested composites have been observed. The ability of the Terahertz technique for internal damage detection is demonstrated.

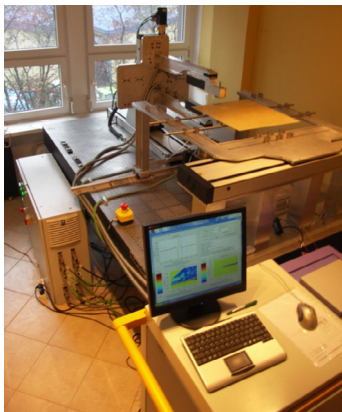
**Fig. 2.** Terahertz TDS spectrometer with scanning unit.

THz-TDS-system TPS Spectra 3000+ by TeraView Limited generates radiation in the form of repeated, very narrow pico-second pulses, which are focused and sent toward the investigated structure. Wide frequency content, small power and non-ionizing radiation are the main characteristics of the pulse. This approach is very interesting when the material allows for penetration at THz-frequencies, such as polymer composites. The experimental setup using THz TDS system is shown in Figure 2. The investigated samples are supported by steel bars mounted to system. They are responsible for the movement in the horizontal plane.
