Muhamad Fatikul ARIF, Yves CHEMISKY, Gilles ROBERT, Joseph FITOUSSI, Fodil MERAGHNI, Nicolas SAINTIER - Fatigue damage investigation of PA66/GF30 by X-Ray microtomography - 2014

# FATIGUE DAMAGE INVESTIGATION OF PA66/GF30 BY X-RAY MICROTOMOGRAPHY

## Abstract

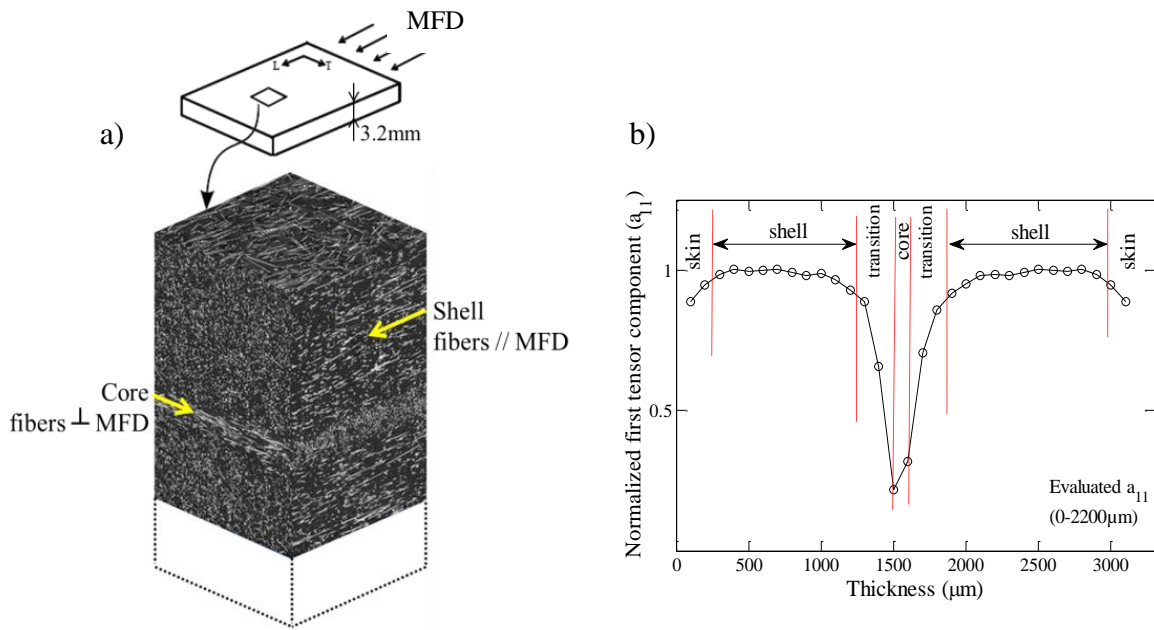
Due to the injection process, PA66/GF30 has a skin-shell-transition-core microstructure as shown in Fig. 1. It can be seen that the shell layers, with preferential fiber orientation parallel to the mold flow direction (MFD), are the most dominant ones. Thin core layer is developed and mostly fibers in this layer are oriented transversely to the MFD. Additionally, thin skin layers at the upper and lower specimen surfaces, and the shell-core transition layers are also developed. For further description of PA66/GF30 microstructure, readers can refer to [4,5].

**Figure 1.** Microstructure formation of PA66/GF30; a) fiber orientation description by  $\mu\text{CT}$ , and b) normalized fiber orientation tensor. (MFD = mold flow direction)

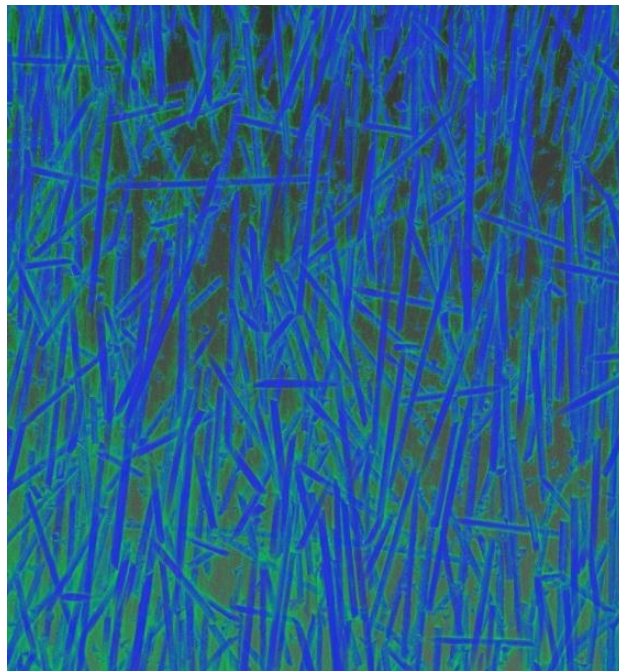
To build a more consistent analysis on damage mechanisms of PA66/GF30, segmentation process which involves separation of the composites' phases (fiber, matrix and damage) has been carried out. Fig. 3 shows the rendered  $\mu$ CT image representing the damage and fibers. One can see that the fiber/matrix interfacial debonding is frequently observed in the fatigue loaded composites. Therefore, this interfacial debonding can be considered as the main fatigue damage mechanisms in dry PA66/GF30.

**Figure 3.** Rendered  $\mu$ CT image of fatigue loaded specimen which shows damage in the form of fiber/matrix interfacial debonding. The blue (and green) color represents the fiber (and damage).

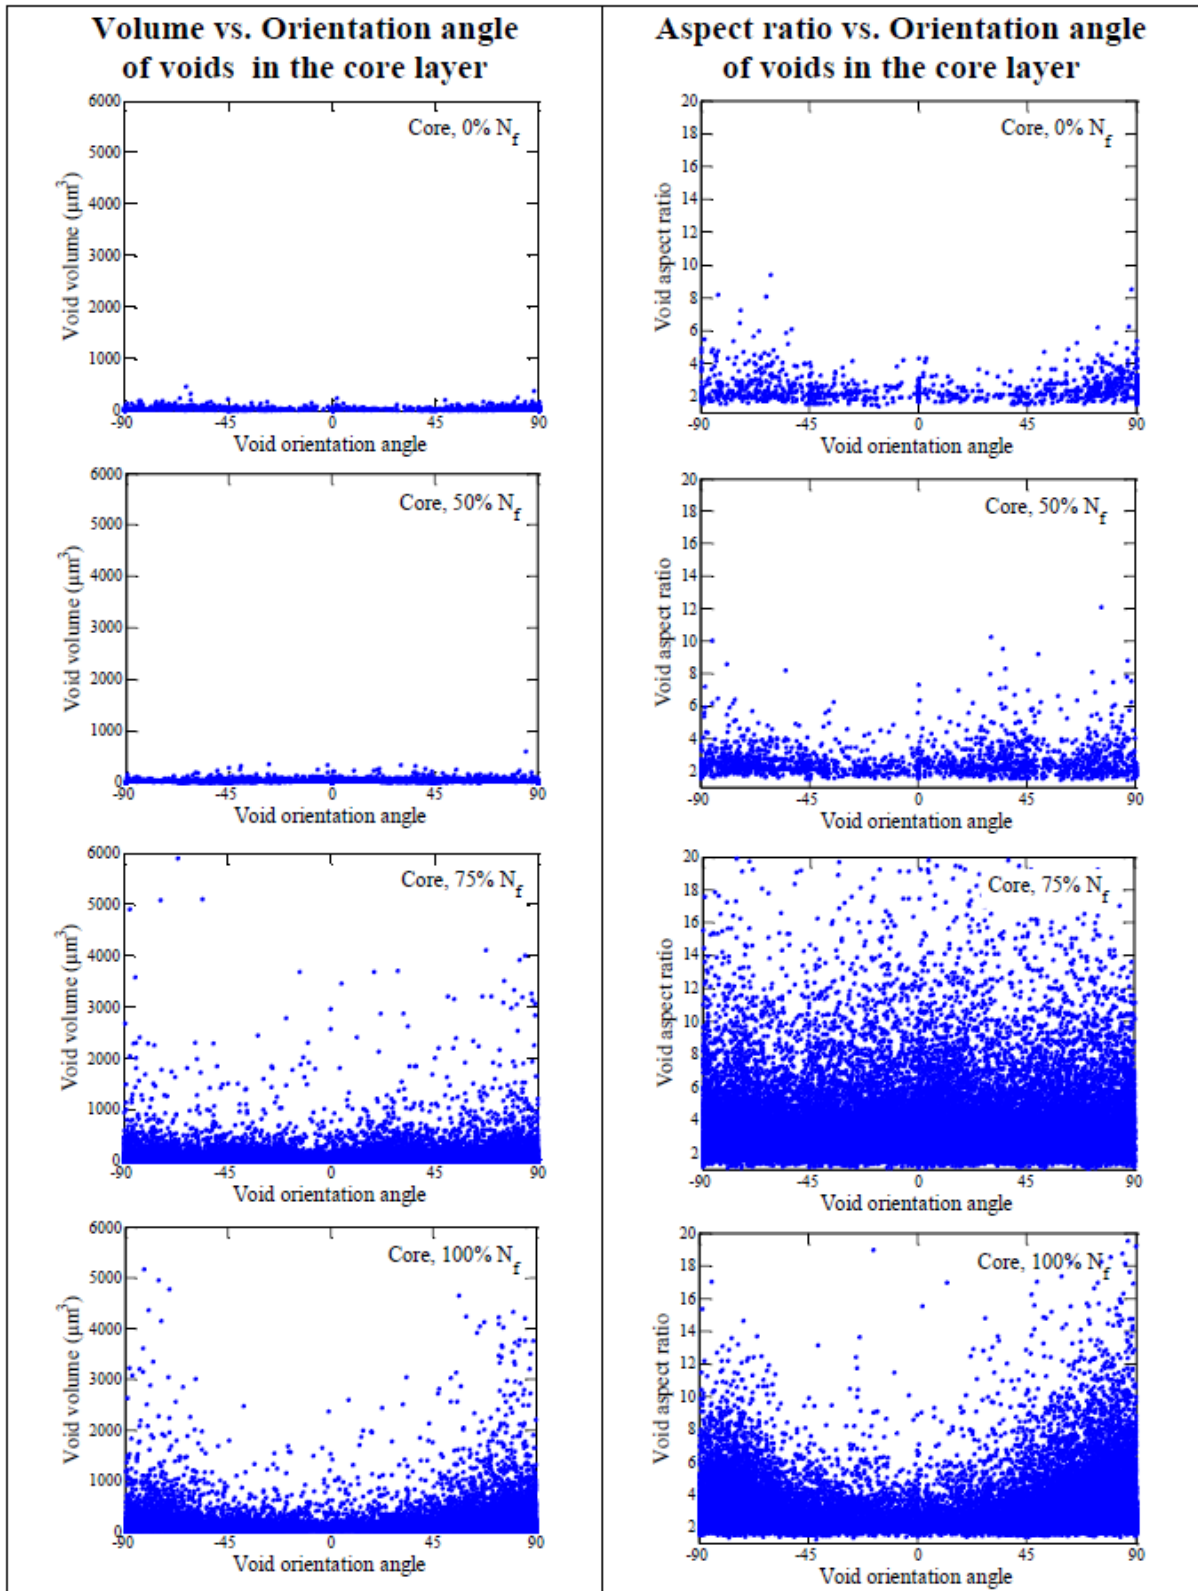
The evolution of void volume and void aspect ratio with respect to the void orientation angle and number of cycles at the core layer is then analyzed. As seen in Fig. 5, obvious increase of void volume is only remarked at 75% and 100% of fatigue life. It should be noted that the thin core layer for the specimens used in the current study doesn't impart an active role on the load transfer due to its perpendicular configuration with respect to the applied fatigue loading direction. Due to this reason, the voids are only significant at 75% and 100% of fatigue life. At 75% of fatigue life, voids are mainly situated along the fiber interface. However, these voids have no tendency to be oriented into a certain orientation angle. This is affirmed by the trend of void aspect ratio which shows a highly varying aspect ratio without any preferential void orientation. As the number of cycles increases, the void volume increases and elongates along the fiber interface. Therefore, at 100% of fatigue life, voids with high volume and aspect ratio are oriented at around  $90^\circ$ , parallel to the principal fiber orientation of the core layer but perpendicular to the applied fatigue loading direction.

**Figure 5.** Graphs of void volume vs. void orientation angle (*left*) and void aspect ratio vs. void orientation angle (*right*) of the representative  $\mu\text{CT}$  volume of **the core layer** of the specimens fatigue loaded up to different percentage of fatigue life ( $N_f$ ). The  $0^\circ$  void orientation angle represents the orientation parallel to the MFD and the applied fatigue loading.
