Maxime SAGNARD, Romain ECAULT, Laurent BERTHE, Kay BRUNE - Development of the symmetrical laser shock test for weak bond inspection - Optics and Laser Technology - Vol. 111, p.644-652 - 2019

Full length article

Development of the symmetrical laser shock test for weak bond inspection

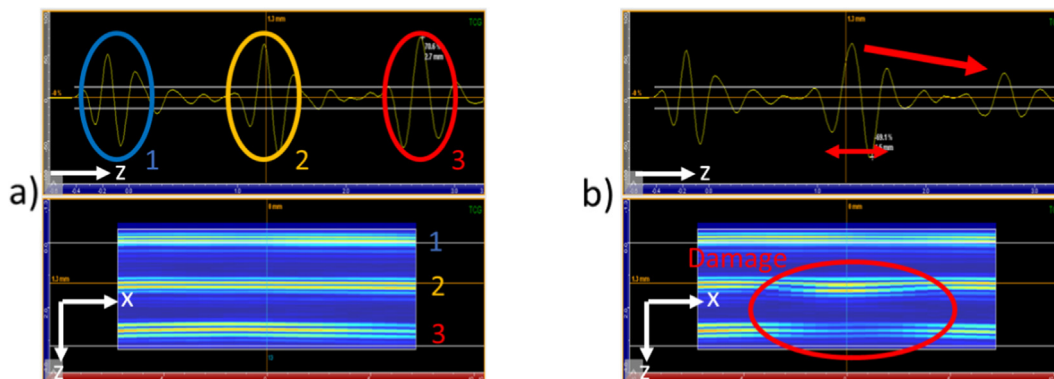
Fig. 7. A-Scan and B-Scan of the bonded CFRP assembly: (a) no damage (b) with damage.

For ultrasonic testing, a 32 elements linear probe was used, with a frequency of 5 MHz. CFRPs act as a low-pass filter, limiting the probe scanning frequency. The sample is composed of three different layers: a CFRP laminate, the adhesive bond, and the second CFRP laminate. Each one of these layers has a specific material impedance that is detected by ultrasounds. Fig. 7(a) is a typical signal obtained for a sound sample. The upper signal is a A-Scan. It is a 1D local measurement and each spike (marked 1, 2 and 3) is due to an impedance modification in the scanned part. In this case, 1 is the signal obtained when the ultrasonic wave first encounters the sample, 2 is the signature signal of the adhesive bond, and 3 is the signal obtained when ultrasounds reach the back of the sample. The lower image, called B-Scan, is a 2D cross-section cartography of the sample.

Ultrasounds cannot go through empty area, typically here disbondings. The signal is blocked, and little to no information is available after the opening. With A-Scan, it can be spotted by a loss of amplitude of one of the echoes. For example, the A-Scan from Fig. 7(b) shows a loss of signal from the back-face echo (3) as well as a widening of the bond echo. The B-Scan confirms the damage location on the bond, and thus, the occultation of the signal below it. Each time the sample was scanned from both sides to assure no defaults were hidden by the damaged bond.
