Maxime SAGNARD, Romain ECAULT, Laurent BERTHE, Kay BRUNE - Development of the symmetrical laser shock test for weak bond inspection - Optics and Laser Technology - Vol. 111, p.644-652 - 2019

Full length article

Development of the symmetrical laser shock test for weak bond inspection

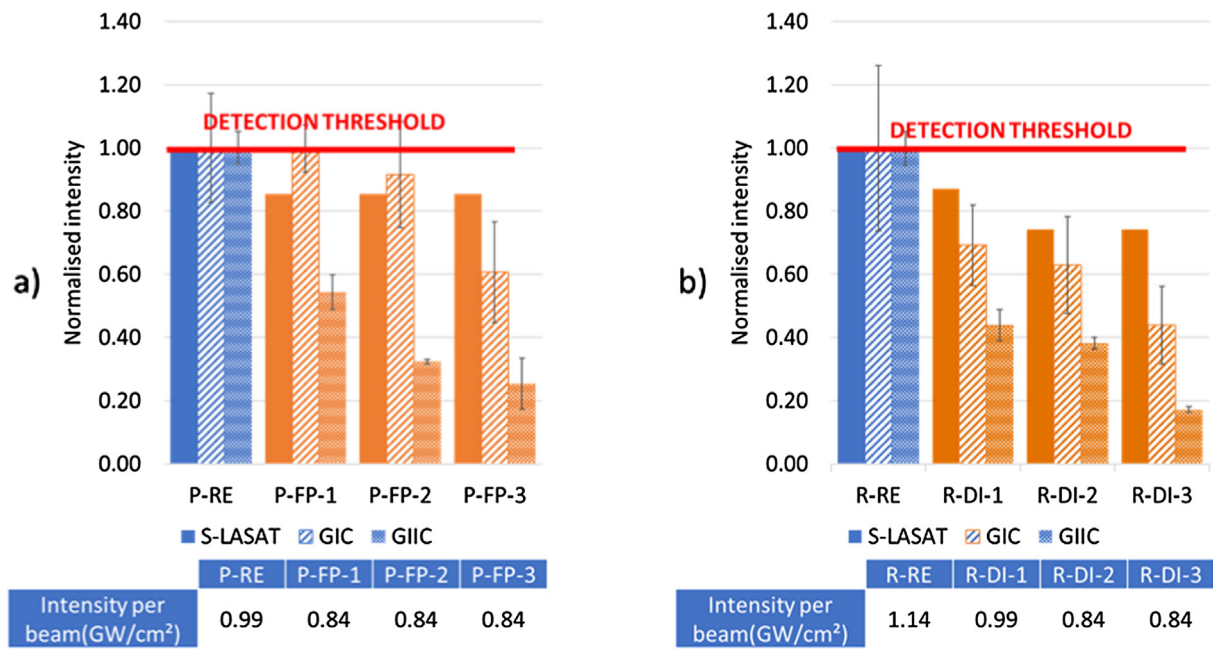
Fig. 8. Normalised results comparison between S-LASAT and the mechanical tests for: (a) the production reference sample (P-RE) and the three levels of finger print contamination, low (P-FP-1), medium (P-FP-2) and high (P-FP-3) – (b) the repair reference sample (R-RE) and the three levels of de-icing fluid.

Results for the finger print and the di-icer contaminations are presented in Fig. 8. To confirm the ability of the S-LASAT to spot a specific contamination, the measured energy required to open the faulty bond must be lower than the one obtained for the reference sample. Since data has been normalised, a contamination correctly isolated must be below the 1.0 mark (represented by the red line entitled “detection threshold” in Fig. 8).

As the GIC and GIIC test showed, the contamination of the sample modified the adherence strength of the sample. The S-LASAT showed the same results: a contaminated bond requires less laser intensity loading to be opened than a healthy one. The same observation was made for both contaminations.

In the case of the finger print sample, the technique did not differentiate the three levels of contamination. However, unlike standard mechanical tests that apply a constant load increase, the LASAT was performed using a load step, limiting the results’ accuracy. A smaller intensity step size could give more precise results. However, even with

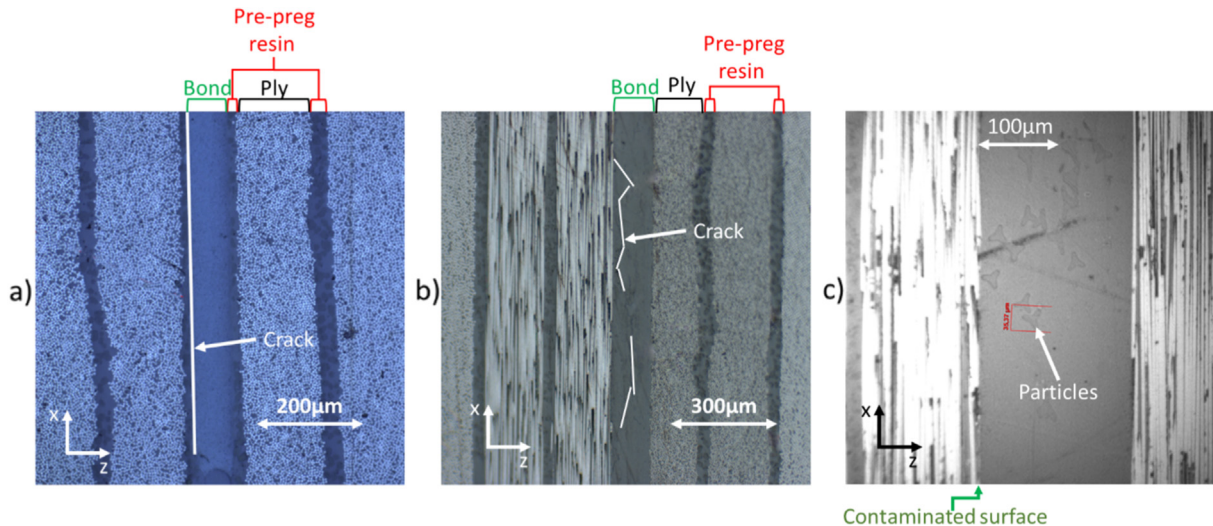
Fig. 9. Photomicrographs of the bond after damage created by S-LASAT: (a) production reference sample [13], (b) repair reference sample [13], and (c) highest degree of de-icing fluid contamination.

Important differences have been spotted however when comparing the damage patterns of the repair and production reference samples. In the production reference sample, the disbonding seemed to propagate mainly between the epoxy from the pre-impregnated CRFP and the

bond (Fig. 9(a)). However, cracks appeared primarily in the centre of the bond for a repair sample (Fig. 9(b)). The difference of bonding surfaces (CFRP fibres vs epoxy) could explain this variance as well as the presence of the knit carrier within the production bond.

Following the same study process, micrographs were realised on both sets of contaminated samples. The damage inside the FP contaminated samples was similar to the one observed before: creation of a disbonding between the epoxy from the pre-impregnated CFRP and the bond. However, no clear crack pattern was found for DI samples, instead microcracks were observed. This type of defect is harder to detect using linear ultrasounds and may not be spotted in the case of a lower contamination. A closer study of the specimen also revealed particles probably from the Safeway KF (Fig. 9(c)).
