Jianguang BAO, Siyuan BAO, Xiaofeng GUO, Yonghong WANG, Wei SUN, Adil BENAARBIA - High temperature strain heterogeneities tracking within hole-specimens of fv566 turbine steel via digital image correlation - Materials Science and Engineering: A - Vol. 777, p.139068 - 2020

# High temperature strain heterogeneities tracking within hole-specimens of FV566 turbine steel via digital image correlation

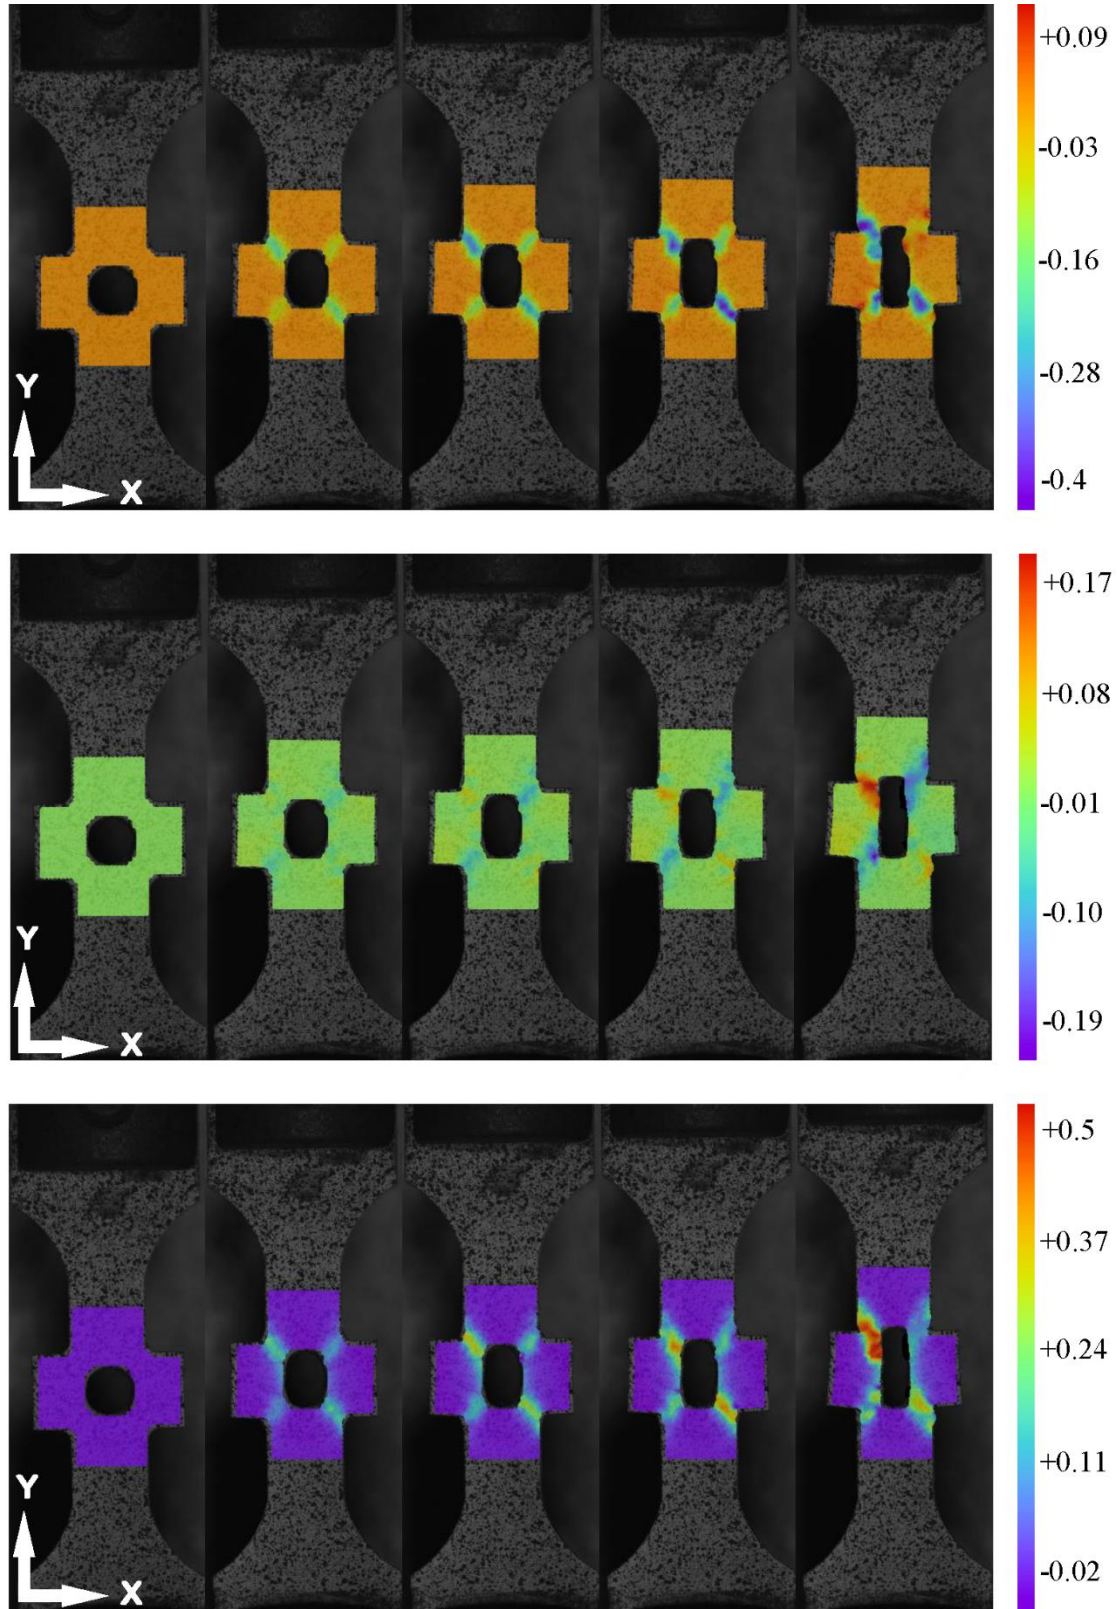
**Fig. 6.** 2D maps of the transverse strain,  $\epsilon_{xx}$  (top), shear strain,  $\epsilon_{xy}$  (middle), and longitudinal strain,  $\epsilon_{yy}$  (bottom) at: the very beginning of the test ( $\tau_1=0s$ ), intermediate times ( $\tau_2=810s$ ,  $\tau_3=1060s$  and  $\tau_4=1310s$ ) and the last stage before the macroscopic fracture ( $\tau_5=1877s$ ). These results were extracted from measurements performed under the 500 °C test temperature.

Fig. 6 and Fig. 7 show the full-field strain maps for the investigated FV566 tensile specimens at both 500 °C and 600 °C test temperatures, selected at different specimen life stages ( $\tau_1$ ,  $\tau_2$ ,  $\tau_3$ ,  $\tau_4$ ,  $\tau_5$ ). The spatial resolution was set at 20  $\mu\text{m}$  per pixel. The results show a precocious and gradual development of strain localization zones. These zones were clearly visible for all the strain components (longitudinal,  $\epsilon_{yy}$ , transverse,  $\epsilon_{xx}$ , and shear,  $\epsilon_{xy}$ , components). For 500 °C condition, at the very beginning of the loading, the spatial heterogeneities were less visible as indicated at  $\tau_1$ . These heterogeneities started to intensify at the following life stages till the macroscopic failure (see Fig. 6). It is worth noting that the painting near the strain concentration zones (where the hole is located) eroded due to the high temperature and large displacement exhibited by the test specimens. This results in inaccurate strain estimate at the last stages before the macroscopic fracture. Note that most of the observed hotspots were located around the specimen hole at the ROI due to the geometry singularity. Nevertheless, the strain field contours show that the strain concentrations were not perfectly symmetric. For the transverse strain, the top-left and the bottom-right sides of the hole were slightly intensive than these on the top-right and the bottom-left sides. However, at the instant  $\tau_5$ , some of strain localization zones were significantly less intensive than others. This is probably caused by inhomogeneous features of the investigated specimen and/or the inaccuracy of the measurements. The spatial distributions of the longitudinal strain component on the top-left side of the hole were more intensive than these on the bottom-right side. From a statistical point of view, the absolute values of both the minimum and maximum longitudinal strain were almost the same at the

very beginning of the loading, highlighting the homogeneous character of the investigated gauge part. However, with the increase of the load, the absolute value of the minimum longitudinal strain was about thousand-fold lower than the maximum longitudinal strain. For the shear component, the spatial strain concentrations were mostly located on the top-left and top-right sides of the hole. As expected, the localization patterns seemed to progress preferably according to 45° angle (with a shape of “X” letter). At 600 °C (see Fig. 7), the strain localizations for the transverse and longitudinal components showed similar patterns as those obtained for the 500 °C condition while the higher values of the shear strain were appeared at top-right and bottom-left side with a shape of “/” from where sample fractured finally.

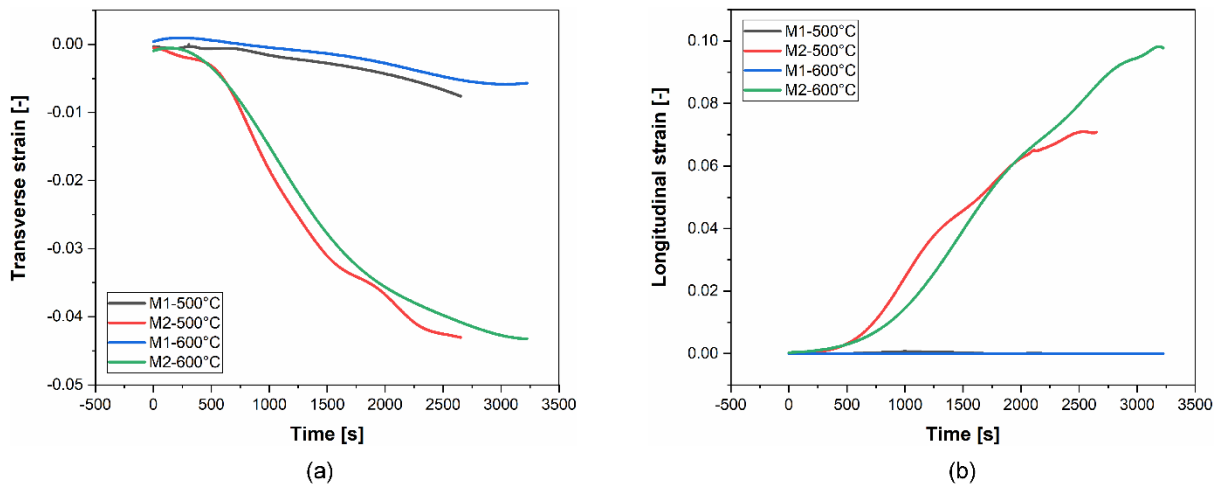
**Fig. 9.** (a) True transverse strain curves, and (b) true longitudinal strain curves with respect to the test time at M<sub>1</sub> and M<sub>2</sub>.

Selected points  $\{M_k\}_{k=1,2}$  were considered for the time dependent strain analysis (see Fig. 5b). Figs. 9a and b depict the temporal evolution at both 500 °C and 600 °C test temperatures of the selected longitudinal and transverse strain components,  $\epsilon_{xx}$  and  $\epsilon_{yy}$ , respectively. It can be seen that at the beginning of the tests, all strain components had very small magnitudes. After 300s, the absolute strain values at  $M_2$  started to increase rapidly with time, while those at  $M_1$  seemed to slightly evolve throughout the test. Indeed, Fig. 9a shows that the transverse strain curves at both temperatures were almost identical. Fig. 9b shows that the orders of magnitude of the longitudinal component for  $M_1$  were smaller compared to those of  $M_2$ ,

which were almost identical to the true principle strains under both test temperatures. This allows to suggest that the longitudinal strain component significantly contributed to the ductile failure of the specimen. The maximum longitudinal strain value at 600 °C was around 0.1, while this value reached 0.07 at 500 °C, highlighting the effect of temperature on the ductile damage evolution of the FV566 steel under investigation.
