Microstructure investigation of hydrothermal damage of aged SMC composites using Micro-computed tomography and scanning electron microscopy

This paper presents an investigation on the effects of hydrothermal aging on Sheet Molding Compound (SMC) composite. Two different techniques were carried out to study the inner structure of aged SMC composite. Firstly, X-ray micro computed tomography (X μ CT) was used to evaluate the changes using 3D images. The results showed cracks in all the composite structure with different shapes and volume in response to the hydrothermal conditions. The cracks results from the build up of an osmotic pressure in microcavities, which is proportional to water concentration. However, it was not possible to quantify separately the hydrothermal induced damage in the studied SMC composite material. Therefore, the X μ CT analyzes were supplemented by a microscopic study. This step has been studied in terms of crack density evolution and crack propagation rate. The results obtained by X μ CT technique and SEM observations show that the damage increases continuously with time and temperature during aging. The damage was found to be located in the voids contained

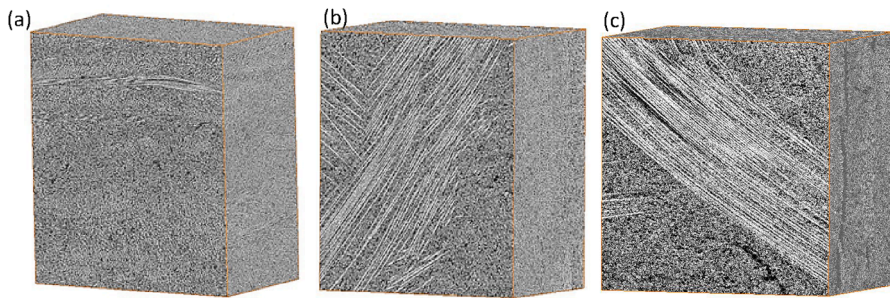
The X μ CT was performed to visualize and understand the 3D damage evolution during hydrothermal conditions. In Figs. 7 and 8, three-dimensional reconstructions of a 50 °C and 90 °C aged samples after three water uptake levels (15%, 30% and 60%) are shown. The focus was put on the inner parts to visualize the most important damage mechanisms namely matrix cracking and fibre–matrix debonding.

Fig. 8. 3D damage observation of 50 °C aged SMC samples after (a) 15% M_s , (b) 30% M_s , and (c) 60% M_s .
