Microstructure and mechanical property assessment of stainless steel–clad plate joint made by hybrid SMAW-GTAW multi-pass welding process

Rami Ghorbel¹ · Ahmed Ktari^{1,2} · Nader Haddar¹

Abstract

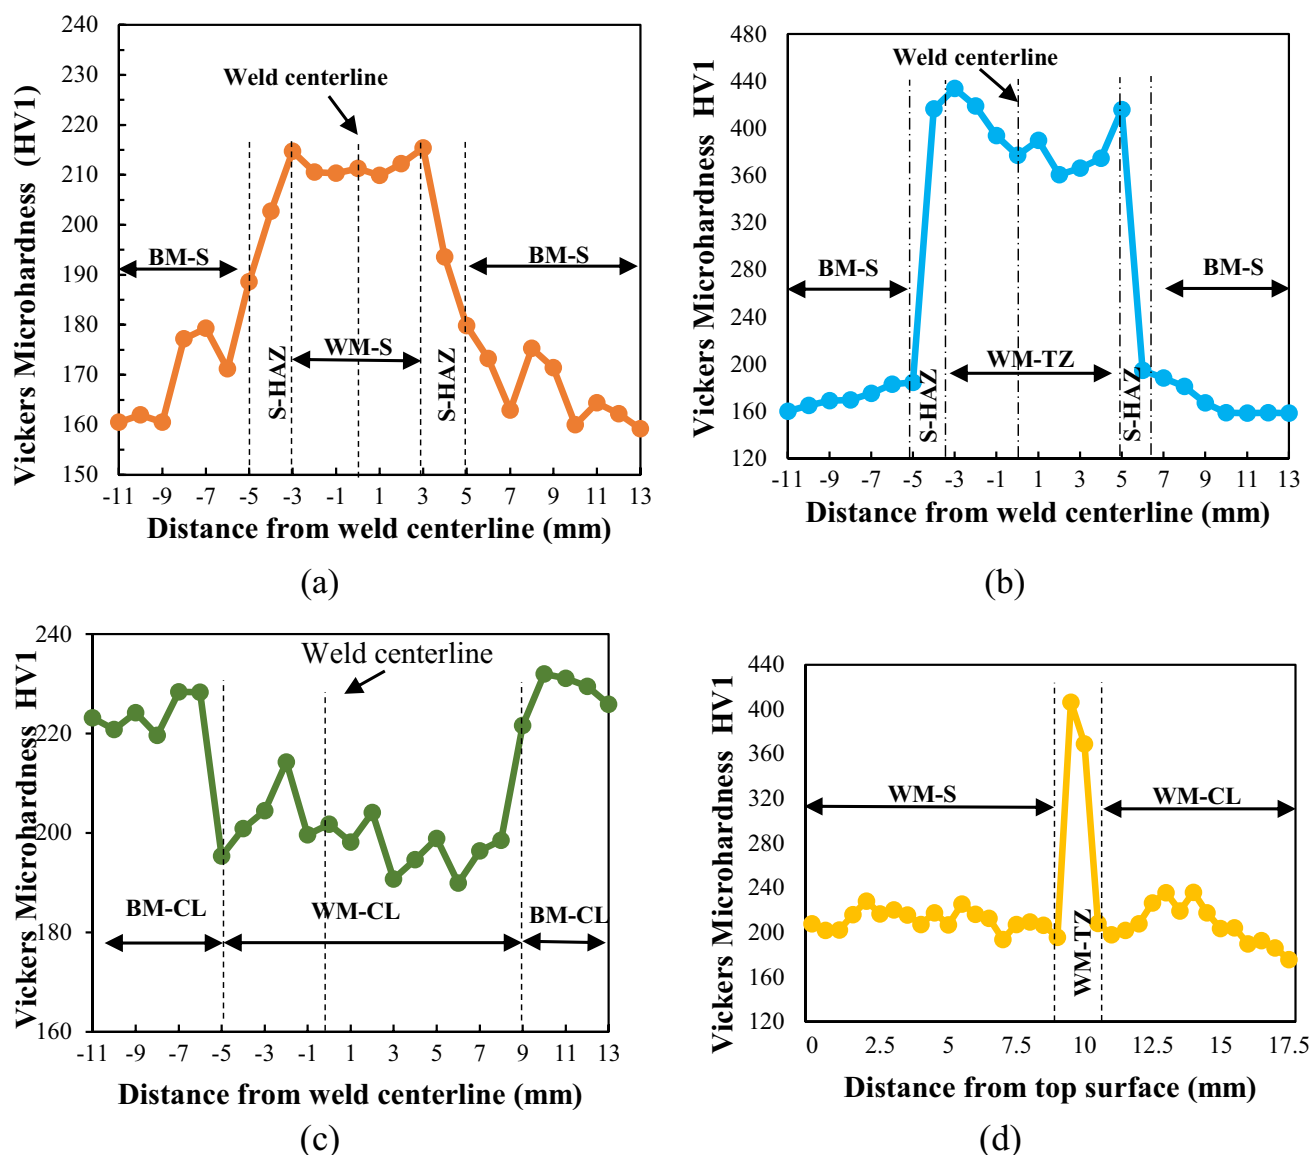
The micro-hardness measurements conducted along four paths on the welded specimen (Fig. 4) are depicted in Fig. 15. The micro-hardness profile performed along L1 direction (Fig. 15a) shows that the hardness values measured on the S-HAZ surface (average 208 ± 8 HV) are slightly higher than those measured on the WM-S (average 213 ± 5 HV) and the BM-S (average 171 ± 9 HV). The highest micro-hardness level measured on the S-HAZ can be ascribed to the perlite dissociation, which is observed in Fig. 7b. In contrast, the micro-hardness values measured on the WM-S are lower, but still higher than those measured on the BM-S owing to the high cooling rate and grain refinement at the WM-S (Fig. 7c).

Figure 15b displays the micro-hardness profile of the welded joint along L2 direction. It is obvious that micro-hardness values measured on the S-HAZ near the interface (average 429 ± 30 HV) are significantly higher than those measured on the WM-TZ (average 384 ± 14 HV) and the BM-S (average 171 ± 17 HV). The highest micro-hardness level measured on the S-HAZ can be assigned to the carburized layer shown in Fig. 10a along the FB. Herein, it is obviously clear from Figure 15b that the highest micro-hardness values are in the vicinity of the fusion line. Indeed, the carbide forms in this area due to the chrome and carbon diffusion phenomenon at high temperature leading to the formation of the type I and type II boundaries as clearly seen in Fig. 14. However, the micro-hardness values measured on the WM-TZ are lower, but still higher than those measured on the BM-S. This can be ascribed to the presence of the martensite laths as already observed in Figure 10c.

Figure 15c shows the micro-hardness curve across the L3. The micro-hardness values measured on the WM-CL vary slightly (average 221 ± 19 HV) and are found to be

Fig. 15 Micro-hardness of the welded joint along: **a** L1, **b** L2, **c** L3 and **d** L4 profiles

The micro-hardness profile along L4 direction is shown in Fig. 15d. It is clear that both of WM-CL and WM-S have shown no large variation in micro-hardness values. In contrast, the micro-hardness value of the WM-TZ increased significantly and reached about 406 HV. This can be attributed to the presence of the martensitic phase previously observed in Fig. 10c as well as the presence of the carbide agglomerated in the FB and observed as type I and type II boundaries (Fig. 14).
