Evaluation of the performance of coated and uncoated carbide tools in drilling thick CFRP/aluminium alloy stacks

M. Montoya · M. Calamaz · D. Gehin · F. Girot

Keywords Drilling · Composite/aluminium stacks · Tools wear · Holes quality · Thrust force

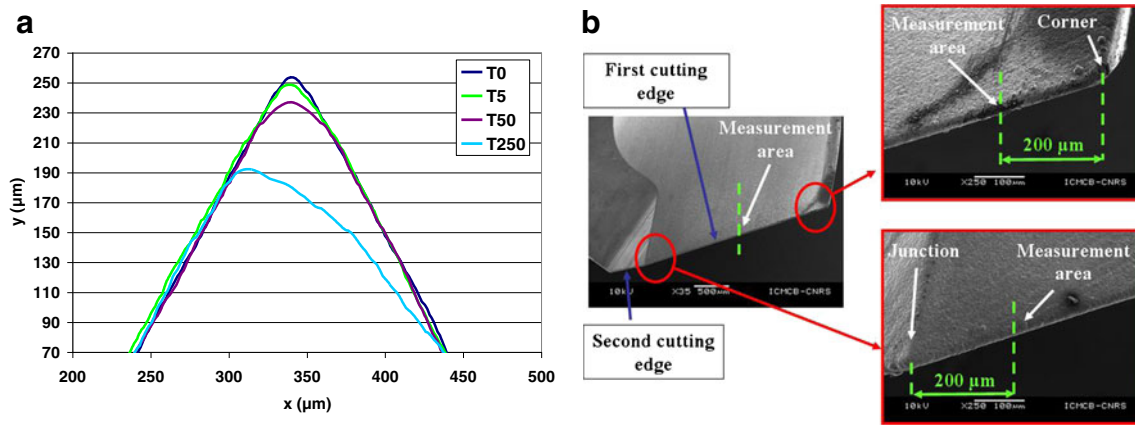
Fig. 1 a Cutting edge profile for tool A at 200 μm from the drill corner after 5, 50 and 250 holes compared with the unworn profile (T0). b Measurement location on the cutting edge to obtain 2D edge profile

measures were performed on three locations on the tool cutting edges: at 200 μm from the drill corner, at the centre and at 200 μm from the junction between the first and the second cutting edges, as seen in Fig. 1b. In addition, tool wear mechanisms were identified using a scanning electron microscope (SEM).

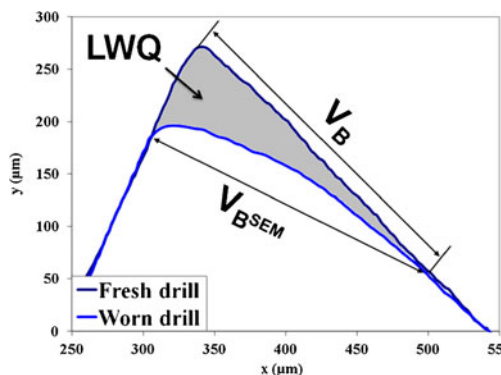
Fig. 2 Measurements of flank wear (V_B) and local wear quantity (LWQ) on a cutting edge profile

edge and the last point worn on the flank face (V_{BSEM} in Fig. 2).

From the 2D cutting edge profiles, the actual flank wear value (V_{B} in Fig. 2) can be obtained. It is also possible to estimate, from the tool edge profiles superposition, the amount of the material locally lost by the tool (grey surface in Fig. 2)

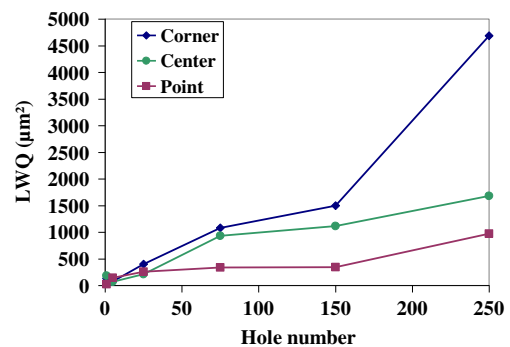
Fig. 3 LWQ measured on three locations on the cutting edge

The measurement of the LWQ, on three locations on the cutting edge, has shown the non-proportionality of the LWQ with the radial position of the measurement location (Fig. 3). The higher LWQ is found at the drill corner and it decreases up to the drill point.

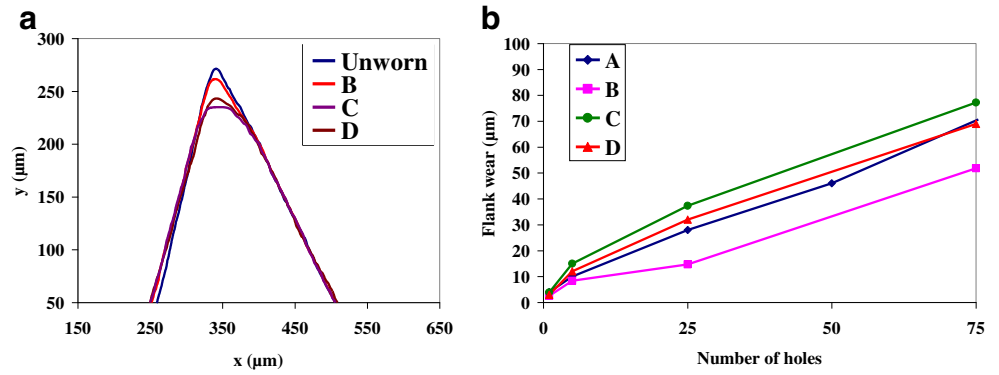
Fig. 4 **a** Cutting edge profiles near the drill corner after 75 holes for drills B–D. **b** Flank wear evolution with the number of holes (located at 200 μm from the drill corner) for drills A–D

All the drills have the same unworn profile, except the cutting edge radius. Therefore, in Figs. 4a and 5a, only the

unworn profile of the drill A is shown. TiAlCrN (tool C) and AlTiSiN-G (tool D) coatings were not efficient. Their flank wear was very close to the one measured on the uncoated tool A (Fig. 4b). As shown in Fig. 4a, the cutting edge profiles of these tools are also similar.

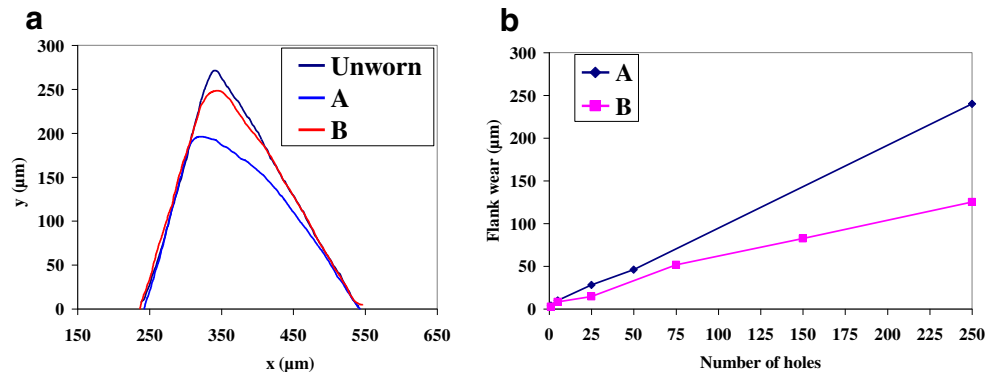
Fig. 5 **a** Cutting edge profiles of unworn and worn A and B drills (after 250 holes). **b** Flank wear (near the drill corner) evolution with the number of holes

Diamond coated tool B is the only really effective one. For this tool, the coating breakage occurred after drilling 150 holes. The flank wear measured on this coated drill is 50 % lower than that measured on the uncoated drill (tool A), as shown in Fig. 5b. As for the LWQ, the use of a diamond coating allows a drill wear decrease of about 80 %.

Low hole surface roughness with a good stability in time (Fig. 14) is obtained by diamond coated tool B, due to its slight evolution of the cutting edge profile (Fig. 5a).

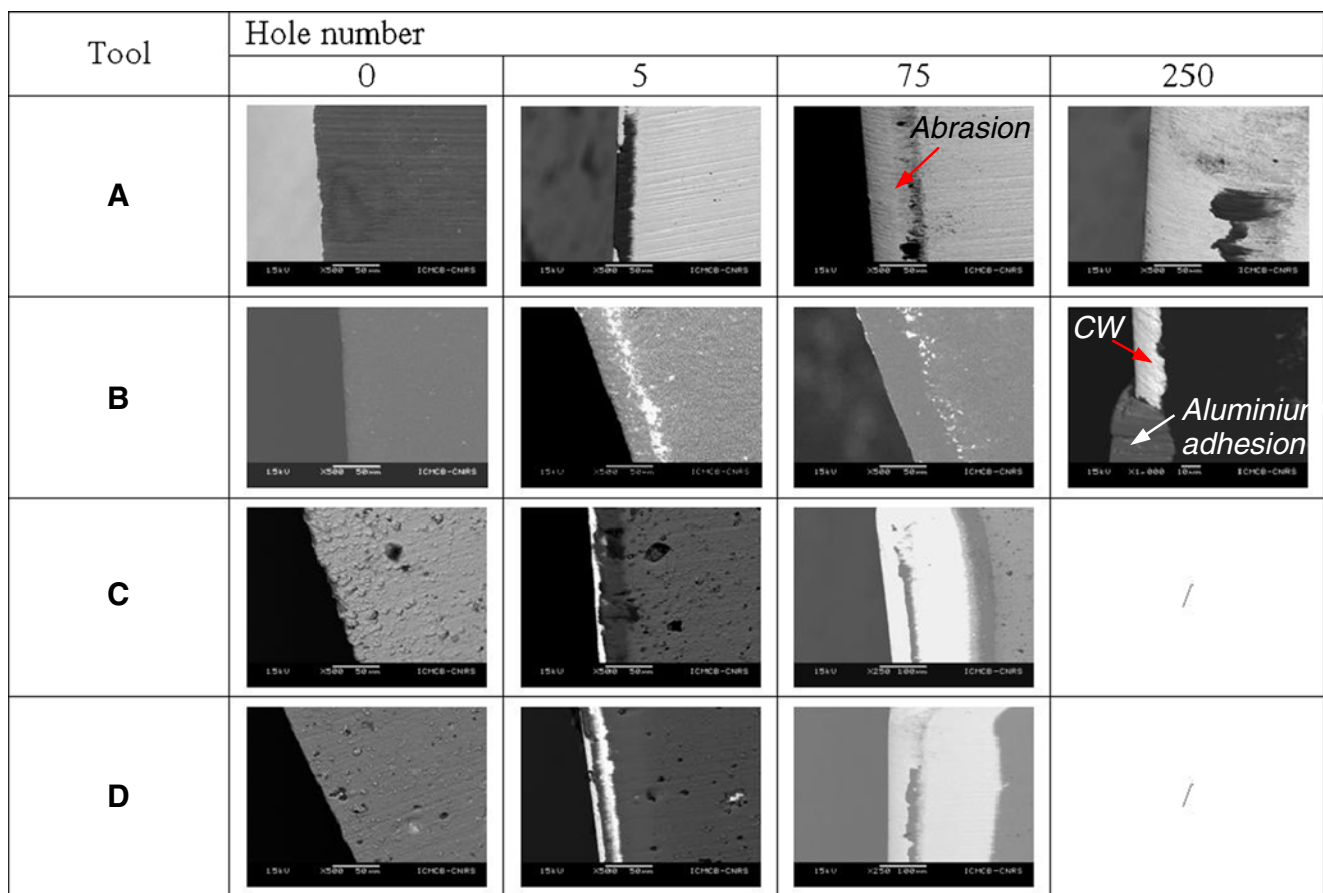
Fig. 6 SEM images of drills flank faces

Figure 6 shows the SEM images of the rake and the flank drill faces, beginning with the unworn stage (hole 0) up to hole 250. These images show that the drill cutting edge was mainly affected by abrasion wear, but some adhesion of Al can also be identified on the cutting edges. The abrasion was the main wear mechanism identified on the uncoated tool. Some adhesion can also be seen on the tool rake face but far from the cutting edge (tool A in Fig. 8). The coated drills underwent abrasion, followed by coating failure on the

As it can be seen on Fig. 6, the SEM images show the coating failure after the 5th hole, for tools C and D. The coating was removed all along the cutting edge. After drilling 75 holes, these tools can be considered as uncoated because extended areas on the flank and rake faces lost their coating. Therefore, the drilling tests were stopped after 75 holes.

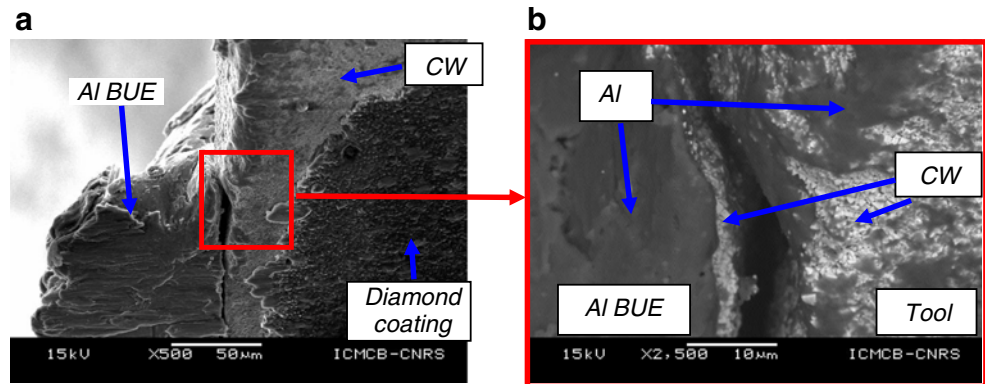
Fig. 7 **a** Attrition phenomenon on the cutting edges for tool B. **b** Zoom of the zone of interest, in chemical contrast (magnitude, 2,500)

For uncoated tools, abrasion was observed on the chisel edge, on the corner, on the primary and on the second cutting edges. Before the coating failure, coated drill B underwent the same type of wear as the uncoated drill. It was subjected to abrasion, followed by coating failure on the cutting edge. After the coating failure, an aluminium layer replaced it on the cutting edge and created a build-up edge (BUE). This adhesive wear is then the site of WC attrition. The BUE, stuck on the cutting edge, tears CW particles when it is removed, as observed on Fig. 7a, b.

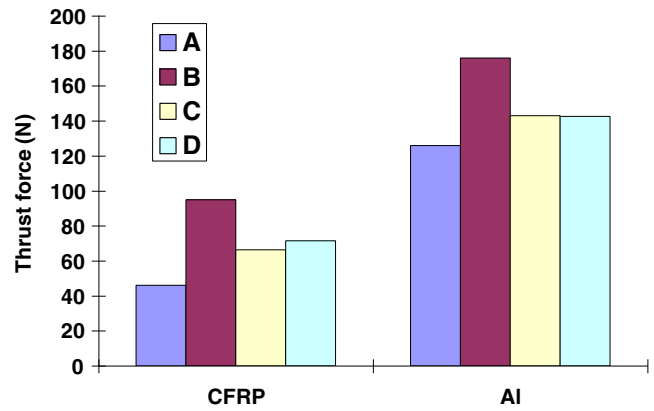
Fig. 9 Average thrust force on the first hole

For the first hole, when the drills are unworn, the average thrust force of the uncoated drill A is from 30 to 50 % lower than the thrust forces of the coated drills B–D (Fig. 9), mainly due to the cutting edge sharpness. Cutting edge radius was 9 μm for tool A, 11 μm for tools C and D, and 15 μm for tool B. This difference concerning the cutting edge sharpness is the consequence of the coating thickness.

CFRP and Al have dissimilar mechanical properties. Therefore the thrust force generated by drilling has different magnitudes. As shown in Fig. 9, the force generated by CFRP drilling was lower than that produced in the aluminium, on the first hole. Zitoune et al. [12] obtained a similar trend, using comparable drill diameters. Brinksmeyer et al.

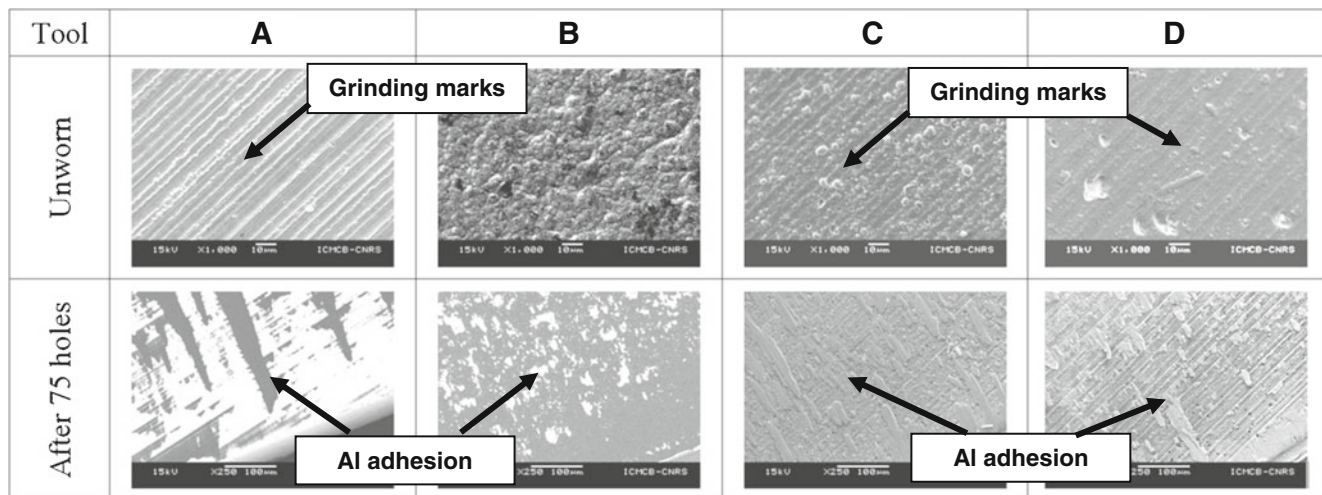
Fig. 8 SEM images of rake faces of unworn and worn drills (after 75 holes)

Adhesion was also observed on the tool rake face. Grinding processes, carried out to prepare drill flutes, generate a relatively rough surface. Therefore, Al adheres on the rake face. The amount of Al deposited on the tool depends on the surface roughness. With a thin layer coating, like for tools C and D, the coating thickness was unable to totally erase the grinding marks (Fig. 8). It can be observed that the coating takes the surface profile and the same amount of material adheres on the tool, as for the uncoated drill. The diamond coating thickness was able to “erase” the previous grinding marks (see tool B on Fig. 8). Therefore, for this coating, less Al alloy has stuck on the rake face, as seen in Fig. 8.

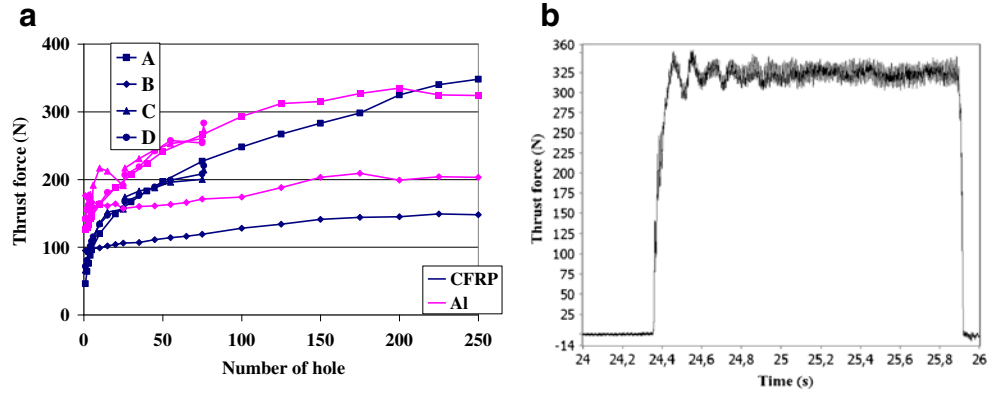
Fig. 10 **a** Evolution of average thrust force with the number of holes. **b** Thrust force signal on hole No. 200 (for one of the five cutting passages in Al plate)

The average thrust forces increase with the number of drilled holes (Fig. 10a). The thrust forces generated by the uncoated drill, gradually rise in both CFRP and Al alloy. This trend was also observed for the coated drill B, but it was lower. This increase is mainly due to the tool wear. The thrust force grow is dissimilar between the two materials. For the aluminium, the increase of thrust force is asymptotic near the 250th hole while for the CFRP, the thrust force continues to increase. This implies that the thrust force measured in the CFRP can become higher than that observed in the aluminium, as for tool A on the 250th hole.

The benefit of the diamond coating on thrust force is shown in Fig. 10. For the same cutting conditions, the use of a diamond coating can decrease the force (by limiting wear) by 65 % when drilling CFRP and by 35 % in Al.

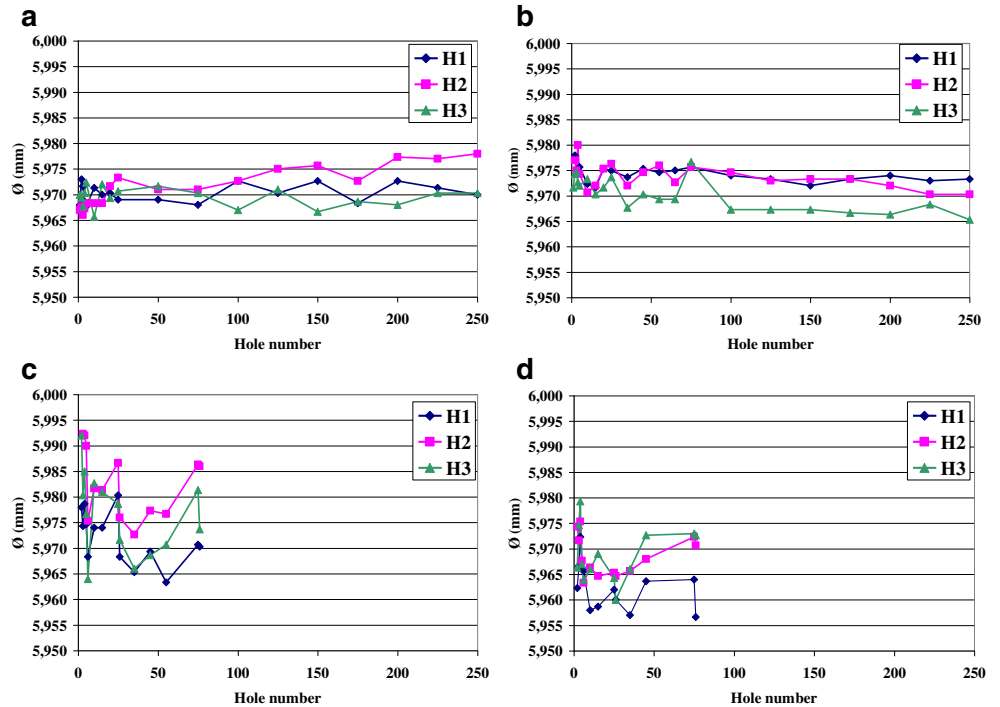
Fig. 11 Hole diameter evolution for tool **a** A, **b** B, **c** C and **d** D

Figure 11a–d shows that the evolution of the diameter of the holes with the number of drilled holes is relatively stable, especially for tools A and B. This stability was also observed by Benezech et al. [17]. It can also be seen that the diameter of the holes drilled in CFRP (H1 and H2 in Fig. 11) is bigger than the one measured in the Al alloy. Some additional experiments have shown that opposite trends can be obtained following the used cutting condition and particularly, the lubrication condition. Without lubrication and for the same tool geometry, the diameter of the holes drilled in CFRP remains the same but bigger diameters are produced in the aluminium. Therefore, diameters of the holes drilled in Al are becoming bigger than those produced in the CFRP. This difference can be due to thermal phenomena that occur during the drilling process. A diameter difference in CFRP and in the metal part was also noted by Shyha et al. [18].

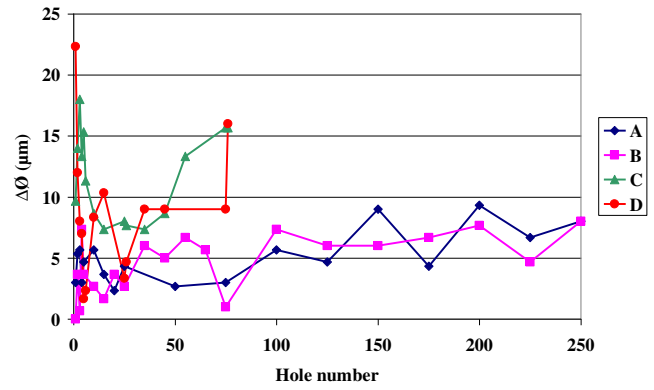
Fig. 12 $\Delta\phi$ evolution with the number of drilled holes

The difference between the average diameter in both altitudes in CFRP, and the diameter in metal, noted $\Delta\phi$, is shown in Fig. 12. Best results are observed for drills A and B with a $\Delta\phi$ of 8 to 9 μm against 16 to 18 μm for drills C and D. As it can be seen in Figs. 11 and 12, the presence of a coating has little or no influence on the diameter difference ($\Delta\phi$). No diameter deviation was observed with the number of holes, as it can be seen in Fig. 11. With a similar drill diameter, different results were obtained by Benezech et al. [17] where the diameter difference was nearly 30 μm .

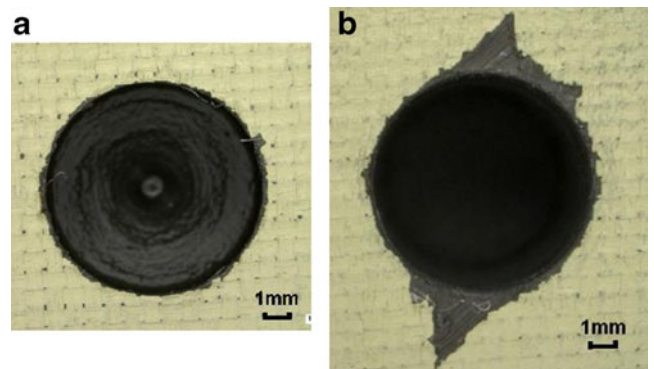
Fig. 13 CFRP damages at the hole entry **a** before and **b** after aluminium chip evacuation

The CFRP damage at the hole entrance, shown in Fig. 13b, was observed whatever the drill used, starting with the first hole. Therefore, it can be concluded that this phenomenon is not due to the tool wear. It can be caused by the tool geometry, as described by Hocheng et al. [19], where the drill flute pulls out the first layers of the composite material. Or, in the case of a multi-material, this damage can be due to the metallic chip evacuation through the hole, as observed by Brinksmeier et al. [8]. The last hypothesis has been proved in our case by observations made before aluminium part drilling and chip evacuation. Due to the chip removing cycle, the drilling process can be stopped at any time. For ten holes, the drilling process was stopped before creating aluminium chips. A workpiece photo was taken at this moment and no CFRP damage was observed, as it can be seen in Fig. 13a. After completed drilling process, the CFRP damage reaches more than 2 mm (Fig. 13b). The drill flute does not guide the chip

enough all along its length and, as seen by a CCD high speed camera, the metal chip is in contact with the hole entrance. As shown in Fig. 13b, this damage is not localised all around the hole entrance. It is situated in places where the direction of the chip movement (due to drill rotation) and the fibre orientation creates a -45° angle. In this configuration, similar damages have been observed by Iliescu [20] during CFRP cutting.

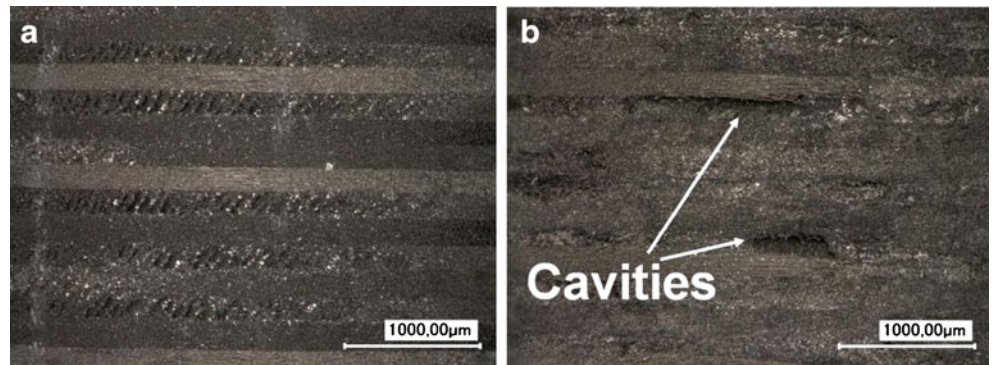
Fig. 15 CFRP hole wall on the **a** 1st and **b** 250th hole drilled by the uncoated tool A

The increasing of the roughness is due to the wear undergone by tool A and its rapid growth. Sharp cutting edges generate no defect on the holes wall (Fig. 15a) and low roughness is measured. When the tool cutting edge sharpness becomes too low, the drill is unable to cut the carbon fibres. These fibres are rather pulled out than cut, especially when the cutting direction and the fibres create a -45° angle. As a consequence, little cavities are generated on the holes wall (Fig. 15b) and therefore, the roughness increases. The same phenomenon was observed by Iliescu [20] when drilling CFRP plates.
