Kamel MAKHLOUF, Naziha SIDHOM, Ammar KHLIFI, Habib SIDHOM, Chedly BRAHAM - Low cycle fatigue life improvement of AISI 304 by initial and intermittent wire brush hammering - Materials and Design - Vol. 52, p.1088-1098 - 2013

# Low cycle fatigue life improvement of AISI 304 by initial and intermittent wire brush hammering

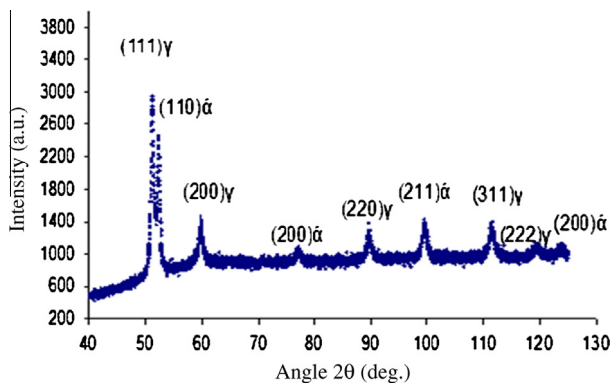
Fig. 10. Wire brush hammering of AISI 304 showing austenite  $\gamma$  and martensite  $\alpha$  after cyclic plastic deformation at ( $\Delta\epsilon_t/2 = \pm 1\%$ ).

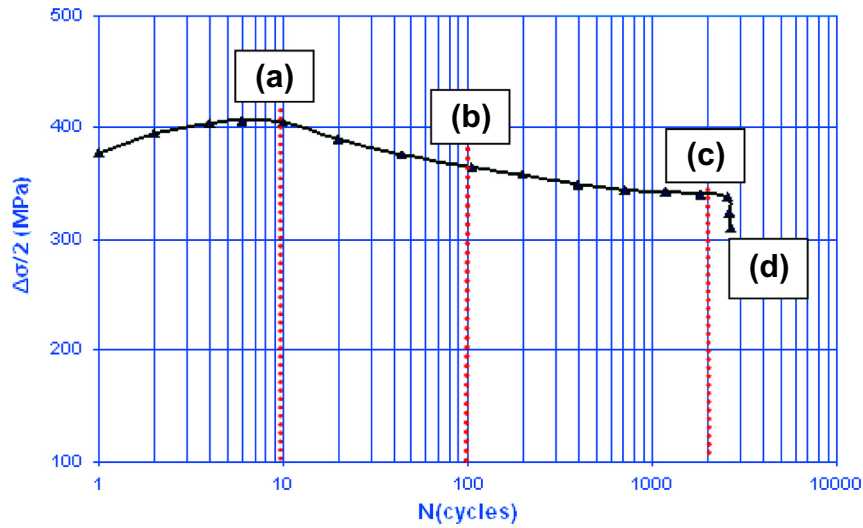
(a) Localized deformation in persistent slip bands produced after 10 cycles.

(b) Denser persistent slip bands observed after 100 cycles.

(c) Appearance of micro-cracks at the grain scale after 1000 cycles.

(d) Coalescence of these micro-cracks to produce the final fracture.

Fig. 12. Damage made in low cycle fatigue in AISI 304 stainless steel.

3.3.3.1. *Basic mechanisms.* The damage mode in low cycle fatigue was evaluated by SEM metallographic examination of the samples surfaces loaded at  $\Delta\epsilon_t/2 = 0.7\%$  at different periods marked (a, b, c and d) on the consolidation curve ( $\Delta\sigma/2$  versus  $N$ ) given in Fig. 12. These samples were polished and etched before the fatigue tests. Metallographic examination of these surfaces revealed the following:

- After only 10 loading cycles, the material strengthens slightly resulting in an increase of  $\Delta\sigma/2$  from 377 MPa to 405 MPa. This strengthening is caused by cyclic plasticity through the appearance of low density slip lines with few steps as shown in Fig. 12a. This phenomenon is referred to as stage I.
- After 100 loading cycles, the material undergoes softening as  $\Delta\sigma/2$  goes down from 405 MPa to 358 MPa. This is referred to as stage II.

- After 1000 cycles, the stress amplitude decreases furthermore to 340 MPa and few micro-cracks appear along the slip lines as shown in Fig. 12c. These are stage III features.

At this level, micrographic analysis reveals widespread damage characterized by the appearance of micro-cracks at the grain scale associated with very dense persistent slip bands. It should be noted that these micro-cracks are substantially perpendicular to the axis of the applied load (Fig. 12c).

Additional loading leads to further accumulation of damage to form networks of interconnected micro-cracks as shown in Fig. 12d. These micro-crack networks will grow to produce the final fracture of the sample.
