M.H. STAIA, Eli-Saul PUCHI-CABRERA, Alain IOST, E. CARRASQUERO, Y.Y. SANTANA, J.G. LA BARBERA-SOSA, Didier CHICOT, Adrien VAN GORP - Sliding wear of a-C:H coatings against alumina in corrosive media - Diamond and Related Materials n°38, p.139-147 - 2013

# Sliding wear of a-C:H coatings against alumina in corrosive media

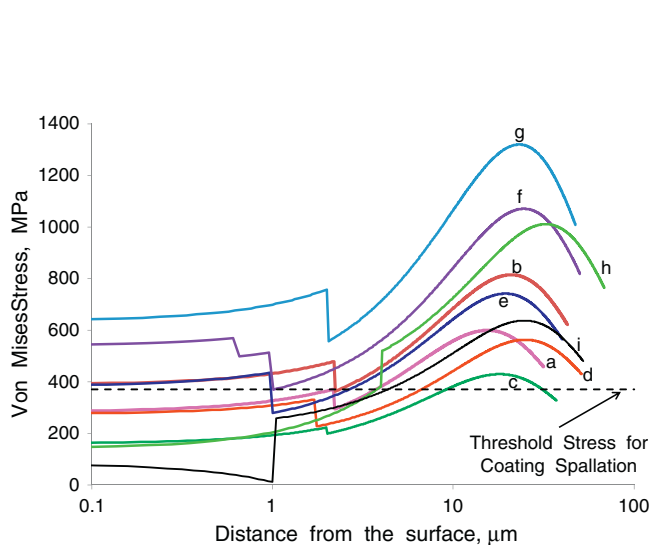
**Fig. 7.** Variation of the von Mises stress with the distance from the surface for the systems under study and for other DLC coated systems reported in the literature and described in Table 2.

to the work of Park et al. [15], as the distance from the surface increases, the stress also increases smoothly within the coating up to the interface. At this location one or two discontinuities can be observed, depending on the presence of a bonding interlayer between the substrate and coating. At these interfaces the stress decreases abruptly. Once the substrate is achieved, the stress continues to rise as the distance from the surface increases. Thus, a maximum stress value is achieved, after which the stress starts to decrease. In the case of curve i, it can be observed that the stress decreases smoothly within the coating and rises abruptly at the interface, after which it exhibits the same trend found for the other curves. The different coated systems have been identified with a corresponding letter both in Tables 2 and 3. A dotted line indicating a stress of 370 MPa is also included in the plot, which indicates the

However, it should also be borne in mind that below the coating, the existence of a 316L stainless steel layer could provide an elastic support to it. For example, for curves a and b in Fig. 7, corresponding to the tests conducted in the present research, it can be seen that when a normal load of 2 N is applied (curve a), the thickness of the elastic layer, of about 8.3 μm, is approximately 4 times the thickness of the coating and decreases to 5.5 μm for a load of 5 N (curve b). Consequently, it will be expected that plastic deformation of the substrate occurs at a distance from the surface greater than approximately 3 μm (curve f) and that during a wear test carried out in air, for both values of the applied load, no cracking will occur that could give rise to the coating detachment.

As can be seen in Fig. 7, the state of stress for the coated system under a load of 5 N (curve b) is more severe than in the case of a 2 N load (curve a). Therefore, it could be argued that its severity enhances the corrosive action of the solutions, similarly to the commonly observed stress corrosion-cracking phenomenon.

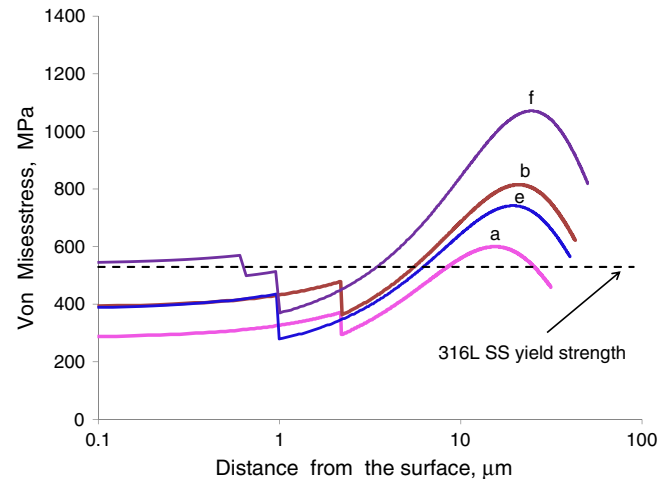
**Fig. 8.** Stress distribution curves for the coated systems whose substrate is 316L stainless steel: curve a (wear test carried out in 3.5% NaCl solution at 2 N normal load—present work); curve b (wear test carried out in 3.5% NaCl solution at 5 N normal load—present work); curve e (wear test carried out in water at 4 N normal load—Yi et al. [12]); curve f (wear test carried out in Ringer solution and 9 N normal load—Azzi et al. [10]). Dotted line corresponds to the substrate yield strength of 530 MPa.

Fig. 8, on the other hand, illustrates the stress distribution curves only for the coated systems whose substrate is 316L stainless steel. From Table 3 and Fig. 8, it can be observed that for the coated systems investigated in the present work (corresponding to curves a and b in Fig. 8), as well as in those studied by Yi et al. [12] (curve e) and Azzi et al. [10] (curve f), the substrate yield strength is approximately equal to 530 MPa. These coated systems should behave similarly, given the fact that the maximum values of the von Mises stress computed for each system exceed the yield strength of the substrate for all the normal loads used.
