M.H. STAIA, Eli-Saul PUCHI-CABRERA, Alain IOST, E. CARRASQUERO, Y.Y. SANTANA, J.G. LA BARBERA-SOSA, Didier CHICOT, Adrien VAN GORP - Sliding wear of a-C:H coatings against alumina in corrosive media - Diamond and Related Materials n°38, p.139-147 - 2013

Sliding wear of a-C:H coatings against alumina in corrosive media

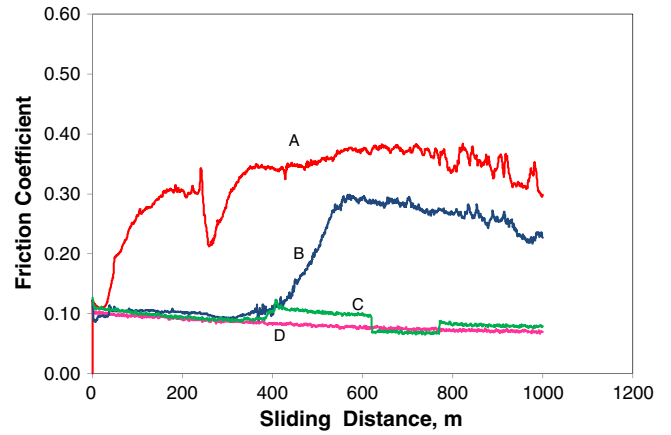
Fig. 4. Variation of the friction coefficient with the sliding distance for a coated sample tested with a 5 N normal load: (A) in the SBF solution; (B) in the 3.5% NaCl solution; (C) coated sample tested a 2 N normal load in a SBF solution; (D) coated sample tested a 2 N normal load in a 3.5%NaCl solution.

The typical friction behavior of the coated samples under the conditions tested in this work is shown in Fig. 4. It can be observed that the friction coefficient for the samples tested employing a 2 N normal load shows values of 0.08 and 0.09 for the NaCl and SBF, respectively. Some small events take place, as indicated in curve C corresponding to the coated sample in the presence of the SBF solution, which could be attributed to the interaction of the liquid under this load with the coating defects, producing locally a higher amount of debris.

In both cases, the coatings have been worn due to the interaction with the alumina ball, but have maintained their adherence to the substrate without spalling or delamination. However, the friction coefficients exhibited by the coated samples under a normal load of 5 N are considerably higher and the events taking place during the friction evolution curve with the sliding distance indicate that coating failure has occurred starting from the first meters of sliding for the sample A and around 400 m for the sample B.

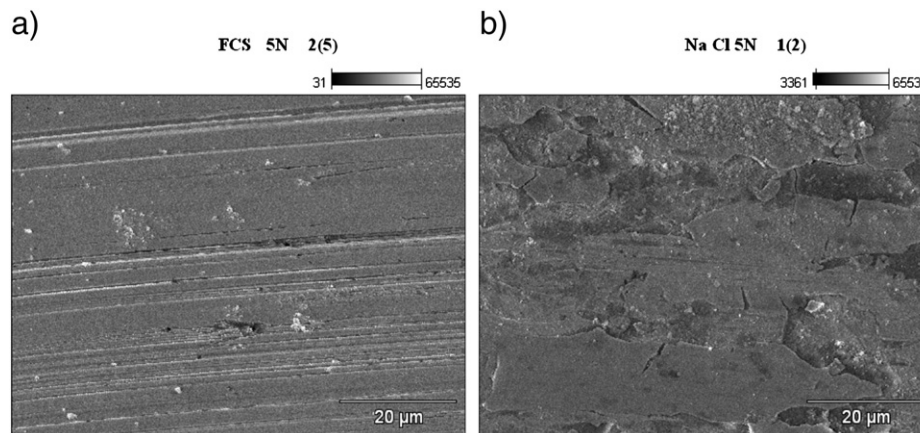
Fig. 5. SEM micrographs corresponding to the morphology of the center of the wear tracks of the coated samples for the load of 5 N: (a) sample immersed in the SBF solution indicating the presence of some abrasive features on the bare steel surface and showing the coating absence. The white particles correspond to the alumina debris from the ball; (b) sample immersed in the 3.5% NaCl, where the fractured coating is still present and some parts have been embedded into the substrate surface.

Fig. 5a and b shows the morphological characteristics of the worn coated surface, indicating the presence of abrasive features produced as a consequence of the differences between the hardness of the two counterparts.

As it can be observed, in the case of the sample immersed in the 3.5% NaCl solution (see Fig. 5b), the fracture of the coating has taken place and some parts have been embedded in the substrate, giving rise to a new surface with different tribological characteristics.

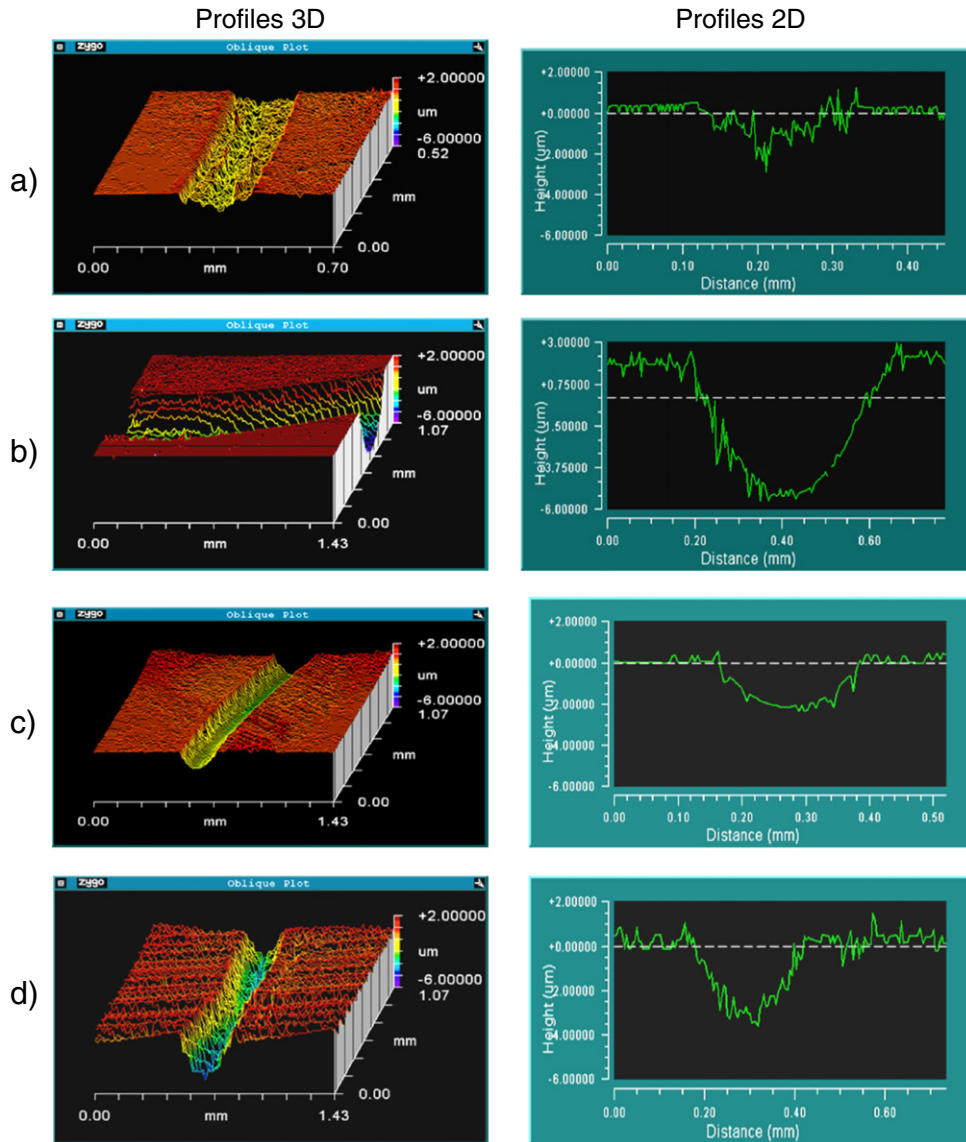
Fig. 6. Profiles of the wear tracks corresponding to the DLC coating tested in: (a) SBF solution at 2 N; (b) SBF solution at 5 N; (c) 3.5% NaCl solution at 2 N; (d) 3.5% NaCl solution at 5 N.

The 2D and 3D profiles obtained by means of the optical profilometer of the wear tracks for all the coated systems tested under the experimental setting described previously are shown in Fig. 6.

From Fig. 6 it can be clearly observed that when the normal load employed corresponds to the lower value of 2 N, the coatings are still present on the stainless steel substrate and, therefore, the value of the intrinsic rate constant can be calculated by dividing the wear volume by the product between normal load and the sliding distance (see Table 1).

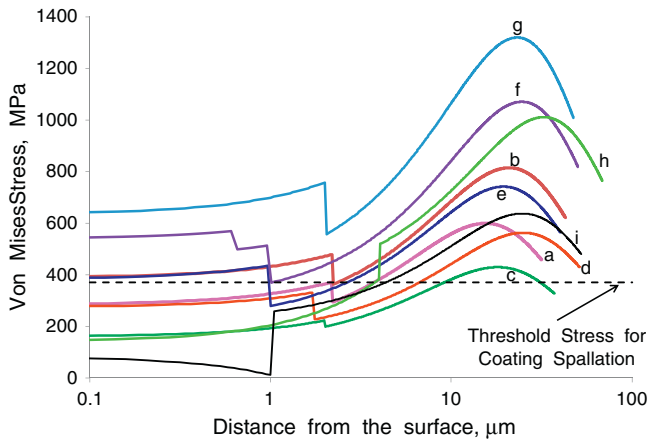
Fig. 7. Variation of the von Mises stress with the distance from the surface for the systems under study and for other DLC coated systems reported in the literature and described in Table 2.

However, it should also be borne in mind that below the coating, the existence of a 316L stainless steel layer could provide an elastic support to it. For example, for curves a and b in Fig. 7, corresponding to the tests conducted in the present research, it can be seen that when a normal load of 2 N is applied (curve a), the thickness of the elastic layer, of about 8.3 μm , is approximately 4 times the thickness of the coating and decreases to 5.5 μm for a load of 5 N (curve b). Consequently, it will be expected that plastic deformation of the substrate occurs at a distance from the surface greater than approximately 3 μm (curve f) and that during a wear test carried out in air, for both values of the applied load, no cracking will occur that could give rise to the coating detachment.

As can be seen in Fig. 7, the state of stress for the coated system under a load of 5 N (curve b) is more severe than in the case of a 2 N load (curve a). Therefore, it could be argued that its severity enhances the corrosive action of the solutions, similarly to the commonly observed stress corrosion-cracking phenomenon.

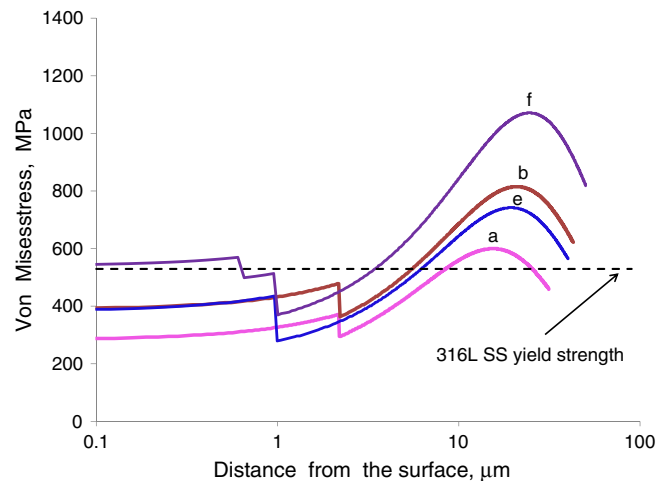
Fig. 8. Stress distribution curves for the coated systems whose substrate is 316L stainless steel: curve a (wear test carried out in 3.5% NaCl solution at 2 N normal load—present work); curve b (wear test carried out in 3.5% NaCl solution at 5 N normal load—present work); curve e (wear test carried out in water at 4 N normal load—Yi et al. [12]); curve f (wear test carried out in Ringer solution and 9 N normal load—Azzi et al. [10]). Dotted line corresponds to the substrate yield strength of 530 MPa.

Fig. 8, on the other hand, illustrates the stress distribution curves only for the coated systems whose substrate is 316L stainless steel. From Table 3 and Fig. 8, it can be observed that for the coated systems investigated in the present work (corresponding to curves a and b in Fig. 8), as well as in those studied by Yi et al. [12] (curve e) and Azzi et al. [10] (curve f), the substrate yield strength is approximately equal to 530 MPa. These coated systems should behave similarly, given the fact that the maximum values of the von Mises stress computed for each system exceed the yield strength of the substrate for all the normal loads used.
