Amine AMMAR, Benoit FURET, Guénaël GERMAIN, Yessine AYED - Degradation modes and tool wear mechanisms in finish and rough machining of Ti17 Titanium alloy under high-pressure water jet assistance - Wear - Vol. 305, n°1-2, p.228-237 - 2013

Degradation modes and tool wear mechanisms in finish and rough machining of Ti17 Titanium alloy under high-pressure water jet assistance

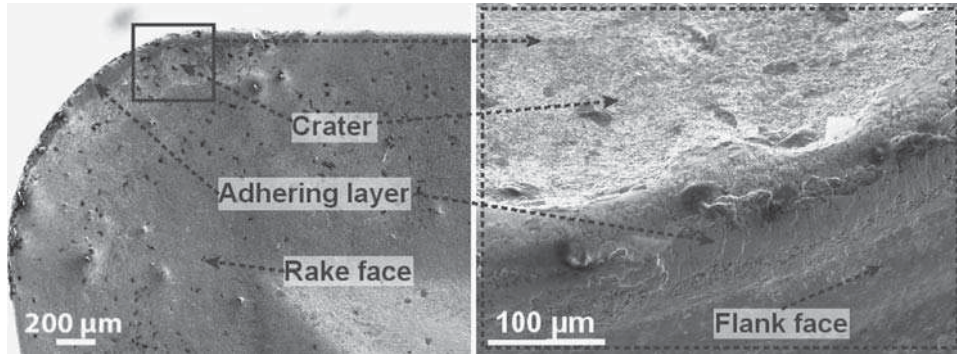
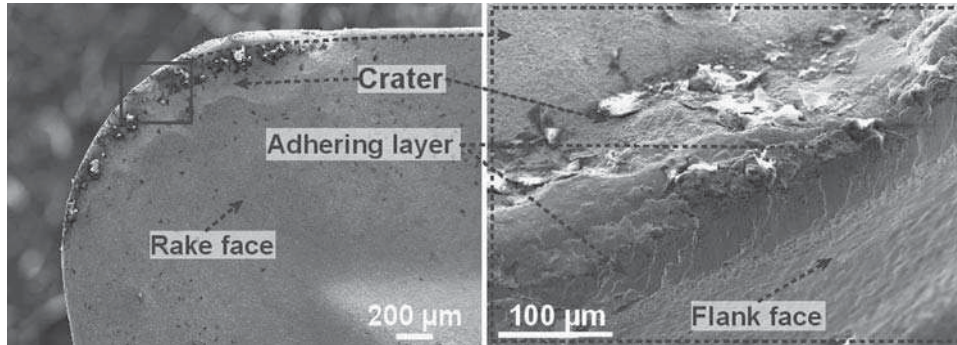
Fig. 4. SEM image of the tool rake/flank face after 20 min of machining in the finishing configuration with conventional lubrication.

Fig. 5. SEM image of the tool rake/flank face after 20 min of machining in the finishing configuration with 100 bars.

Fig. 6. SEM image of the tool rake/flank face after 20 min of machining in the finishing configuration with 250 bars.

Figs. 4–6 show the SEM images of the worn areas on the tool rake face and on the tool flank face for the three tests in the finishing condition. For conventional lubrication, significant flank wear at the nose radius (VBc) is observed. In addition, layers adhering to the rake face are noticed. During machining, the chip rubs on these adherent layers which appear to protect the rake face. However, when the formation of these layers reaches a stagnation level, they become instable and may be peeled-off

leading to wear by adhesion [10]. Alternatively, with HPWJA, a loss of material on the tool rake face and the formation of a crater can be seen. Damage in these areas is more important at a pressure of 250 bars. In this case, it seems that the most important wear mechanism is adhesion accompanied by abrasion and erosion.
