Amine AMMAR, Benoit FURET, Guénaél GERMAIN, Yessine AYED - Degradation modes and tool wear mechanisms in finish and rough machining of Ti17 Titanium alloy under high-pressure water jet assistance - Wear - Vol. 305, n°1-2, p.228-237 - 2013

Degradation modes and tool wear mechanisms in finish and rough machining of Ti17 Titanium alloy under high-pressure water jet assistance

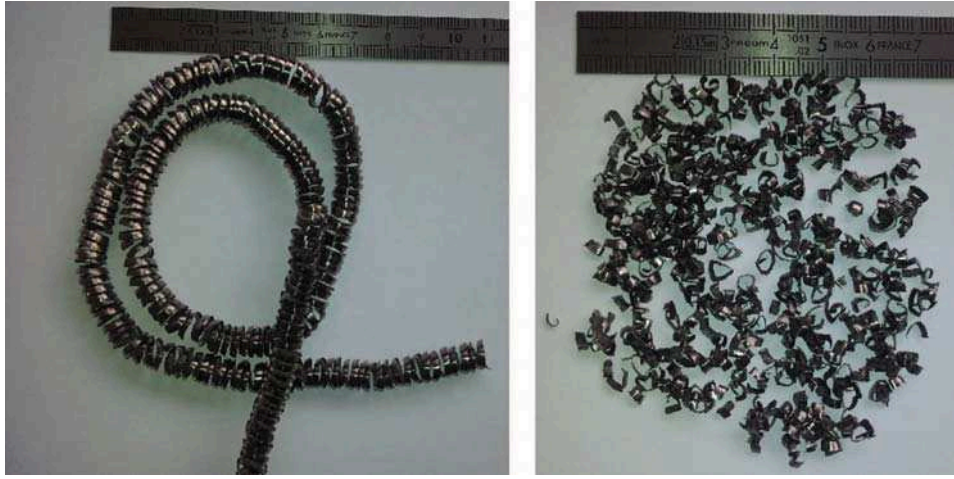
Fig. 2. Chip fragmentation at 100 bars (finishing condition).

Fig. 2 shows the morphology of the chips obtained when machining with conventional lubrication and with HPWJA at 100 bars, respectively. It can be seen that HPWJA ensures chip fragmentation.

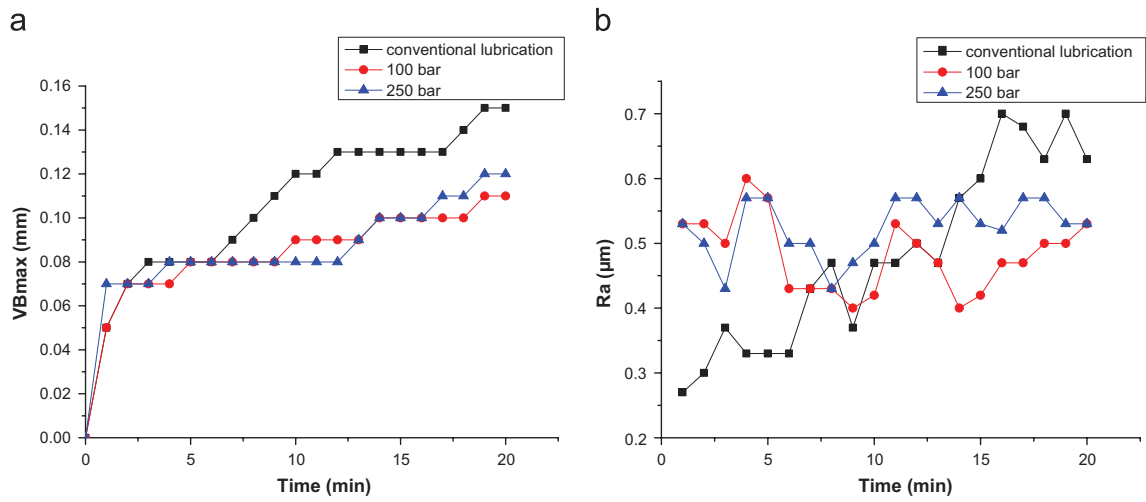
Fig. 3. (a) Flank wear (VB) and (b) surface roughness (R_a).

Fig. 3(a) shows the evolution of the flank wear criterion (VB) and (b) the evolution of the R_a criterion. For all the configurations, flank wear (VB) does not exceed 0.15 mm after 20 min of machining, but its evolution is slower with HPWJA. Indeed, in conventional lubrication after the running-in phase, flank wear increases linearly to 0.15 mm after 20 min.

However, for the HPWJA condition, after the running-in phase, the flank wear remains constant for a significant period. Indeed, in both assistance configurations (100 bars and 250 bars), flank wear remains constant at about 0.08 mm for approximately 6 min at a pressure of 100 bars and for about 9 min at a pressure of 250 bars. After this stable regime, flank wear increases in a way similar to conventional lubrication. Fig. 3(b) shows a significant variation of surface roughness. For conventional lubrication, the surface roughness tends to increase linearly as a function of machining time, going from $R_a = 0.25 \mu\text{m}$ to $R_a = 0.7 \mu\text{m}$ (i.e. R_a reaches three times its initial value). For tests with high-pressure water jet assistance, the initial surface roughness is higher, but its value remains globally constant (between $0.4 \mu\text{m}$ and $0.6 \mu\text{m}$ throughout the test). In addition, there is no marked tendency for the surface roughness to increase even at the end of the test. The surface roughness thus appears uninfluenced by flank wear.

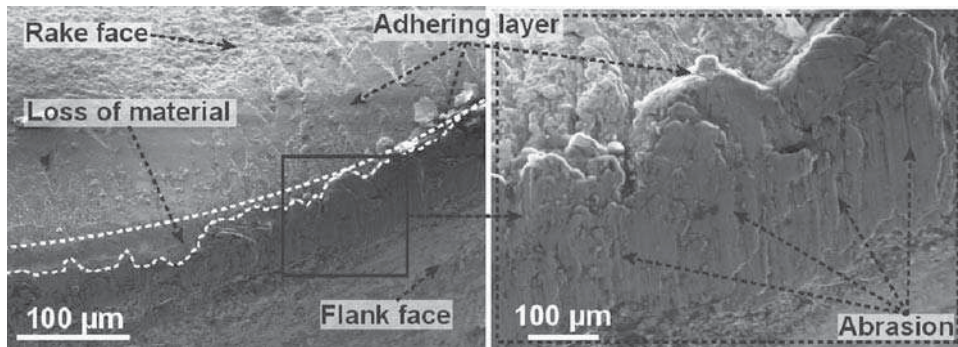
Fig. 4. SEM image of the tool rake/flank face after 20 min of machining in the finishing configuration with conventional lubrication.

Figs. 4–6 show the SEM images of the worn areas on the tool rake face and on the tool flank face for the three tests in the finishing condition. For conventional lubrication, significant flank wear at the nose radius (VBc) is observed. In addition, layers adhering to the rake face are noticed. During machining, the chip rubs on these adherent layers which appear to protect the rake face. However, when the formation of these layers reaches a stagnation level, they become instable and may be peeled-off

leading to wear by adhesion [10]. Alternatively, with HPWJA, a loss of material on the tool rake face and the formation of a crater can be seen. Damage in these areas is more important at a pressure of 250 bars. In this case, it seems that the most important wear mechanism is adhesion accompanied by abrasion and erosion.

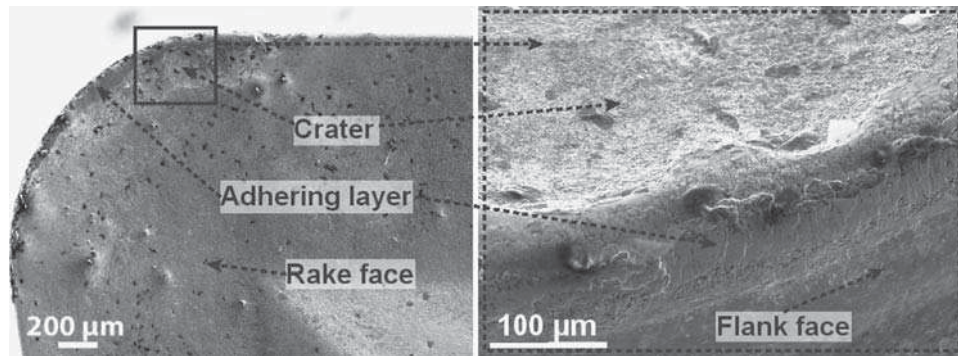
Fig. 5. SEM image of the tool rake/flank face after 20 min of machining in the finishing configuration with 100 bars.

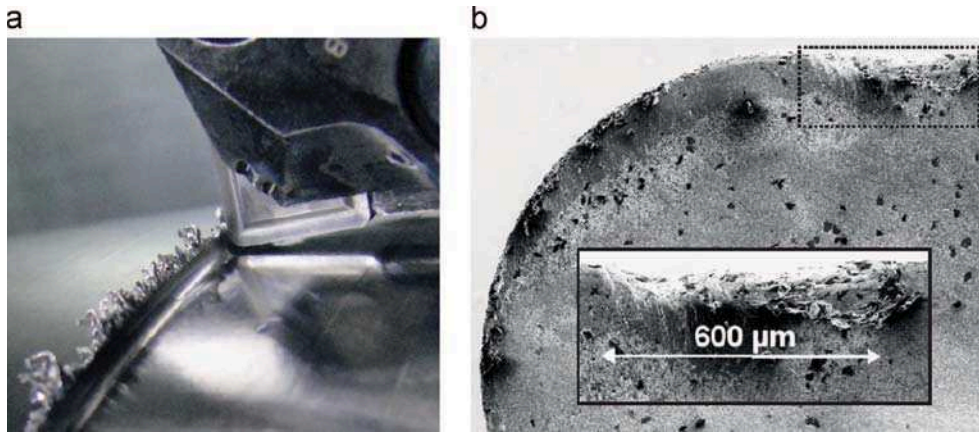
Fig. 7. (a) Formation of burr on the work-piece and (b) notch wear after 20 mm of finishing machining with conventional lubrication.

For conventional lubrication conditions, burrs are formed on the work-piece during machining, as shown in Fig. 7. At the height corresponding to these burrs, significant notch wear (VBn) is formed. The width of the notch is around 600 μm after 20 min of machining. However, no burrs and no notch wear are visible under high-pressure water jet assistance. The specific effort has a slow and gradual evolution, but it is slightly lower in HPWJA.

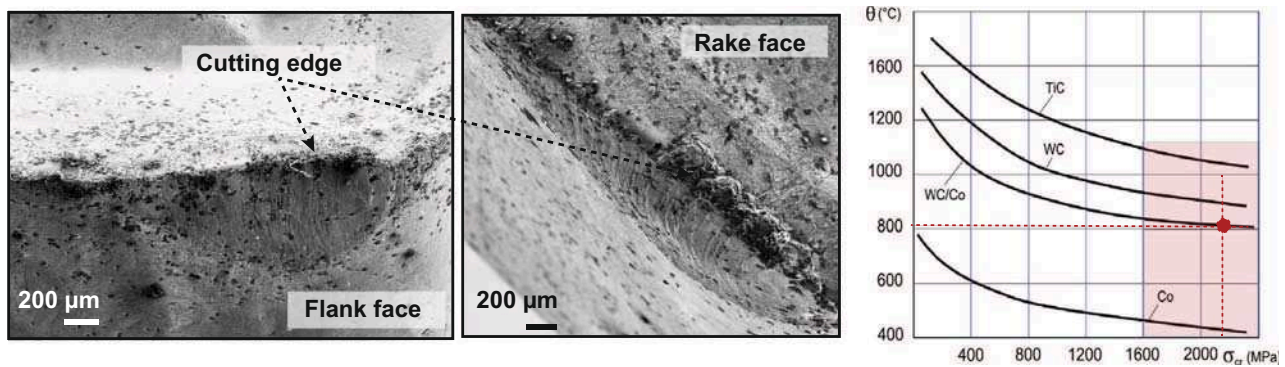
Fig. 8. (a) Image of the cutting edge after 75 s of roughing machining with conventional lubrication and (b) creep resistance [12].

pressure K_C (about 2100 MPa). Fig. 8(a) shows tool rake and flank faces after 75 s of roughing machining.

The measurement of the cutting force reveals that the average specific pressure is around 2100 MPa in conventional machining. Fig. 8(b) shows that, to avoid creep in the tool when exposed to a contact pressure of 2100 MPa, the cutting temperature must not exceed 900 °C for the WC and 800 °C for the WC/Co inserts. However, these temperatures correspond to those obtained when machining titanium [13–15]. This result confirms the degradation mode of the cutting edge by creep in conventional machining.

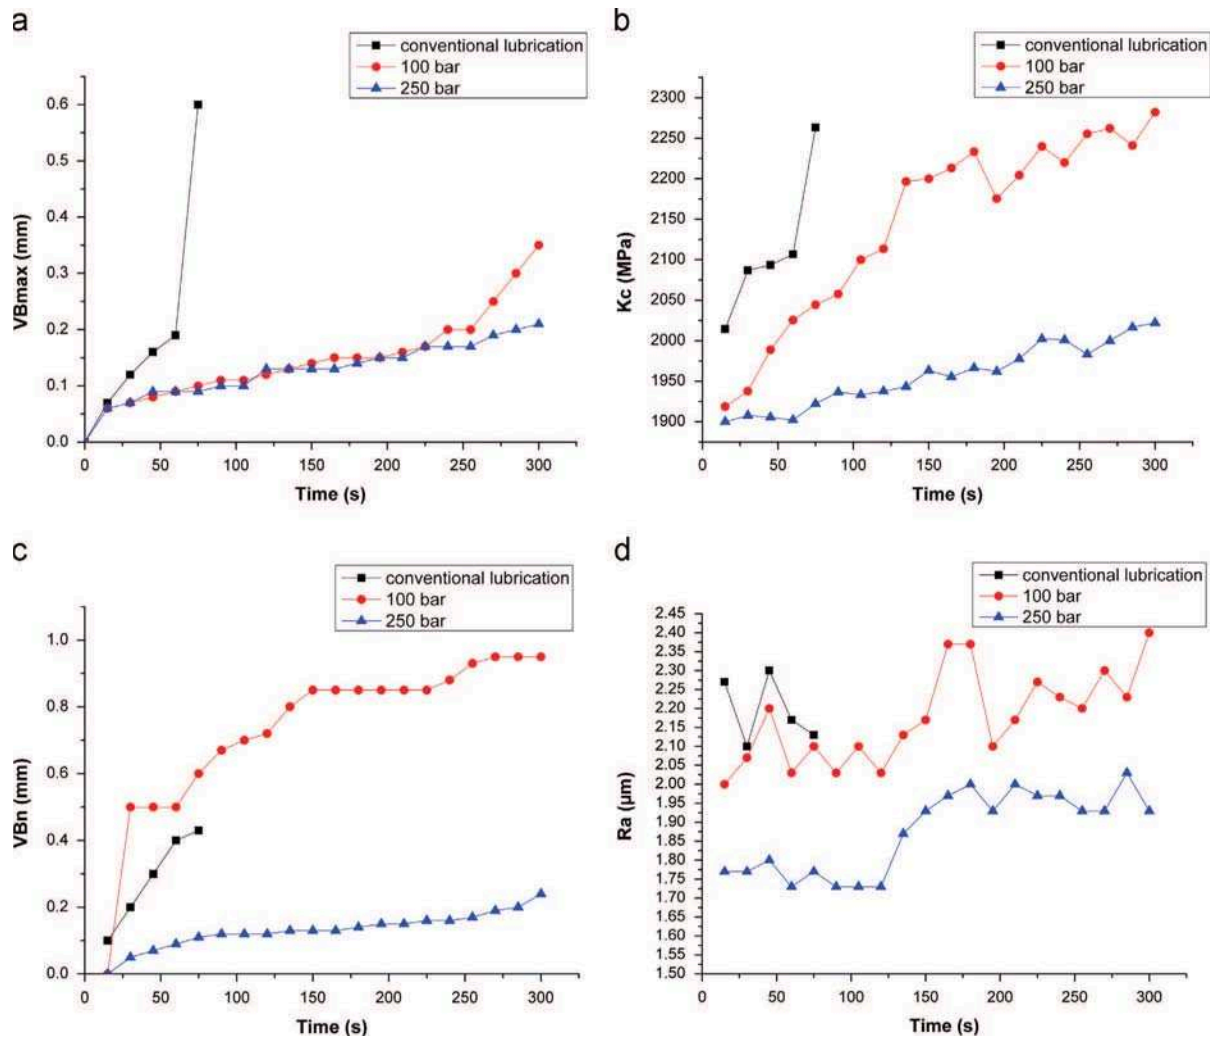
Fig. 9. Evolution of (a) flank wear, (b) specific cutting pressure, (c) notch wear, and (d) surface roughness.

The notch wear, VBn was also observed. Fig. 9(c) shows the evolution of notch wear for the three lubrication configurations in the roughing condition. With conventional lubrication, the notch size increases significantly with machining time. It reaches a value of 0.4 mm when the tool cutting edge collapses. Therefore, the tool degradation mode is the collapse of the cutting edge by plastic deformation, not by notch wear. With water jet assistance at 100 bars, a relatively large notch (0.5 mm) is present from the start of the test and progresses constantly until it reaches 0.95 mm after

Fig. 9(b) shows the evolution of the specific cutting pressure versus machining time. The specific cutting pressure seems to increase with increasing tool wear. It can also be noticed that the cutting force under HPWJA is lower than in conventional machining. Indeed, with a pressure of 250 bar, the specific cutting pressure K_c is about 10% lower than in conventional machining for an unworn tool. This could be due to a decrease in the friction coefficient. Indeed, the lubricant jet is inserted between the chip and the tool, which may change the coefficient of friction. The cooling is mainly localized at the tool and the tool–chip interface. The primary shear zone does not seem significantly cooled.

Fig. 9(d) shows the evolution of the surface roughness. For the three configurations, R_a is generally stable despite a slight tendency to increase over time.

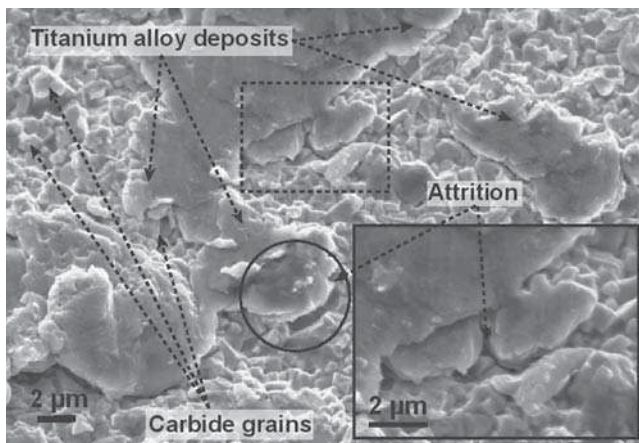
Fig. 10. Adherent layers on the tool rake face after 5 min of roughing machining at a pressure of 100 bars.

Fig. 10 shows material deposits sticking to tungsten carbide grains. Furthermore, it shows the attrition or loss of carbide grains. Fig. 11 shows that the areas with material deposits are protected and are not subjected to damage.

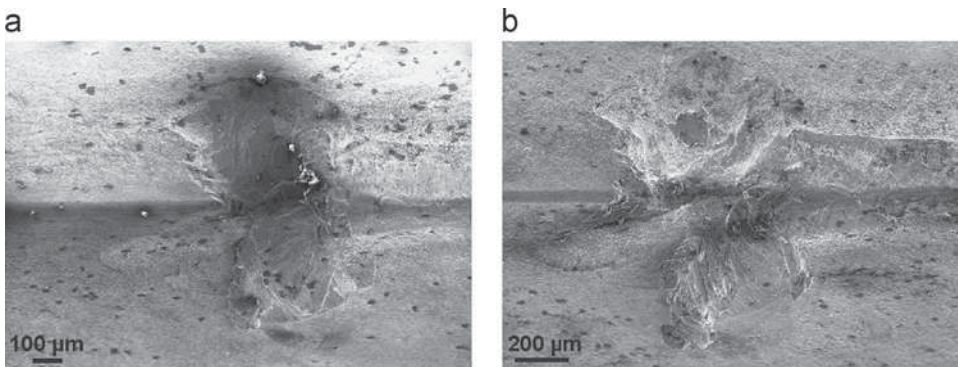
Fig. 12. Evolution of notch wear in roughing condition: (a) 4 min and (b) 5 min.

Fig. 12(a), taken after 4 min of machining, shows layers adhering to the notch. After 1 min of additional machining, the same notch is observed. Fig. 12(b) shows that the previously observed layers are pulled out, leaving a larger notch. Indeed, significant material loss was noted in the areas where material deposits were located. These observations confirm the wear mechanism by tearing-off of adhering layers.

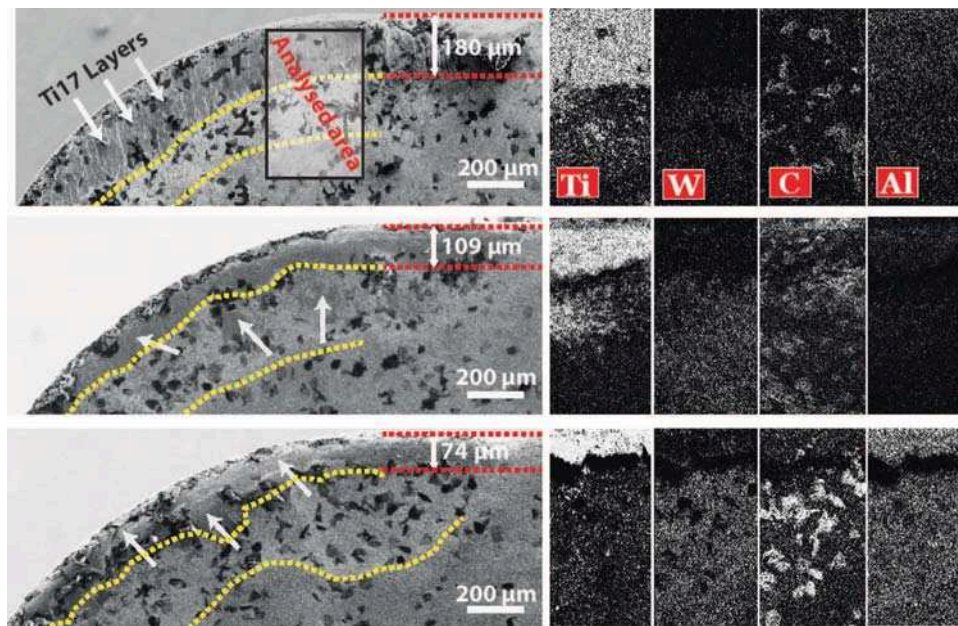
Fig. 13. Analysis of material deposits on the rake face after 15 min of finishing machining: (a) conventional machining, (b) 100 bars and (c) 250 bars.

operation, the control and analysis interval was reduced to 30 s. Fig. 13 shows the results of the qualitative analysis. Three zones can be distinguished.

- The first is formed by Ti17 layers. This is the sticking and adhesion zone;

- The second is an area of material abrasion and tearing-off, characterized by localized loss of material (and formation of a crater);
- The last zone is the area that remains intact.

In addition, the EDS analyses show the distribution maps of the elements forming the tool and the titanium alloy. The distribution maps of the elements Ti, W, C, Al are presented in Fig. 13. It can be seen that increasing the water jet pressure results in a reduction of the adherent layers zone. This reflects a decrease of the zone of strong adhesion and sticking of the chip on the tool rake face. This zone can be related to the tool/chip contact length (LC). Hence, these observations show a decrease in the tool/chip contact length with increasing pressure. The contact length decreases from 180 μm in conventional lubrication, to 74 μm under high-pressure water jet assistance (at 250 bars). In fact, for HPWJA, the fluid infiltrates between the chip and the tool. It has therefore the tendency to separate the chip from the tool rake face, thus decreasing the contact length, LC, and reducing friction between the tool and the chip.

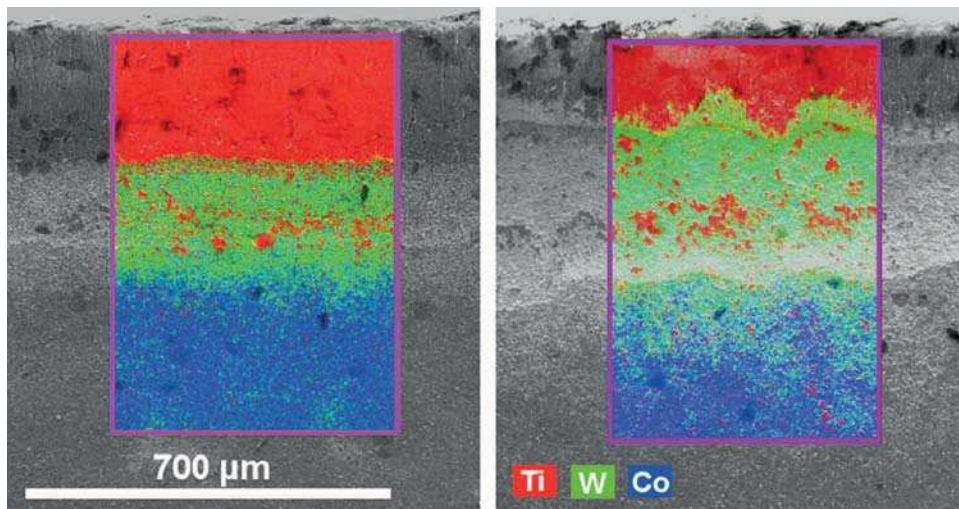
Fig. 15. EDS analysis after 4 min of roughing machining (100 bars and 250 bars, respectively).

Fig. 15 shows the tool rake face of two inserts after 4 min of roughing machining at 100 bars and 250 bars, respectively. It can be seen that the area of the adherent layers becomes smaller when the pressure is increased from 100 bars to 250 bars. In fact, the order of magnitude of the contact length is close to that found in the finishing condition.

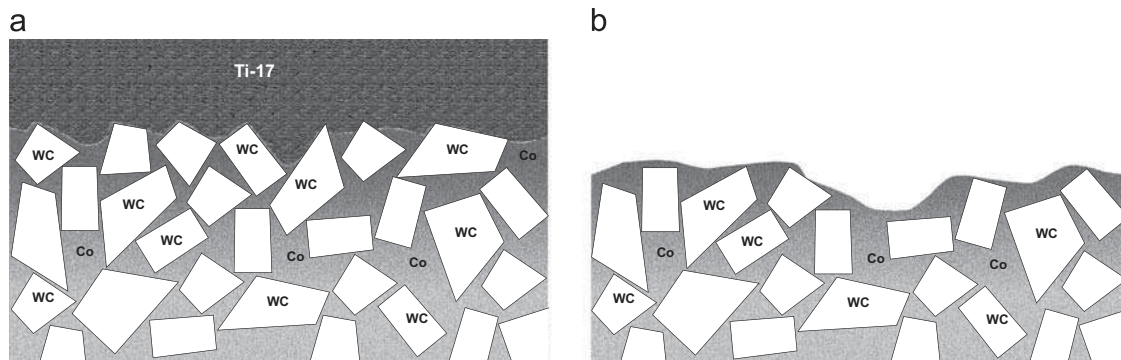
Fig. 16. Mechanism of adhesive wear.

Fig. 16 illustrates wear by adhesion. In fact, during the tool/chip contact, an interfacial layer of titanium is formed. Combined with the high temperature and high contact pressure, this layer reacts chemically with the tungsten carbide and adheres to the surface of the insert [8,11]. Thus, an increase in the cutting temperature promotes the diffusion between the tool and the chip. This deposited layer seems to protect the tool since the chip is no longer directly in contact with the carbide tungsten. However, after a period of time, the deposit may become unstable and so can be torn off by the chip. In this case, it tears fragments of the tool material leading to wear by adhesion. These findings confirm the results of other studies on adhesive wear of nickel-based alloys. Devillez et al. [19] and Bhatt et al. [11] show via SEM pictures and EDS analysis the formation of a sticky layer; it is to be noted that when this layer is pulled-out, it causes the adhesive wear.
