Dorra ABID, Dhouha MELLOULI, Nedia GAFSI, Nader HADDAR, Ahmed KTARI - Failure analysis of shot–sleeves used in brass high pressure die–casting process - Engineering Failure Analysis - Vol. 104, p.177-188 - 2019

Failure analysis of shot–sleeves used in brass high pressure die–casting process

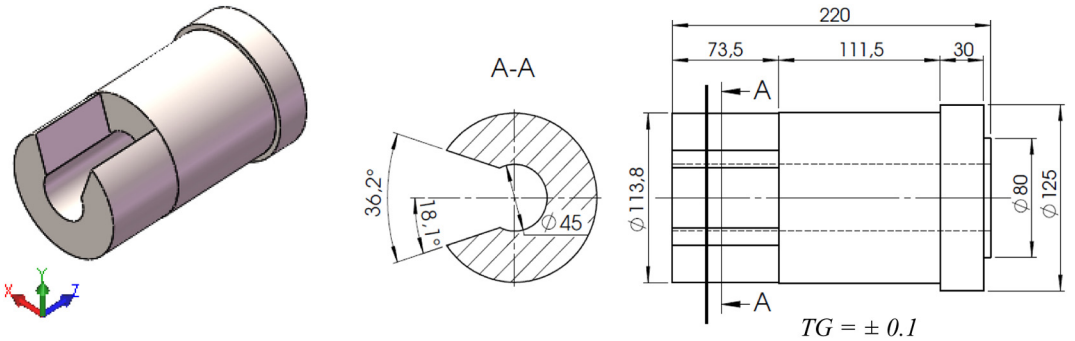
Fig. 1. Geometry and dimensions of the studied shot–sleeves.

In the present study, samples of shot–sleeve failed in service, were investigated to understand the mechanisms, which can lead to their damage. The shot–sleeve (Fig. 1), used in brass high pressure die–casting process, undergoes a severe thermo–mechanical loadings during cast cycles. Each cycle include principally four phases as following:

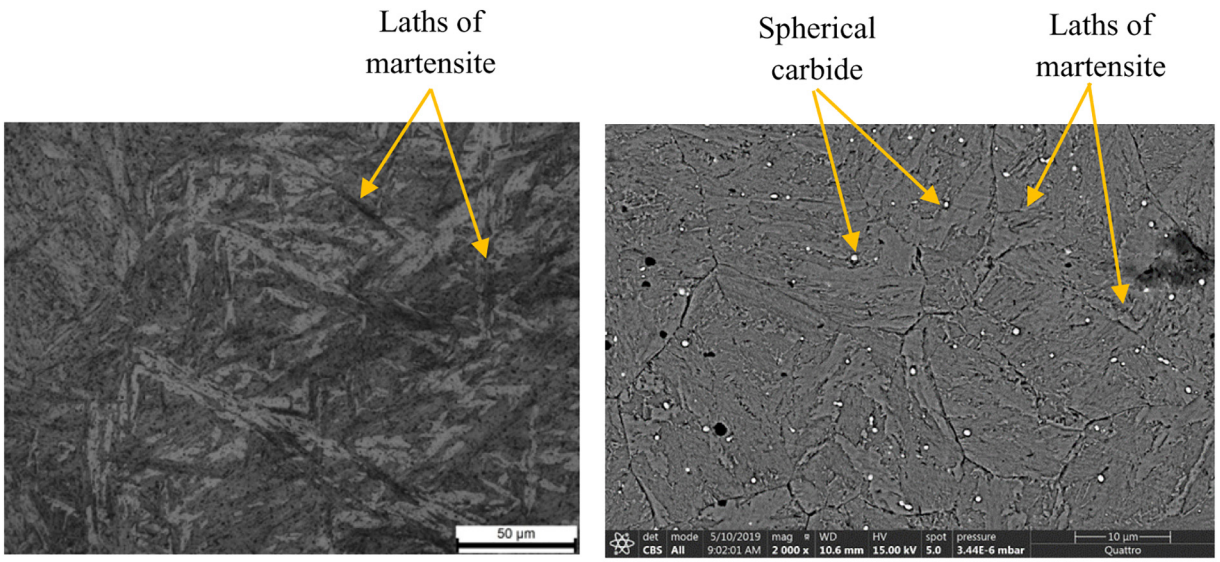
Fig. 2. Microstructure of the shot-sleeve: (a) Light Optical Microscopy (LOM), (b) The SEM microanalysis.

Our studied material is H10, a metallographic observations were realized by means of an optical microscope (Leica®) on the same taken sample polished until mirror state then attacked by Nital (5% of nitric acid diluted in methanol). These observations show the presence of a martensitic structure (Fig. 2).

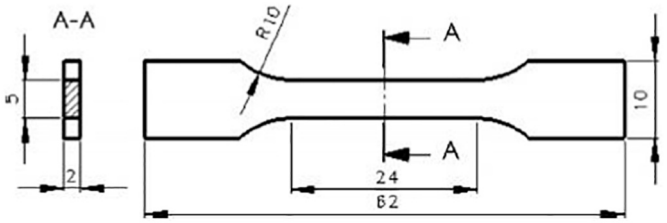
Fig. 3. Dimensions of tensile specimen (in mm).

In order to investigate the tensile properties of the studied material AISI H10, tensile tests were carried out on a three standard flat tensile specimens (NF A 03–151) as presented in Fig. 3. The semi–finishing form of each one was obtained from the damaged

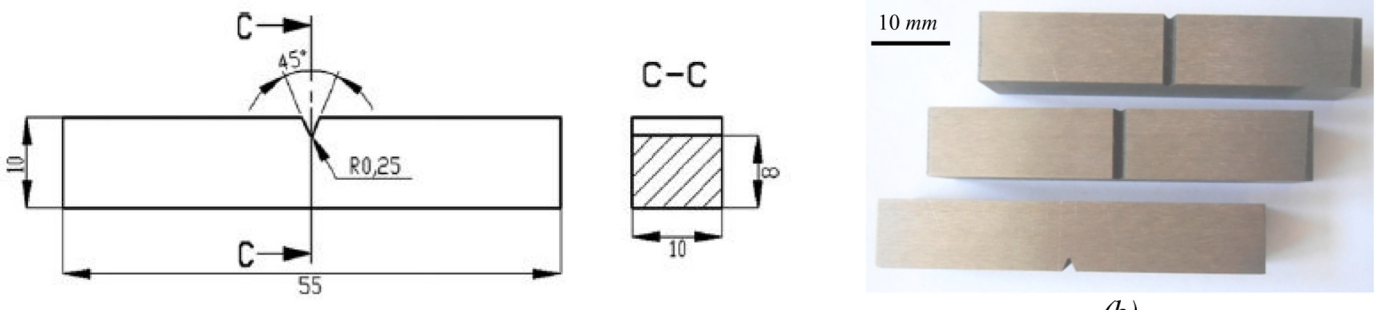
Fig. 4. Charpy V-notch specimens: (a) Geometry and dimensions (in mm), (b) machined Charpy V-notch specimens.

Standard Charpy V-notched specimens were machined from the failed shot-sleeve by a wire EDM machine (Fig. 4). Then, three tests were conducted at room temperatures to determine the material toughness. The average of the measured CVN energy (CVN = 3.4 ± 0.1 J) and the feature of the fractured surface prove the brittle nature of the specimen material (Fig. 5).

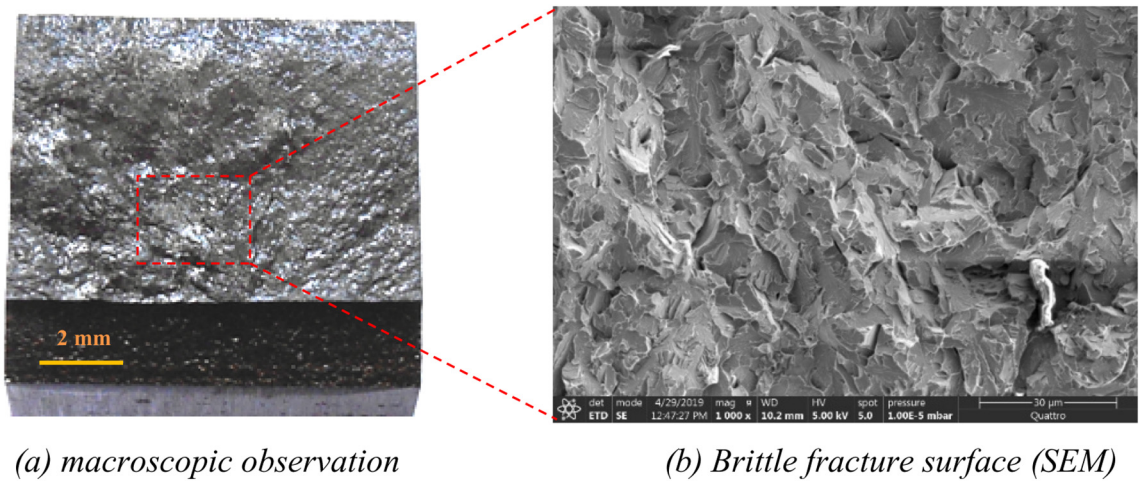
Fig. 5. Fracture surface of Charpy specimen. (a) macroscopic observation, (b) binocular microscope observation.

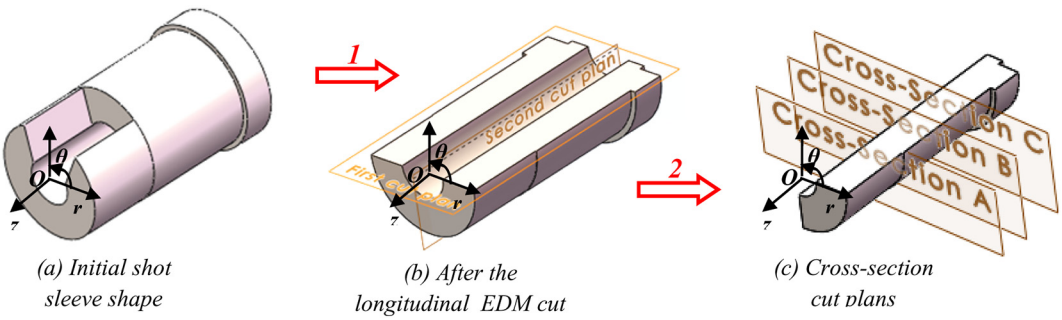
Fig. 6. CAO schema of shot–sleeve cutting planes: (a) Initial shot sleeve shape, (b) After the longitudinal EDM cut, (c) Cross-section cut plans.

The hardness profiles were measured, on a shot–sleeve longitudinal section (Fig. 6 *(b)*) polished until mirror state, from the entry plunger zone to the mold side and from the inner to the outer surface (Fig. 7). These profiles are performed with a Vickers hardness machine using a load of 15 *kg*. The measured profiles reveal that the hardness appears to be constant for all tested samples.

A finer observations of the shot–sleeve inner side were carried out after a longitudinal cut (Fig. 6 *(b)*). The examination of the damaged surfaces was made using an experimental device equipped with a digital *Baumer®* camera *GIgE* (8 bits). This camera is equipped with a CCD sensor allowing to have a resolution of 1624 × 1236 pixels. Several photos are taken and then assembled by means of Photoshop® software to obtain a large image that cover the entire shot–sleeve examined surface (Fig. 9). This surface reveals the presence of three different zones. The first one is located in the plunger entrance side. It presents a number of scratch according the longitudinal direction which corresponds to abrasive wear caused by the friction between the plunger and the shot–sleeve. The second one corresponds to the first zone which enter in contact with the molten metal ($T = 950\,^{\circ}C$). It undergo cyclic thermal shocks. This zone appears to be the most damaged surface in the shot–sleeve. It presents a dense crack network sign of the thermal fatigue. In addition, the investigation of this zone according to the $O\theta Z$ plan shows that some cracks, after initiation, were propagated in depth along the radial direction (Detail A). The last zone reveals also the presence of a crack network however it is less dense compared to this observed in the *2nd* zone (Fig. 9).

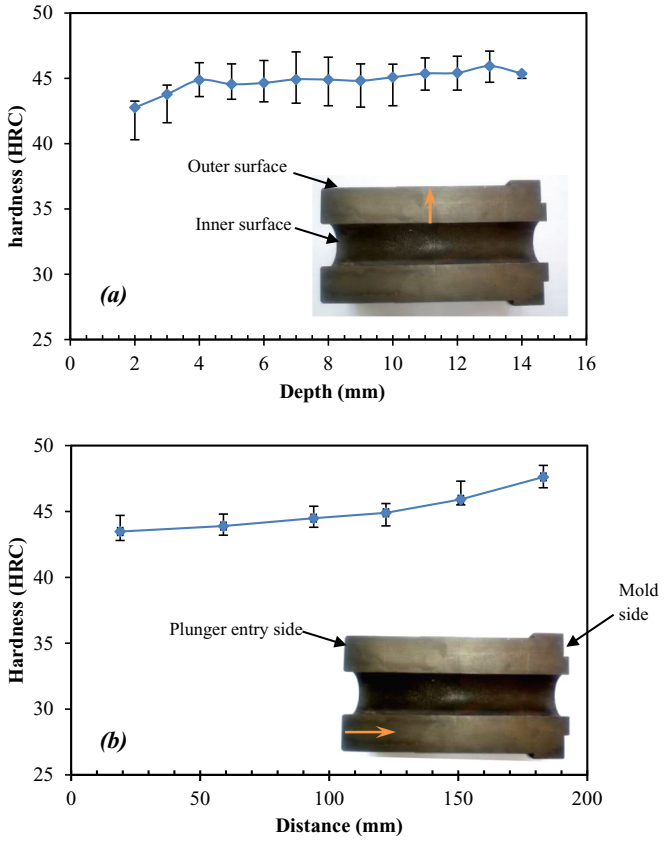
Fig. 7. Hardness shot–sleeve profiles, (a) from the entry to the mold zones, (b) from inner to the outer surfaces.

average of measured hardness is about of $44.8_{-2.4}^{+3.8}$ *HRC*. This shows that the hardness was remained quasi–constant even after a few thousands of thermal heating and cooling phases (more than 74,000 cycles) and which indicate that the mechanical behaviour of the material is stable (*i.e.* absence of significant cyclic hardening or softening) under service conditions. Furthermore, micro-hardness measurements were performed with a Wilson hardness machine 402MVD using a load of 1 kg at a distance of approximately 400 µm from the inner surface. The average of measured micro-hardness is about $49.8_{-6.4}^{+5.5}$ HRC. This result proves that is no significant increase of the hardness from the heart to the inner surface of the shot-sleeve.

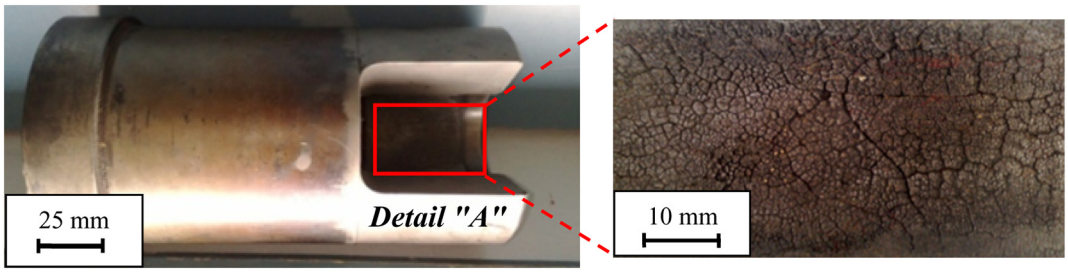
Fig. 8. Cracks network observed on the inner surface of the damaged shot–sleeve.

The second shot–sleeve was cut with a wire EDM machine according to their longitudinal direction to examine the integrity of the damaged surface (Fig. 8). After that, the cut–out parts are subjected to a surface cleaning operations: A chemical pickling with an alkaline solution using a dilute nitric acid was performed, at room temperature, to eliminate all traces of oxides. Then, the damaged shot–sleeve surfaces were subjected to a preliminary assessment with a naked eye to identify their major damage features. The examined surfaces (Fig. 9) clearly show the presence of a cracks network on the inner shot–sleeve surfaces.

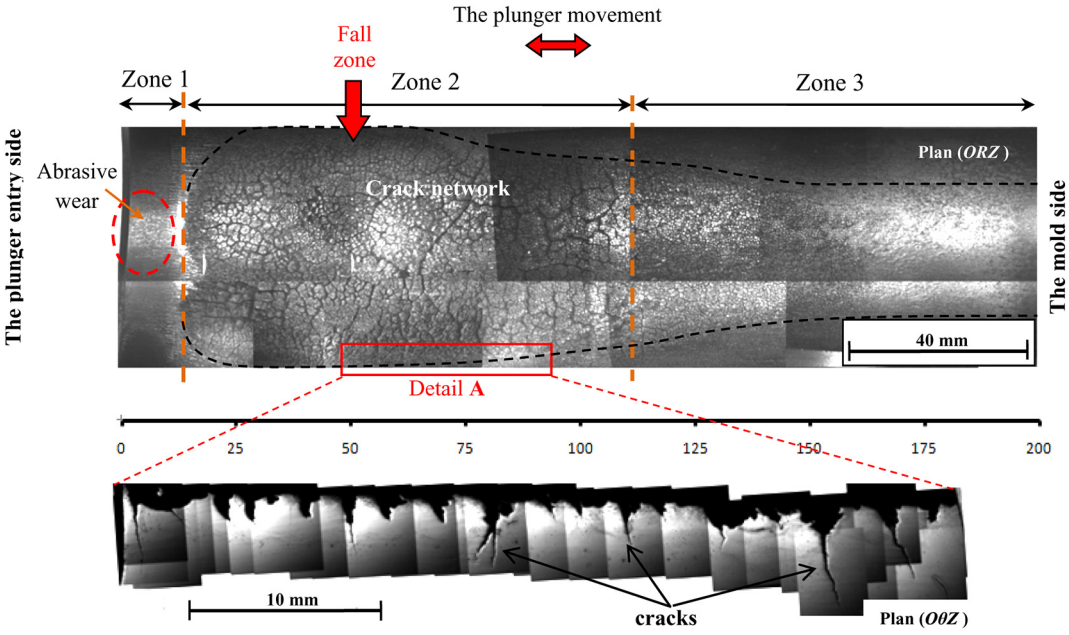
Fig. 9. Shot–sleeve inner surface damage observed with a digital camera.

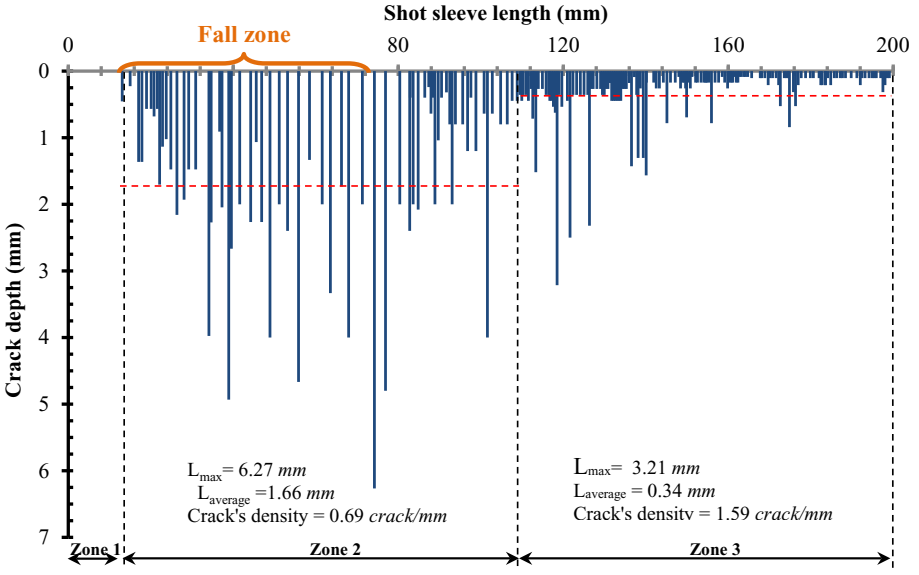
Fig. 10. Crack lengths distribution along the shot sleeve (longitudinal section$\theta = 0$).

In this section, a meticulous investigation on the cracks distribution and density was performed by means of longitudinal and transversal observations (Figs. 10 and 11). The cracks depth according to the axial distance was presented in Fig. 10. It is to be noted that the cracks depth trend along the shot–sleeve follows the Gaussian distribution. Fig. 10 shows that the cracks depth is maximal around the zone *2*, which corresponds to the casting zone (fall zone). This zone is characterized by a maximum crack length and average values of 6.23*mm* mm and 1.66*mm* respectively. In zone 3 the cracks deep is less than those observed in zone *2* nevertheless their density is more pronounced (*i.e.* 1.59*crack/mm* in zone 3 against 0.69*crack/mm* in zone *2*). The presence of the shielding effect between neighbouring cracks existing in zone *2* cause the propagation slows down of the smaller cracks and only a few of the biggest ones continue to propagate. Such a phenomenon was observed in many applications in which the thermal fatigue was the main cause of damage [19–20,28].

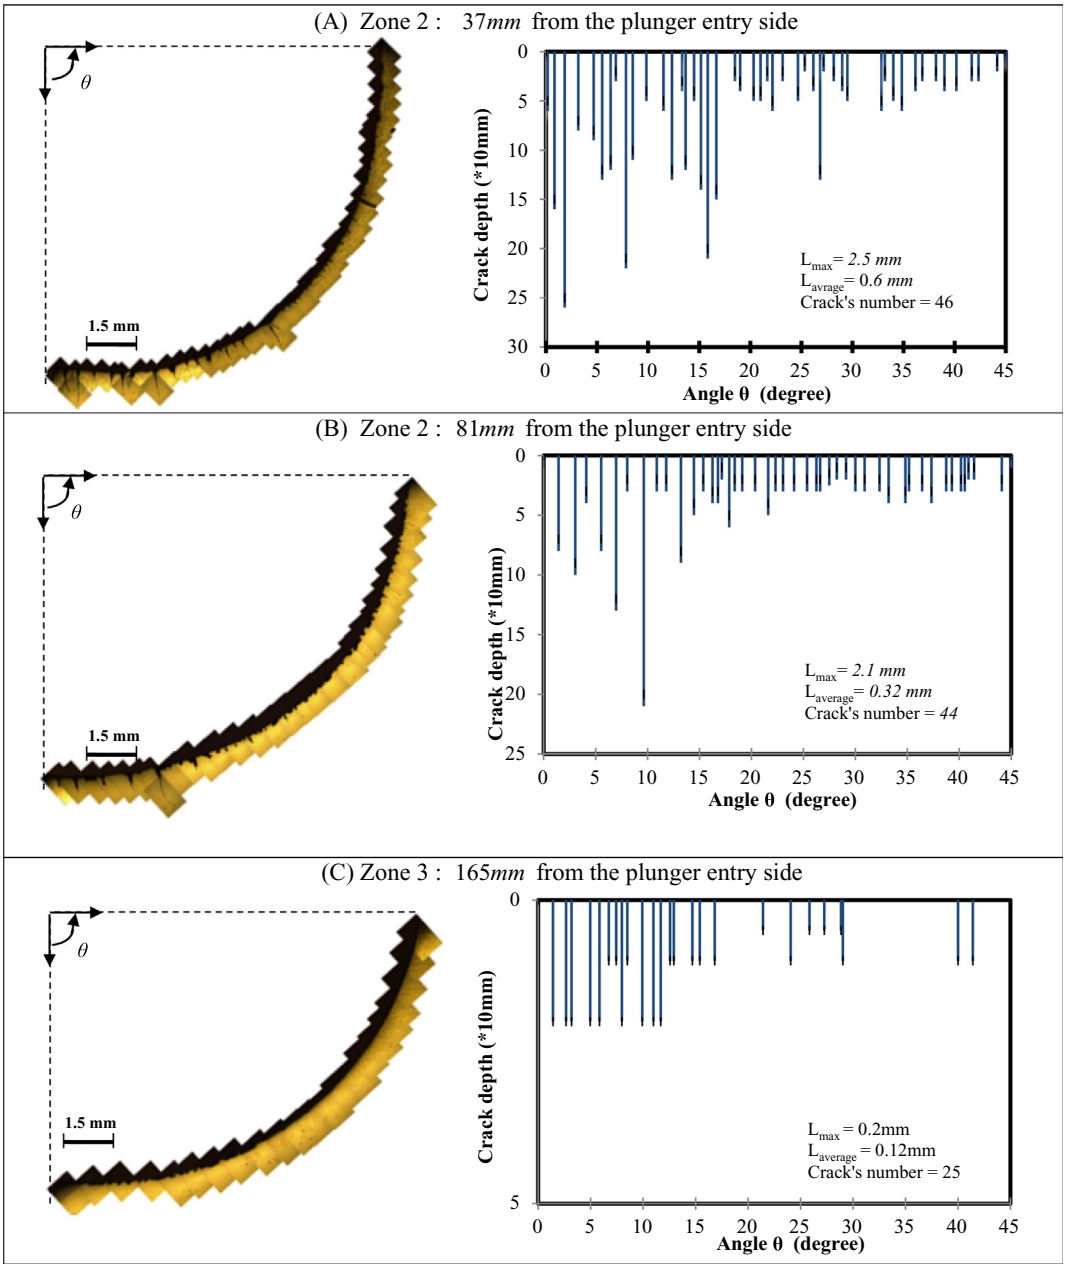
Fig. 11. Crack distribution of damaged shot–sleeve in cross–sections A, B and C.

The cracks depth investigation from the centre of shot–sleeve ($\theta = 0^{\circ}$) to the shot–sleeve horizontal plane ($\theta = 45^{\circ}$) for every shot–sleeve cross–sections A, B and C (Fig. 11). It is obvious that the maximal depths are sited at the level of the zone of casting. This result can be explained by thermal fatigue, oxidation and erosion by the molten brass flow which results in removal of superficial layer.

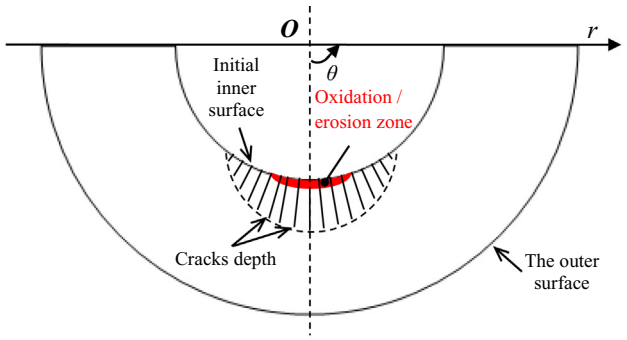
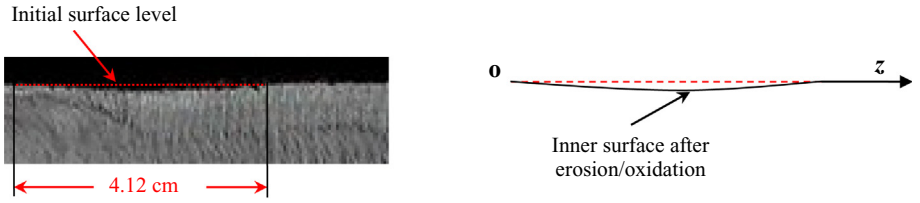
Fig. 12. Oxidation / erosion effect in the fall zone (Zone 2) of the shot-sleeve.

The initial level of the shot–sleeve casting zone (cited in zone 2) was decreased probably due to oxidation and erosion effects as shown in Fig. 12. The cracks situated surroundings the shot–sleeve centre (near $\theta = 0^{\circ}$) are in reality longer compared to their effective length due to the small decrease of the shot sleeve inner surface level produced after the oxidation / erosion effect. Others micro cracks are totally removed what favoured the propagation of persistent cracks because the motive force was located in them, is confirmed by previous research [1,29].

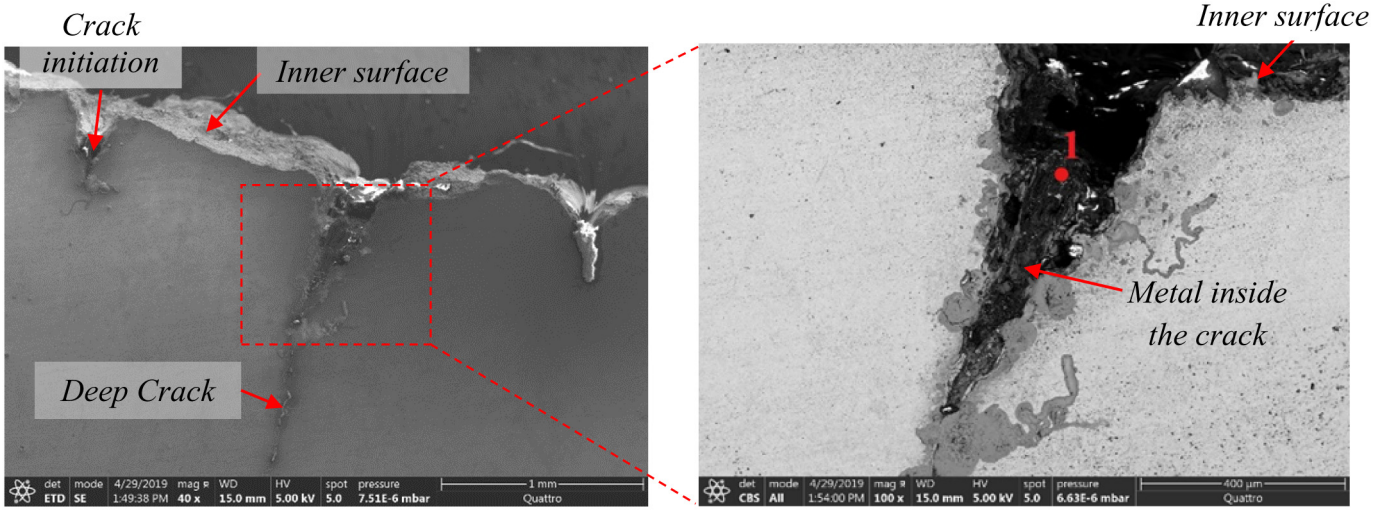
Fig. 13. SEM observation of a damaged shot sleeve cross-section: (a) Short (initiation) and deep crack, (b) Zoom on the examined crack with EDS (point 1).

In addition, in order to more understand the mechanisms leading to the shot sleeve failure, a sample of the cross-section surface was examined using SEM (Fig. 13) and Energy Dispersive X-ray Spectroscopy (EDS) to identify the chemical composition of the metal inside cracks (points 1 in Fig. 13 *(b)*) (Table 4). According to Fig. 13 *(a)*, the cracks tend to propagate perpendicular to the damaged surface. The initial growth of thermal fatigue cracks is facilitated by an oxidation attack on the crack surface, which forms the Fe, Cu, Zn, Cr, Mo, Si and O rich layer (Table 4). The presence of brass and oxides, in the cracks increases plastic yield ($Rp_{0.2}$) and compressive stresses during the heating phase of the thermal cycle [30]. As a result, the tensile stress is further increased during the cooling phase and can leads to the acceleration of the crack growth rate. In addition, the tensile stresses applied on the shot-sleeve inner surface during the cooling phase combined with the erosion phenomenon caused by the molten brass fall in the second zone leads to a local failure, which promote the opening of thermal cracks [13]. These cracks act as channels allowing oxygen to penetrate down to the crack tip area and oxidize both shot sleeve and the filling material. Solidified particles down on the crack act as an obstacle for its closer and the size of the crack openings in the filling material indicates the amount of brass that will fill the crack during the next cycle [20].
