About the relevance of roughness parameters used for characterizing worn femoral heads

D. Najjar[a,*], M. Bigerelle[a,b], H. Migaud[c], A. Iost[a]

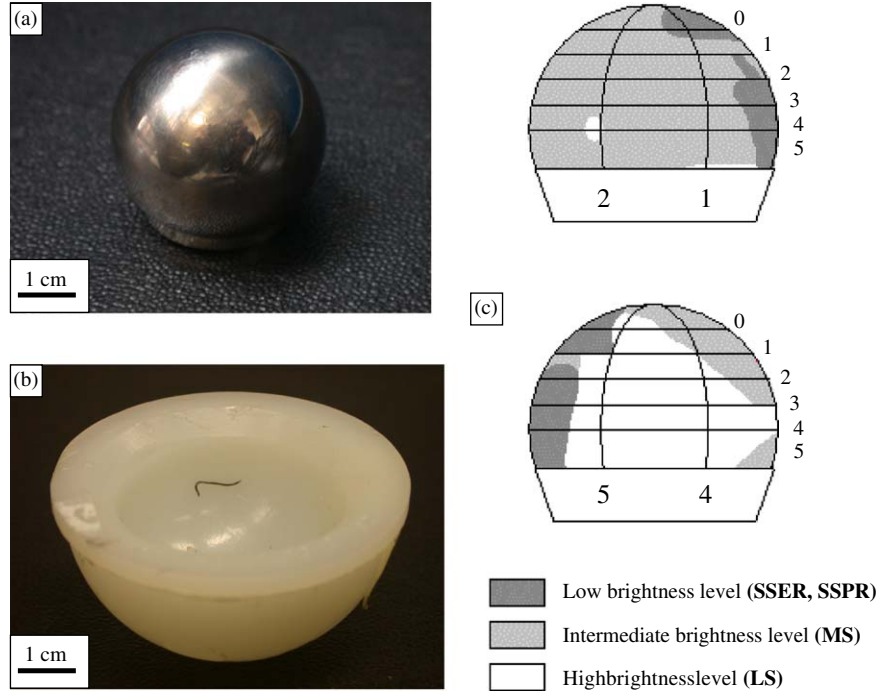
Since the foreign third bodies are increasingly suspected of being the dominant cause of the scratch generation, this titanium alloy (TA6V) femoral head (Fig. 1a) was especially selected because an embedded metallic fiber was detected in the UHMWPE counterface after revision surgery (Fig. 1b). This centimeter-length foreign body came from the titanium fibermesh, which was deposited on the Harris–Galante metallic cup during the fabrication process. It must be pointed out that polyethylene and metallic debris were detected by histological analyses on the peri-prosthetic tissues.

- Regions covering about 30% of the entire surface and visually having a bright finish. These regions noted LS (for lightly scratched) are white-colored in Fig. 1c.
- Regions covering between 10% and 20% of the entire surface and visually having a low brightness level. Two regions of this type were detected along a meridian; a region located near the polar region and another one located near the equatorial region. These regions respectively noted severely scratched polar region (SSPR) and severely scratched equatorial region (SSER) are dark gray-colored in Fig. 1c.

Fig. 1. (a) Retrieved titanium-based femoral head, (b) retrieved UHMWPE acetabular liner with an embedded titanium fibermesh piece, (c) qualitative mapping of location and brightness level of the worn regions under study.

- Regions covering more than 50% of the entire surface and visually having an intermediate brightness level. These regions noted moderately scratched (MS) are gray-colored in Fig. 1c.

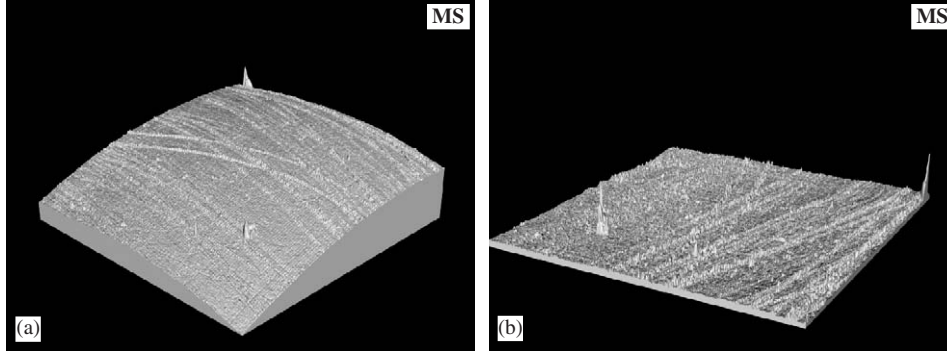
Fig. 2. (a) Visualization of an original data file recorded by means of the three-dimensional contacting profilometer in the region MS, (b) residual data file obtained after removing the spherical form at the first step of our computer algorithm.

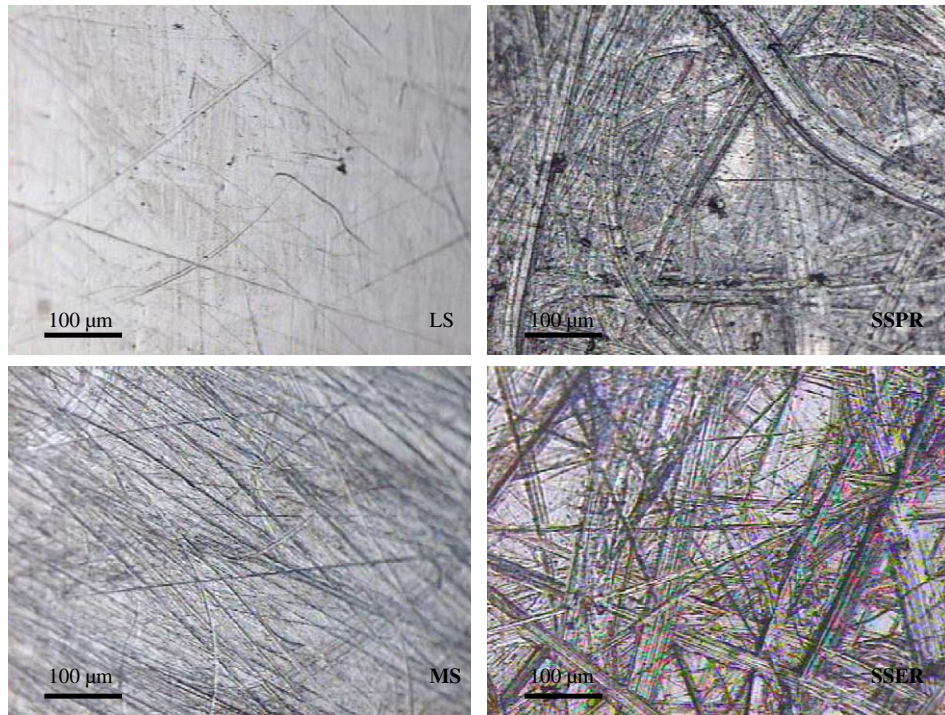
The qualitative information obtained on the topography by means of an optical microscope is summarized in Fig. 4. Only few isolated scratches are observed in the regions LS that visually have a bright finish meaning that the femoral head has only suffered a light degradation of its initial mirror finish in these regions. On the contrary, a severe degree of degradation consisting in a high density of large, deep and multidirectional scratches can be noticed in the regions SSPR and SSER visually having a low brightness level. Finally, a moderate degree of damage is noticed in regions MS which topography consists of a high density of numerous small and multidirectional scratches.

Fig. 4. Optical micrographs showing the characteristics of scratches in the four worn regions LS, MS, SSPR and SSER.

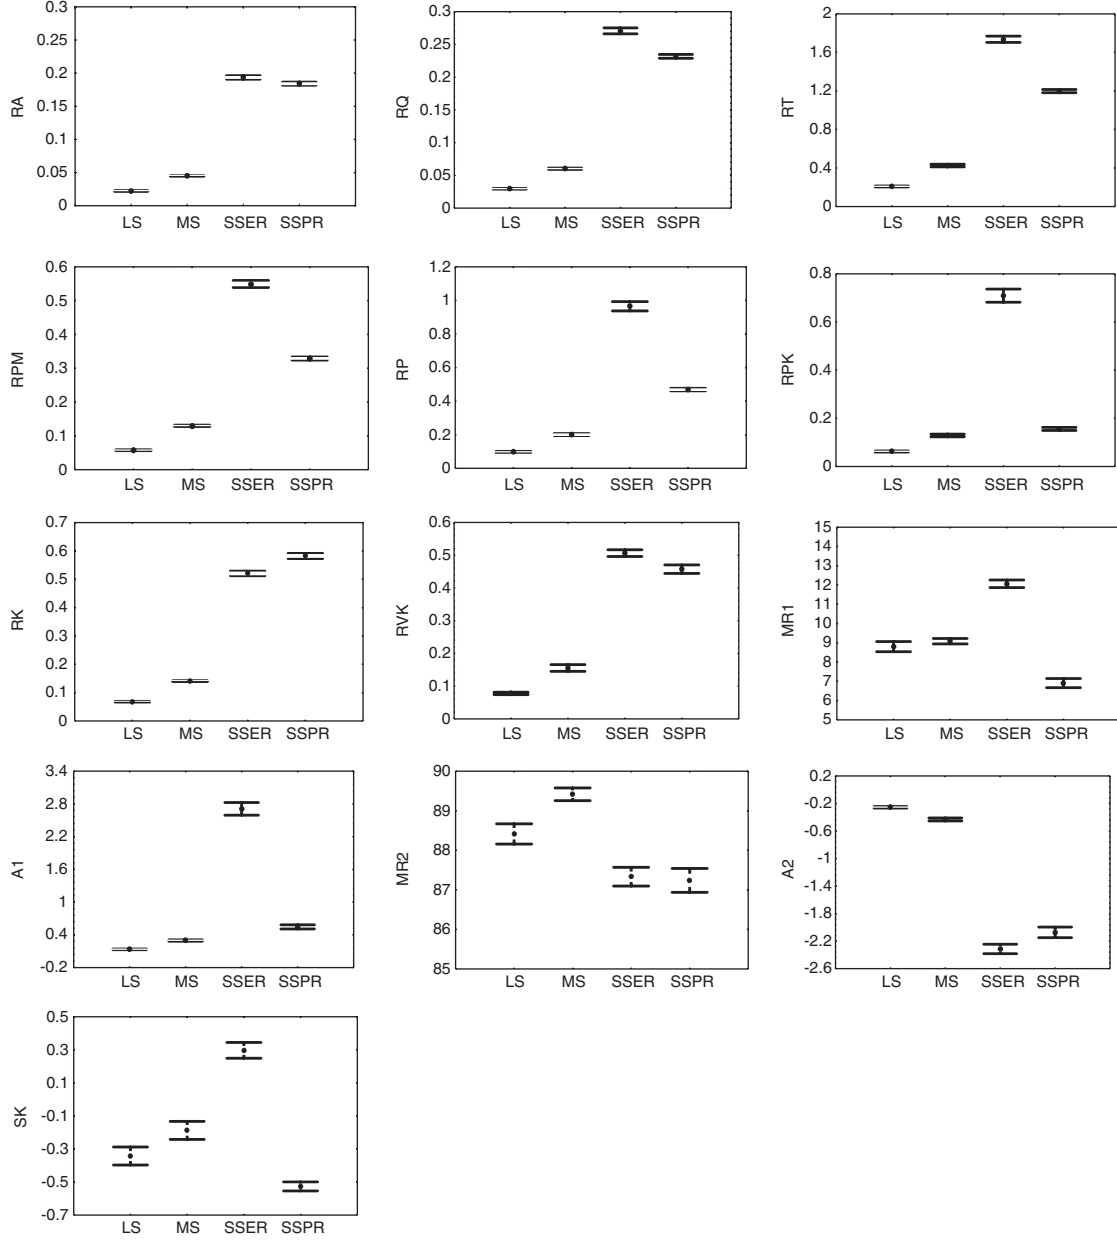
Fig. 5. Means and associated standard errors of the different roughness parameters under investigation for the different regions LS, MS, SSER and SSPR.

standard error are plotted for each element of the set $\{P_{i,j}^{\text{Exp.}}; i \in [1 \text{ to } 13], j \in [1 \text{ to } 1200]\}_k$; i.e. for each roughness parameter P_i under investigation. At first sight, it can be seen on this figure that all the values of the amplitude parameters $R_\alpha (\alpha = a, q, t, p, pm, k, pk, vk)$ tend to increase with the severity of damage degree if the overall regions are considered. This result physically reflect the expected fact that the height of the peaks and the depth of the valleys simply increase with the severity of damage.

It is also very interesting to notice on this figure that, while the values of the average amplitude parameters R_α $(\alpha = a, q, k)$ are of the same order for the two severely scratched regions SSER and SSPR, the values of the extreme-value parameters R_β $(\beta = p, \text{pm}, \text{pk}, t)$ are quite different as well as the values of the roughness parameters

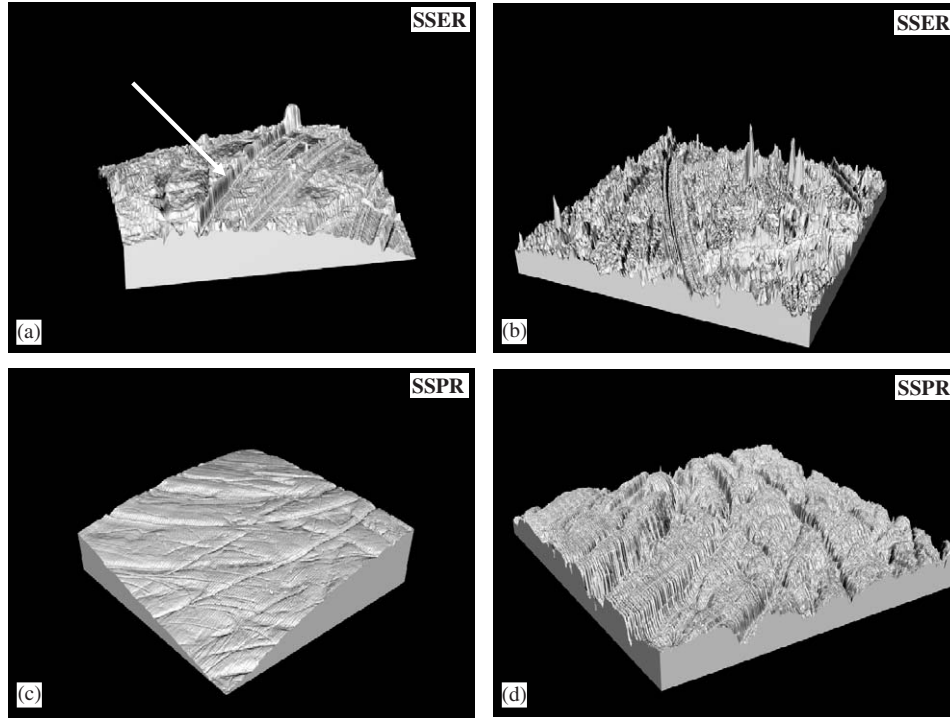
Mr_1 and A_1; the values of all these parameters being always higher in the region SSER. Besides the values of the roughness parameters R_{vk}, Mr_2 and A_2 are of the same order for the two regions. These results physically mean that, while the regimes related to the core roughness and to the valleys lying below the core roughness are similar for the two severely scratched regions, the regime related to the peaks are significantly different; the peaks being higher in the region SSER than in the region SSPR. This result is confirmed by the interesting fact that, visualizing the topography of the measured areas by means of the three-dimensional contacting profilometer, some material build-up can be observed on either side of the large scratches crossing the region SSER whereas it is not the case for the region SSPR (Fig. 6).

Fig. 6. Example of a typical area recorded by means of the three-dimensional contacting profilometer in region SSER (a) before and (b) after removing the spherical form: note the large scratch accompanied by material build-up marked with a white arrow. Example of a typical area recorded by means of the three-dimensional contacting profilometer in region SSPR (c) before and (d) after removing the spherical form: note the absence of peaks on either sides of the large scratches.
