About the relevance of roughness parameters used for characterizing worn femoral heads

D. Najjar[a,*], M. Bigerelle[a,b], H. Migaud[c], A. Iost[a]

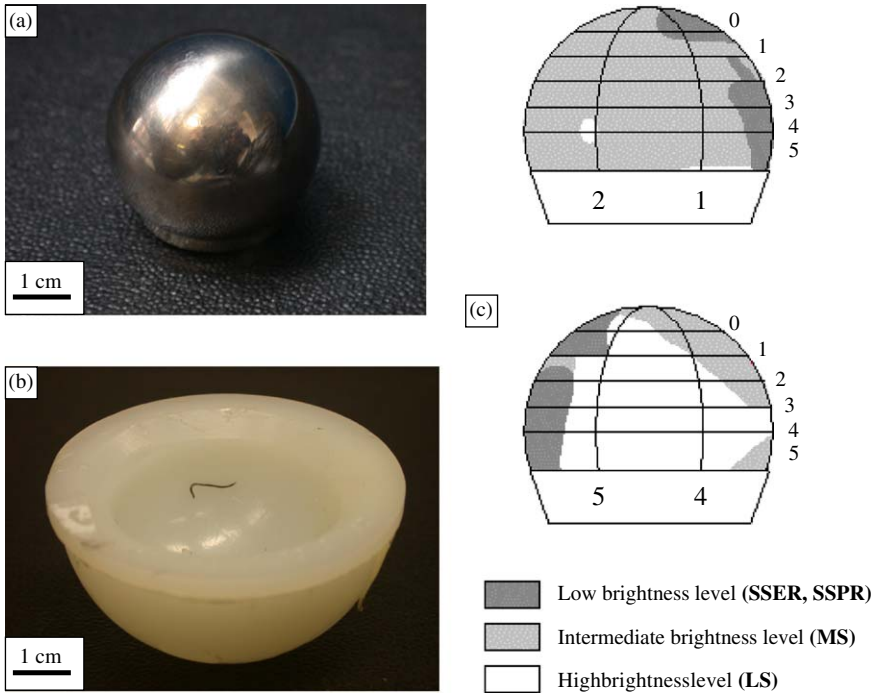
Since the foreign third bodies are increasingly suspected of being the dominant cause of the scratch generation, this titanium alloy (TA6V) femoral head (Fig. 1a) was especially selected because an embedded metallic fiber was detected in the UHMWPE counterface after revision surgery (Fig. 1b). This centimeter-length foreign body came from the titanium fibermesh, which was deposited on the Harris–Galante metallic cup during the fabrication process. It must be pointed out that polyethylene and metallic debris were detected by histological analyses on the peri-prosthetic tissues.

The influence of this foreign body on the degradation mechanisms of both the retrieved UHMWPE acetabular liner and titanium alloy femoral head have already been studied in previous papers [12,13]. As far as the degradation of the titanium alloy femoral head is concerned, three kinds of regions were distinguished by visual inspection at its surface (Fig. 1c):

- Regions covering about 30% of the entire surface and visually having a bright finish. These regions noted LS (for lightly scratched) are white-colored in Fig. 1c.
- Regions covering between 10% and 20% of the entire surface and visually having a low brightness level. Two regions of this type were detected along a meridian; a region located near the polar region and another one located near the equatorial region. These regions respectively noted severely scratched polar region (SSPR) and severely scratched equatorial region (SSER) are dark gray-colored in Fig. 1c.

Fig. 1. (a) Retrieved titanium-based femoral head, (b) retrieved UHMWPE acetabular liner with an embedded titanium fibermesh piece, (c) qualitative mapping of location and brightness level of the worn regions under study.

- Regions covering more than 50% of the entire surface and visually having an intermediate brightness level. These regions noted moderately scratched (MS) are gray-colored in Fig. 1c.

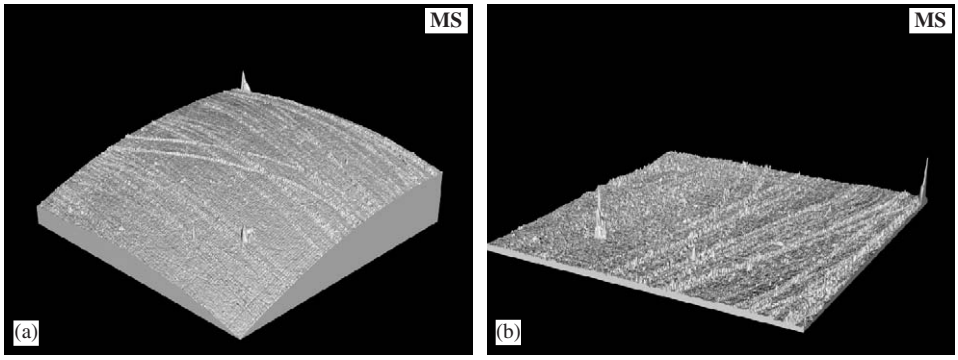
Fig. 2. (a) Visualization of an original data file recorded by means of the three-dimensional contacting profilometer in the region MS, (b) residual data file obtained after removing the spherical form at the first step of our computer algorithm.

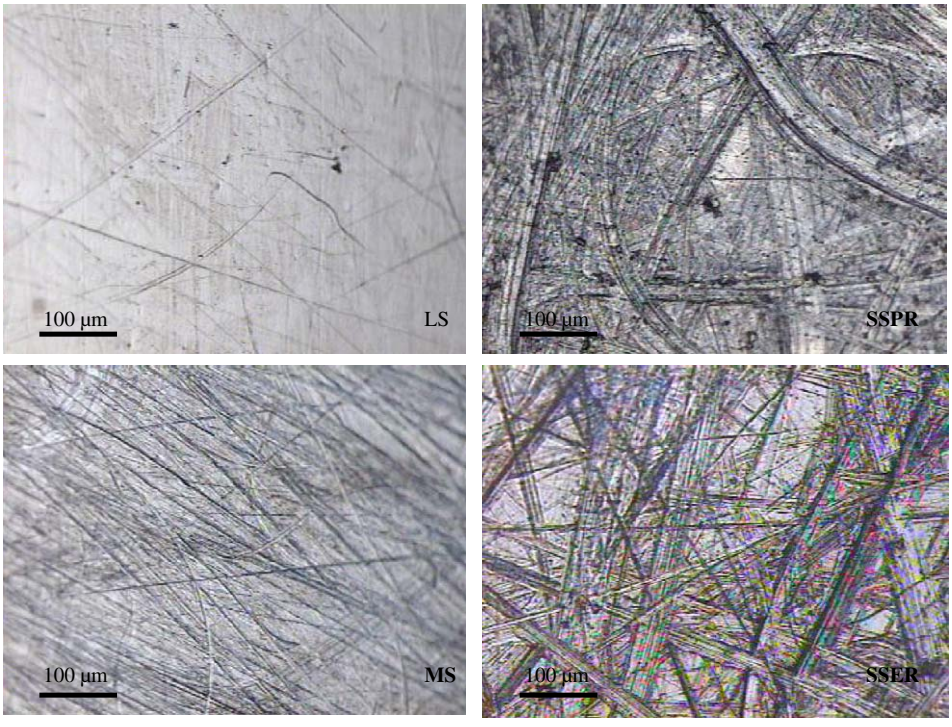
The qualitative information obtained on the topography by means of an optical microscope is summarized in Fig. 4. Only few isolated scratches are observed in the regions LS that visually have a bright finish meaning that the femoral head has only suffered a light degradation of its initial mirror finish in these regions. On the contrary, a severe degree of degradation consisting in a high density of large, deep and multidirectional scratches can be noticed in the regions SSPR and SSER visually having a low brightness level. Finally, a moderate degree of damage is noticed in regions MS which topography consists of a high density of numerous small and multidirectional scratches.

Fig. 4. Optical micrographs showing the characteristics of scratches in the four worn regions LS, MS, SSPR and SSER.

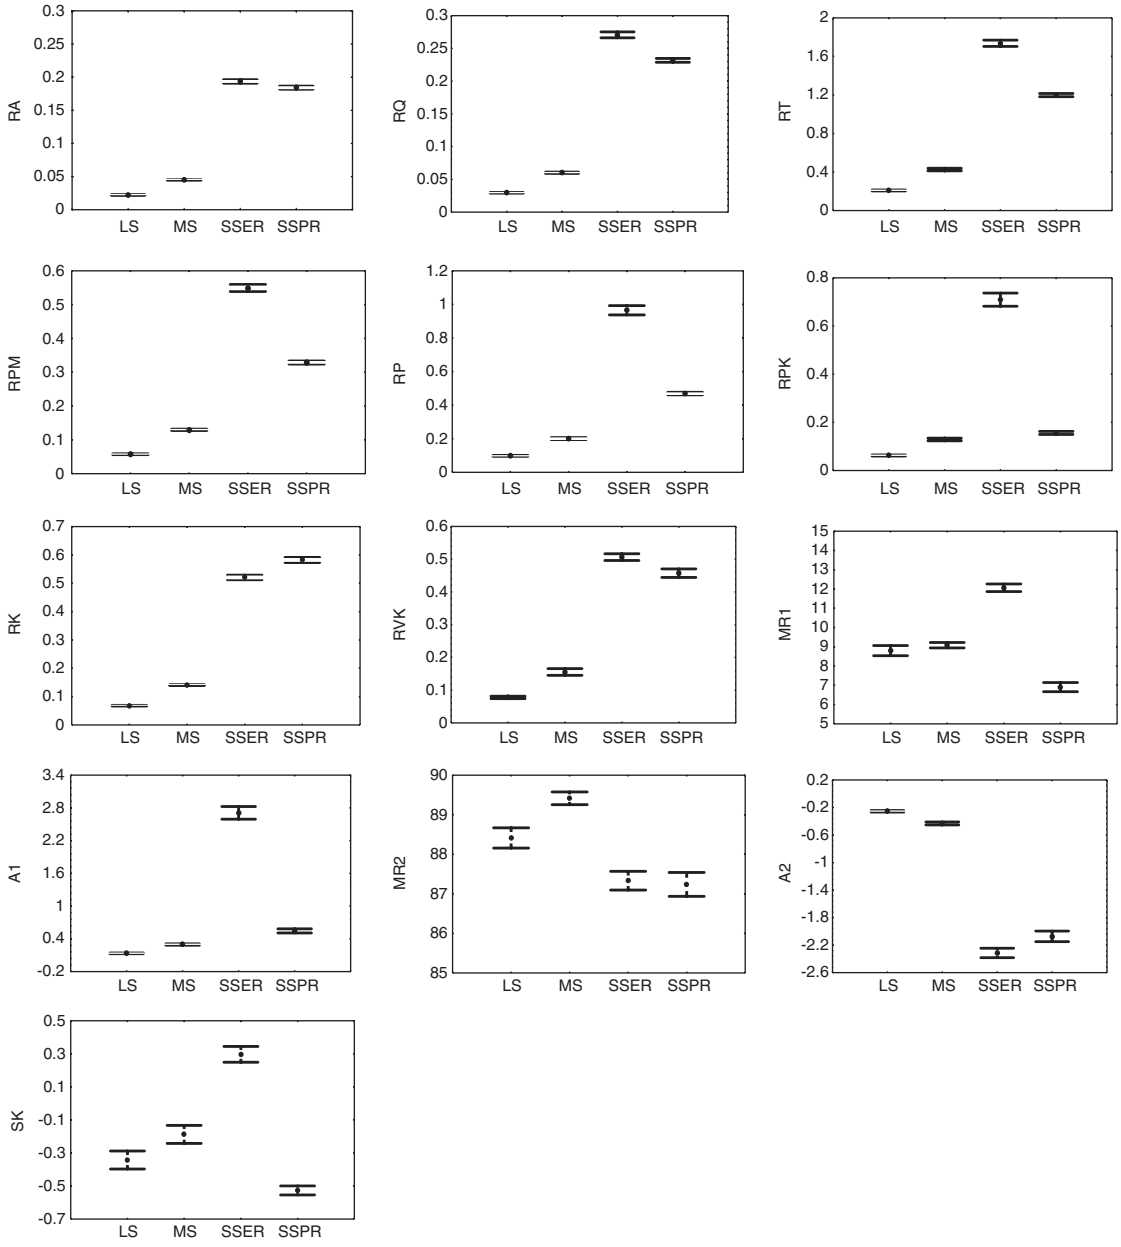
Fig. 5. Means and associated standard errors of the different roughness parameters under investigation for the different regions LS, MS, SSER and SSPR.

standard error are plotted for each element of the set $\{P_{i,j}^{\text{Exp.}}; i \in [1 \text{ to } 13], j \in [1 \text{ to } 1200]\}_k$; i.e. for each roughness parameter P_i under investigation. At first sight, it can be seen on this figure that all the values of the amplitude parameters $R_\alpha(\alpha = a,\ q, t, p, pm, k, pk, vk)$ tend to increase with the severity of damage degree if the overall regions are considered. This result physically reflect the expected fact that the height of the peaks and the depth of the valleys simply increase with the severity of damage.

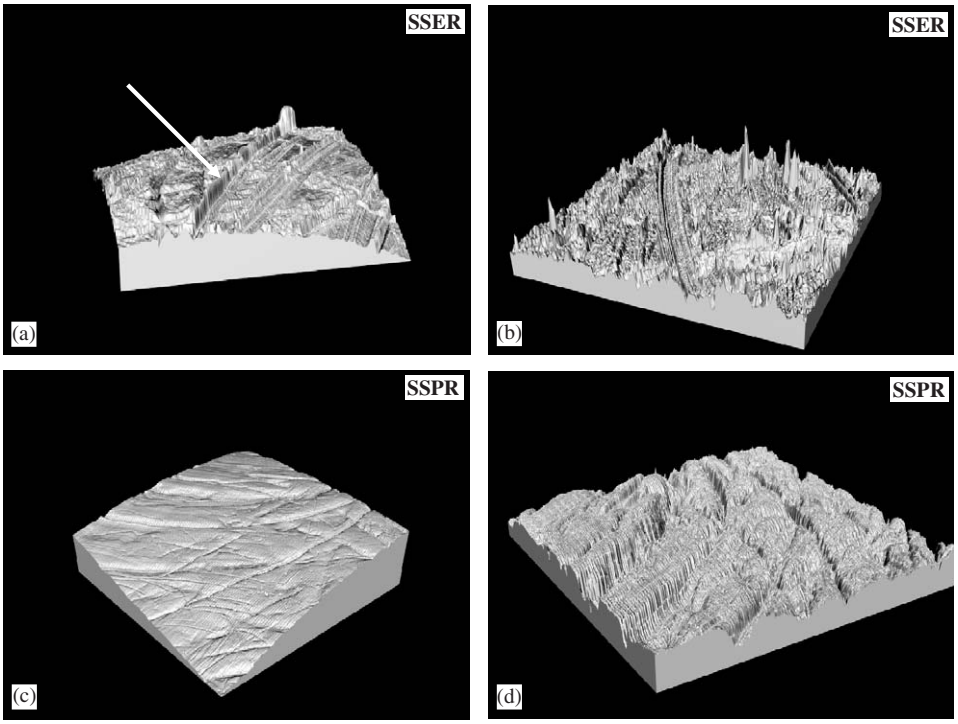
It is also very interesting to notice on this figure that, while the values of the average amplitude parameters R_α ($\alpha = a,\ q,\ k$) are of the same order for the two severely scratched regions SSER and SSPR, the values of the extreme-value parameters R_β ($\beta = p$, pm, pk,t) are quite different as well as the values of the roughness parameters Mr_1 and A_1; the values of all these parameters being always higher in the region SSER. Besides the values of the roughness parameters R_{vk}, Mr_2 and A_2 are of the same order for the two regions. These results physically mean that, while the regimes related to the core roughness and to the valleys lying below the core roughness are similar for the two severely scratched regions, the regime related to the peaks are significantly different; the peaks being higher in the region SSER than in the region SSPR. This result is confirmed by the interesting fact that, visualizing the topography of the measured areas by means of the three-dimensional contacting profilometer, some material build-up can be observed on either side of the large scratches crossing the region SSER whereas it is not the case for the region SSPR (Fig. 6).

Fig. 6. Example of a typical area recorded by means of the three-dimensional contacting profilometer in region SSER (a) before and (b) after removing the spherical form: note the large scratch accompanied by material build-up marked with a white arrow. Example of a typical area recorded by means of the three-dimensional contacting profilometer in region SSPR (c) before and (d) after removing the spherical form: note the absence of peaks on either sides of the large scratches.
