Failure analysis of shot–sleeves used in brass high pressure die–casting process

A failure investigation has been conducted on a two cases of shot-sleeve used in brass-die casting and made up of AISI H10 tool steels to study their failure mechanisms. The chemical composition of the shot-sleeves material and the hardness profiles were evaluated. A preliminary examination of shot-sleeves reveal the presence of cracks network on their inner surfaces which proves that thermal fatigue was probably the main cause of their failure. A Meticulous investigation of these damaged surfaces reveal the presence of an additional small zone cited in the vicinity of the plunger entry side. This zone presents several scratches sign of abrasive wear. Then, the measurement of the cracks length and their linear density along longitudinal and transversal cuts of the damaged shot-sleeve sample are carried out. Results show that the observed cracks network can be divided into two zones. The first one was the most damaged in terms of cracks density and length given that it is the first zone which enter in contact with the molten metal. However, the cracks network examined in the second zone appears to be s

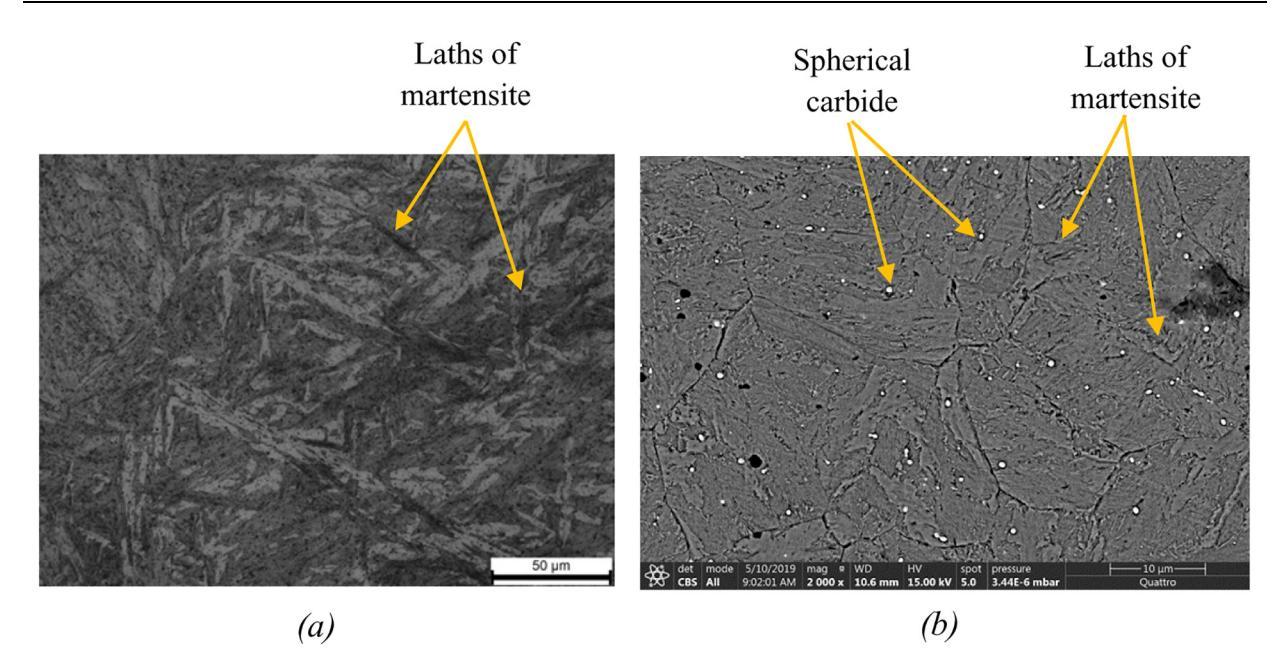
Fig. 2. Microstructure of the shot-sleeve: (a) Light Optical Microscopy (LOM), (b) The SEM microanalysis.

Our studied material is H10, a metallographic observations were realized by means of an optical microscope (Leica®) on the same taken sample polished until mirror state then attacked by Nital (5% of nitric acid diluted in methanol). These observations show the presence of a martensitic structure (Fig. 2).

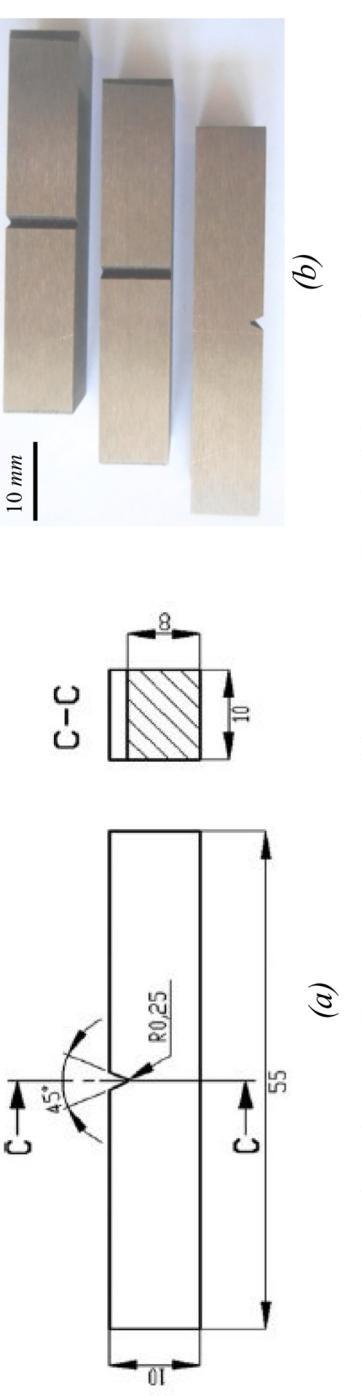
Fig. 4. Charpy V-notch specimens: (a) Geometry and dimensions (in mm), (b) machined Charpy V-notch specimens.

Standard Charpy V-notched specimens were machined from the failed shot-sleeve by a wire EDM machine (Fig. 4). Then, three tests were conducted at room temperatures to determine the material toughness. The average of the measured CVN energy (CVN = $3.4 \pm 0.1 \text{ J}$) and the feature of the fractured surface prove the brittle nature of the specimen material (Fig. 5).

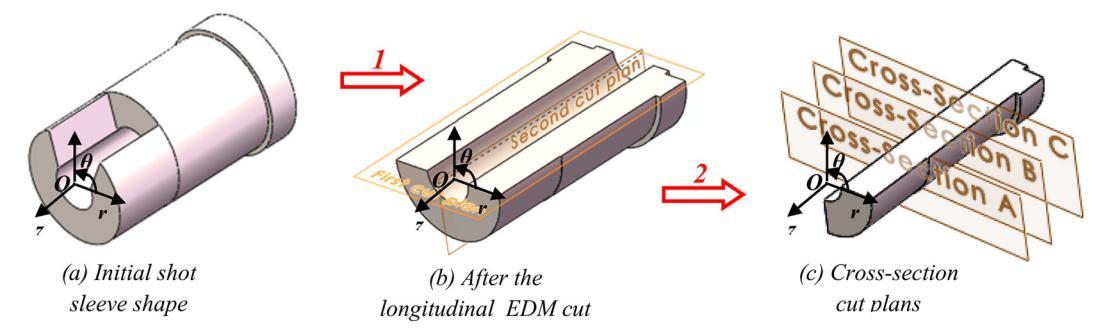
Fig. 6. CAO schema of shot-sleeve cutting planes: (a) Initial shot sleeve shape, (b) After the longitudinal EDM cut, (c) Cross-section cut plans.

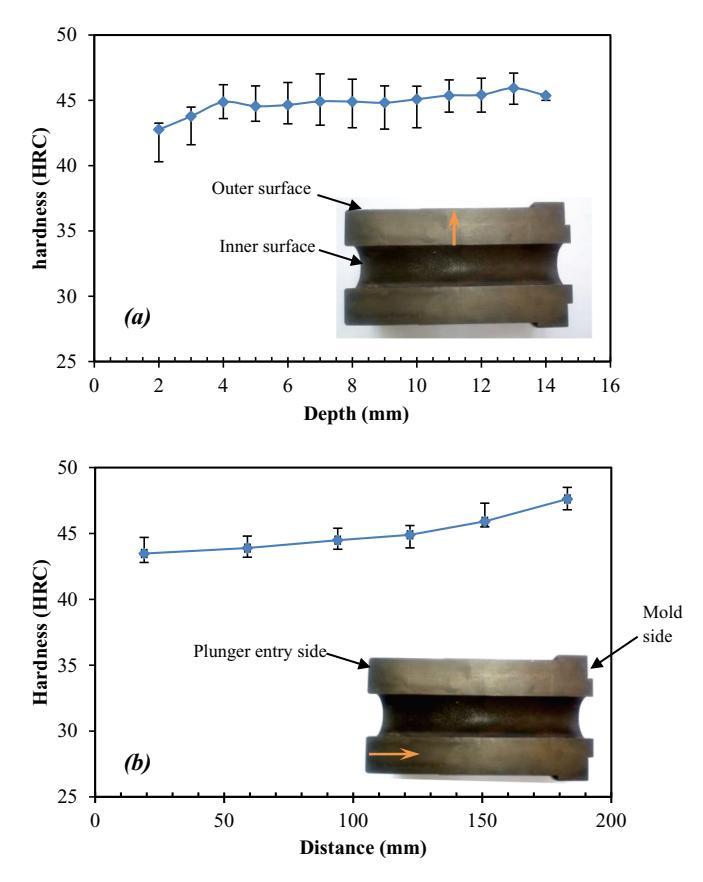
Fig. 7. Hardness shot-sleeve profiles, (a) from the entry to the mold zones, (b) from inner to the outer surfaces.

The hardness profiles were measured, on a shot–sleeve longitudinal section (Fig. 6 (*b*)) polished until mirror state, from the entry plunger zone to the mold side and from the inner to the outer surface (Fig. 7). These profiles are performed with a Vickers hardness machine using a load of 15 kg. The measured profiles reveal that the hardness appears to be constant for all tested samples.
