Failure analysis of shot–sleeves used in brass high pressure die–casting process

Dorra Abid^a, Ahmed Ktari^{a,b,*}, Dhouha Mellouli^a, Nedja Gafsi^a, Nader Haddar^a

A failure investigation has been conducted on two cases of shot-sleeve used in brass–die casting and made up of AISI H10 tool steels to study their failure mechanisms. The chemical composition of the shot–sleeves material and the hardness profiles were evaluated. A preliminary examination of shot–sleeves reveal the presence of cracks network on their inner surfaces which proves that thermal fatigue was probably the main cause of their failure. A Meticulous investigation of these damaged surfaces reveal the presence of an additional small zone cited in the vicinity of the plunger entry side. This zone presents several scratches sign of abrasive wear. Then, the measurement of the cracks length and their linear density along longitudinal and transversal cuts of the damaged shot–sleeve sample are carried out. Results show that the observed cracks network can be divided into two zones. The first one was the most damaged in terms of cracks density and length given that it is the first zone which enter in contact with the mo

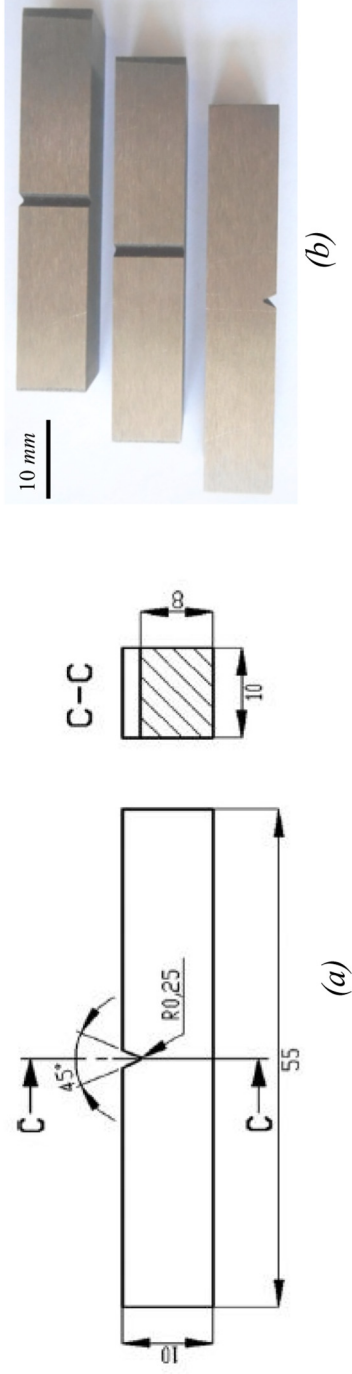
Fig. 4. Charpy V-notch specimens: (a) Geometry and dimensions (in mm), (b) machined Charpy V-notch specimens.

Standard Charpy V-notched specimens were machined from the failed shot-sleeve by a wire EDM machine (Fig. 4). Then, three tests were conducted at room temperatures to determine the material toughness. The average of the measured CVN energy (CVN = 3.4 ± 0.1 J) and the feature of the fractured surface prove the brittle nature of the specimen material (Fig. 5).

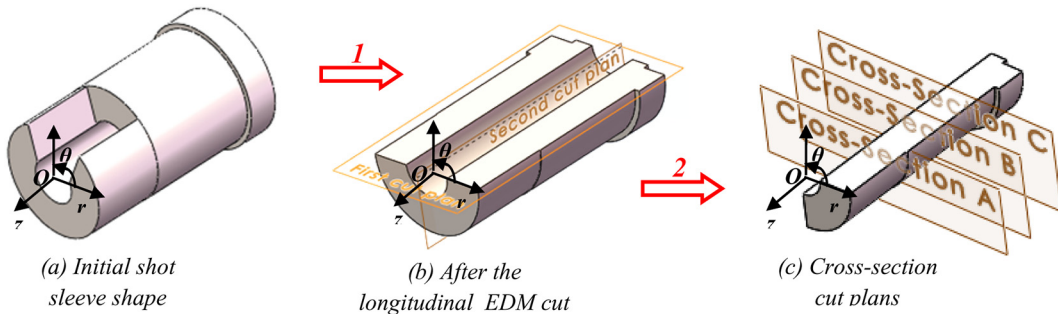
Fig. 6. CAO schema of shot-sleeve cutting planes: (a) Initial shot sleeve shape, (b) After the longitudinal EDM cut, (c) Cross-section cut plans.

The hardness profiles were measured, on a shot-sleeve longitudinal section (Fig. 6 (b)) polished until mirror state, from the entry plunger zone to the mold side and from the inner to the outer surface (Fig. 7). These profiles are performed with a Vickers hardness machine using a load of 15 kg. The measured profiles reveal that the hardness appears to be constant for all tested samples.
