Paola MAZZANTI, Bertrand MARCON, Linda COCCHI, Giacomo GOLI, Lorenzo RIPARBELLI, Luca UZIELLI - An Innovative Method Based on In Situ Deformometric Monitoring to Support Decisions for the Structural Restoration of a Historic Panel Painting - Heritage - Vol. 7, n°8, p.4193-4205 - 2024

An Innovative Method Based on In Situ Deformometric Monitoring to Support Decisions for the Structural Restoration of a Historic Panel Painting

This paper presents an innovative method developed by the authors to provide guidance in planning the structural restoration of a large-scale historic panel painting. Its overly rigid constraints had resulted in severe transverse tensile cracking following major changes in moisture content.

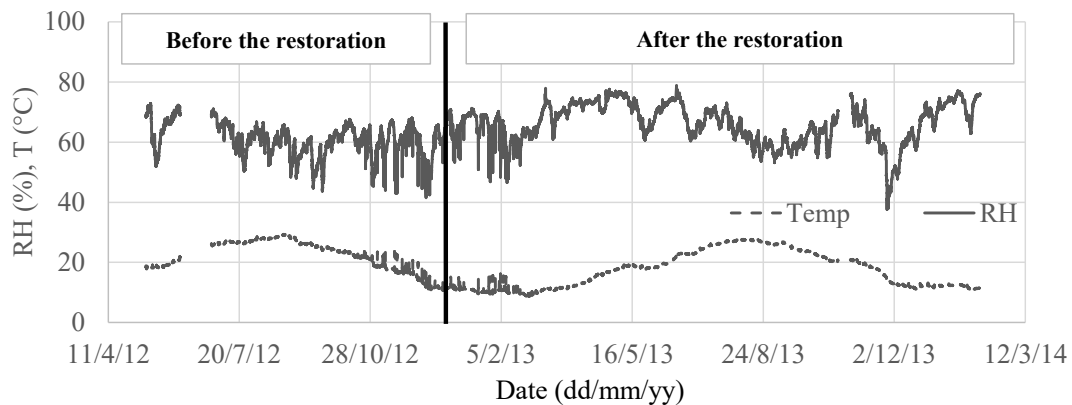
Figure 5. The graph shows the climatic conditions the panel painting underwent before and after the restoration. Note. Due to the unforeseen exhaustion of some batteries, data are missing for approximately the month of June.
