Abir ABDESSALEM, Sahbi TAMBOURA, Joseph FITOUSSI, Hachmi Ben DALY, Abbas TCHARKHTCHI, Fodil MERAGHNI - Microstructure investigation of hydrothermal damage of aged SMC composites using Micro-computed tomography and scanning electron microscopy - Engineering Failure Analysis - Vol. 121, p.105177 - 2021

# Microstructure investigation of hydrothermal damage of aged SMC composites using Micro-computed tomography and scanning electron microscopy

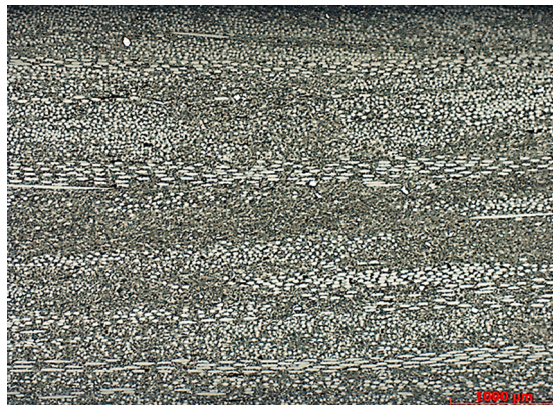
Fig. 3. Microscopic observation of the non-aged sample surface.

Microscopic observations revealed the usual complex morphology of SMC, with the presence of individual fibres, glass tows in various directions and circular voids due to the residual air in the prepreg as shown in Fig. 3.

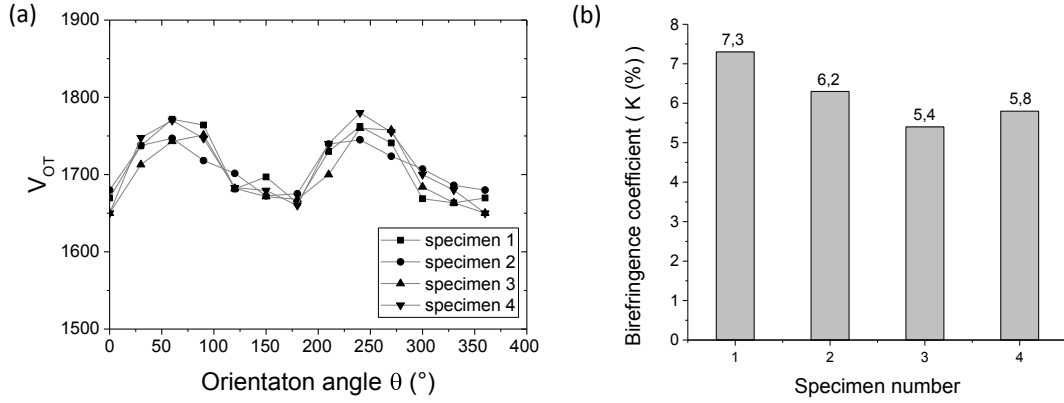
Fig. 4. Ultrasonic results showing (a) fiber orientation around 60° and (b) the fiber orientation intensity.

The determination of the fiber orientation in the studied SMC composite was carried out on various samples using US tests. The results of the ultrasonic characterization method are illustrated in Fig. 4 (a). As it can be denoted, a preferred orientation of the glass fibers was recorded around  $60^\circ$ . This is proved by the presence of two peaks, one at around  $60^\circ$  and its symmetric around  $240^\circ$  corresponding to fiber orientation.

However, the birefringence coefficient records a relative depletion in fibers since its value does not exceed 8% as shown in Fig. 4(b).

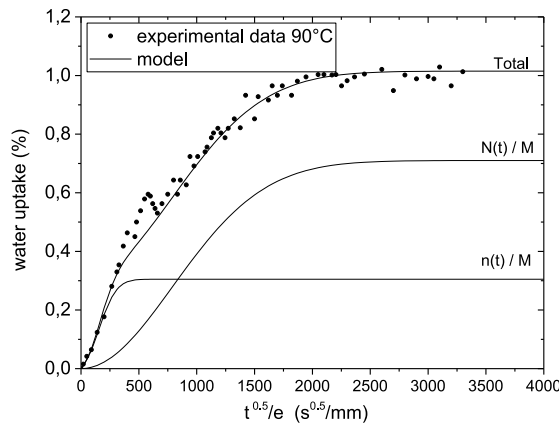
Fig. 5. Gravimetric results for water absorption at 90 °C. (●) experimental, (—) model.

The mass variation shows three behaviors. Firstly, for all the specimens, the water absorption process is linear and  $\left( \frac{M_t - M_0}{M_0} \right) > 0$ .

Then a decrease, at shifted periods of time, was recorded on the absorption curves where  $\frac{M_t - M_0}{M_0} < 0$ . This phenomenon was associated to the leaching of the calcium carbonate fillers due to water attack. Finally, the diffusion restarts again in the material until the saturation.
