Dorra ABID, Dhouha MELLOULI, Nedja GAFSI, Nader HADDAR, Ahmed KTARI - Failure analysis of shot-sleeves used in brass high pressure die-casting process - Engineering Failure Analysis - Vol. 104, p.177-188 - 2019

Failure analysis of shot–sleeves used in brass high pressure die–casting process

Dorra Abid^a, Ahmed Ktari^{a,b,*}, Dhouha Mellouli^a, Nedja Gafsi^a, Nader Haddar^a

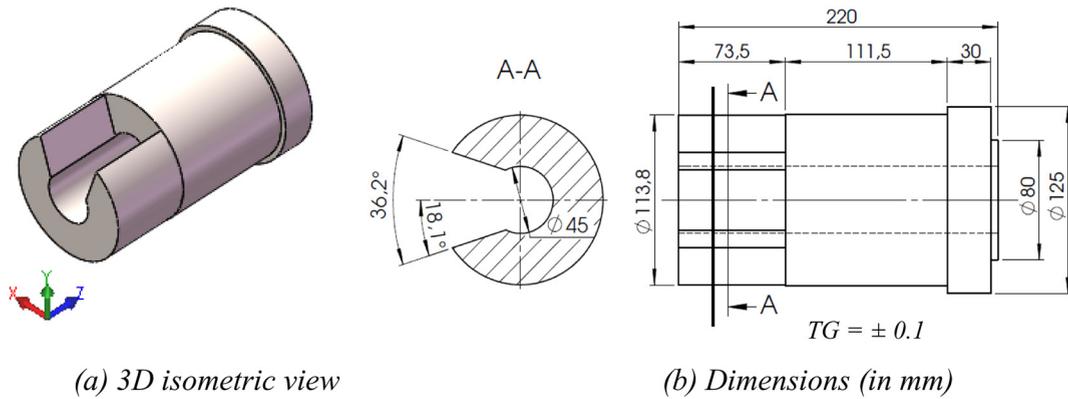
Fig. 1. Geometry and dimensions of the studied shot-sleeves.

In the present study, samples of shot-sleeve failed in service, were investigated to understand the mechanisms, which can lead to their damage. The shot-sleeve (Fig. 1), used in brass high pressure die-casting process, undergoes a severe thermo-mechanical loadings during cast cycles. Each cycle include principally four phases as following:

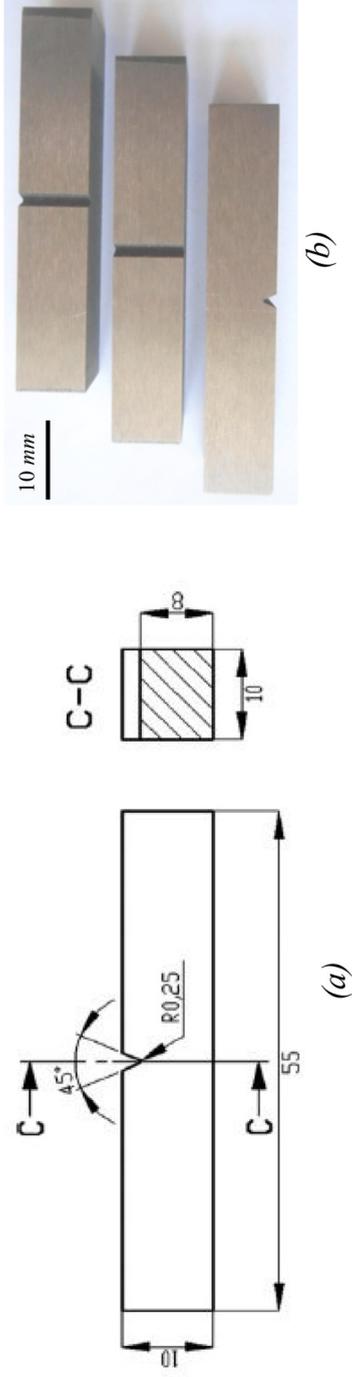
Fig. 4. Charpy V-notch specimens: (a) Geometry and dimensions (in mm), (b) machined Charpy V-notch specimens.

Standard Charpy V-notched specimens were machined from the failed shot-sleeve by a wire EDM machine (Fig. 4). Then, three tests were conducted at room temperatures to determine the material toughness. The average of the measured CVN energy (CVN = 3.4 ± 0.1 J) and the feature of the fractured surface prove the brittle nature of the specimen material (Fig. 5).

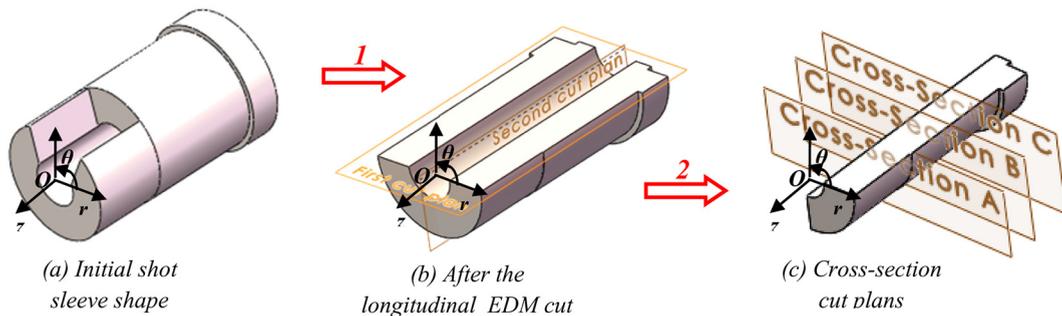
Fig. 6. CAO schema of shot-sleeve cutting planes: (a) Initial shot sleeve shape, (b) After the longitudinal EDM cut, (c) Cross-section cut plans.

The hardness profiles were measured, on a shot-sleeve longitudinal section (Fig. 6 (b)) polished until mirror state, from the entry plunger zone to the mold side and from the inner to the outer surface (Fig. 7). These profiles are performed with a Vickers hardness machine using a load of 15 kg. The measured profiles reveal that the hardness appears to be constant for all tested samples.

A finer observations of the shot-sleeve inner side were carried out after a longitudinal cut (Fig. 6 (b)). The examination of the damaged surfaces was made using an experimental device equipped with a digital *Baumer*[®] camera *GIG*E (8 bits). This camera is equipped with a CCD sensor allowing to have a resolution of 1624×1236 pixels. Several photos are taken and then assembled by means of Photoshop[®] software to obtain a large image that cover the entire shot-sleeve examined surface (Fig. 9). This surface reveals the presence of three different zones. The first one is located in the plunger entrance side. It presents a number of scratch according the longitudinal direction which corresponds to abrasive wear caused by the friction between the plunger and the shot-sleeve. The second one corresponds to the first zone which enter in contact with the molten metal ($T = 950^\circ\text{C}$). It undergo cyclic thermal shocks. This zone appears to be the most damaged surface in the shot-sleeve. It presents a dense crack network sign of the thermal fatigue. In addition, the investigation of this zone according to the $O\theta Z$ plan shows that some cracks, after initiation, were propagated in depth along the radial direction (Detail A). The last zone reveals also the presence of a crack network however it is less dense compared to this observed in the 2nd zone (Fig. 9).
