INVESTIGATION OF DAMAGE MECHANISMS IN 3D INTERLOCK TEXTILE COMPOSITES UNDER LOW VELOCITY SOFT IMPACT LOADING

Keywords: damage, composite textile, soft impact, micrographic study, variability.

Abstract

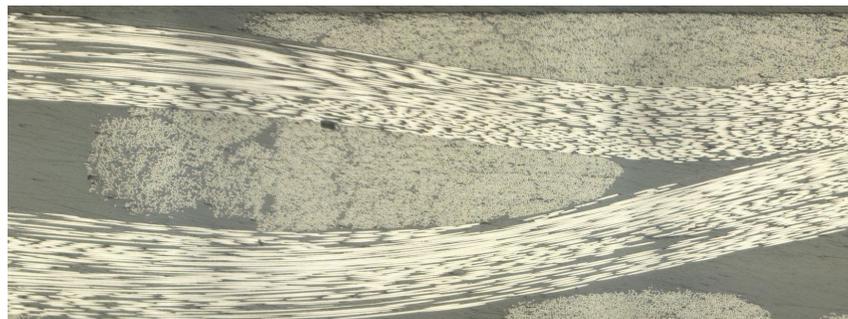
Figure 4 Details of the interlock 3X 55% woven composite microstructure

Figure 4 shows a close-up of the interlaced weft and warp yarns. One can see that the fiber distribution within a yarn is uneven probably caused by compaction during the RTM process. Some resin rich areas are clearly visible and can take the form of paths within the yarn.
