Fatigue damage mechanisms of short fiber reinforced PA66 as observed by in-situ synchrotron X-ray microtomography

H. Rolland^a, N. Saintier^{a,*}, I. Raphael^{a,d}, N. Lenoir^b, A. King^c, G. Robert^d

The understanding of fatigue damage mechanisms of short fiber reinforced thermoplastics are a key issue in order to optimize material processing and propose physically based multiscale fatigue damage models. The presented work aims at a fine description of 3D damage development as observed by synchrotron X-ray microtomography. Damage processes at the micro and mesoscale are fully described in order to extract the elementary damage mechanisms, their sequence and kinetics. The effects of local fiber configuration and orientation are particularly detailed. From observations it is clearly evidenced that cavitation plays a major role in the fatigue damage process as it triggers all elementary damage mechanisms observed at the microscale. It is also shown that a characteristic length appears in the fatigue damage development. This internal length is in the order of magnitude of the spherulite size, suggesting a strong impact of the spherulite size on the fatigue damage development. Finall

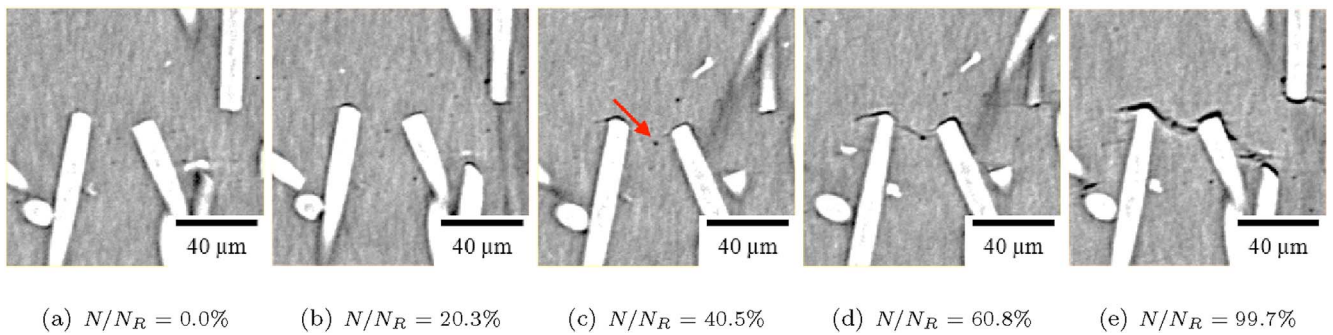
Fig. 6. Damage at fiber ends - RH50 0° specimen $N_R = 2468$ cycles.

The occurrence of decohesion at fiber ends (also called fiber tips) has frequently been observed in our observations. This damage mechanism has also been observed for monotonic tensile testing [15,16] and is explained by the lack of bounding between fiber ends and matrix (due to the process) and the geometry of fibers, turning ends of fiber to stress concentrators. If these damage markers initiate at the first cycle in the same way as in quasi-static sollicitation, they evolve very differently during the fatigue lifetime. Indeed, instead of growing in the matrix as for tensile loading by ductile damage growth [15], each damaged zone tends to initiate a microcrack in the matrix, transversely to the macroscopic tensile direction (as shown in Fig. 6). These damage zones can then be propitious to neighbouring microcracks propagation, depending on the sharpness of their geometry and the orientation of the edge. It should be noticed that the damage to microcrack transition is strongly dependent on the local configuration but starts at approximately 20% of the fatigue life. As observed in Fig. 6, damage progresses by coalescence of adjacent damaged zones. This coalescence is

triggered by cavitation that initiates a microcrack in between two fiber ends (see Fig. 6(c)).

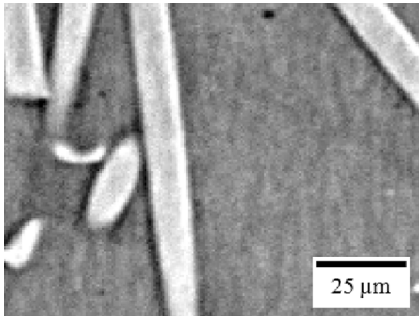
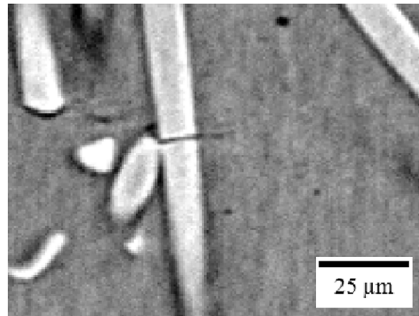
(a) Initial state - $N/N_R = 0.0\%$

(b) fiber failure under cyclic loading - $N/N_R = 40.5\%$

(c) Damage evolution under cyclic loading - $N/N_R = 99.7\%$

(d) Initial state - $\varepsilon/\varepsilon_R = 0.0\%$

(e) fiber failure under monotonic loading - $\varepsilon/\varepsilon_R = 38.9\%$

(f) Damage evolution under monotonic loading - $\varepsilon/\varepsilon_R = 98.1\%$

Fig. 9. Fiber failure evolution according to the loading.

surrounding matrix. It is worth noting that when a fiber breaks, contrary to observations made for monotonic testing, the damage does not grow spherically but grows in the form of a microcrack transversely to the macroscopic loading as illustrated in Fig. 9, or by debonding and coalescence as in Fig. 7(e). These microcracks can also be found on the fracture surface as illustrated by SEM fractography given Fig. 10. Microcracks generated by the fiber failure appear as a disk around fibers, whether it is in ductile zone (see Fig. 10(a)) or in brittle zone (see Fig. 10(b)). These microcracks are due to high stress and strain concentration in the fiber failure zone. The higher criticality of fiber failure compared to fiber ends damage is illustrated in Fig. 11, where the microcracks are developing at the level of the fiber failure instead of fiber ends.

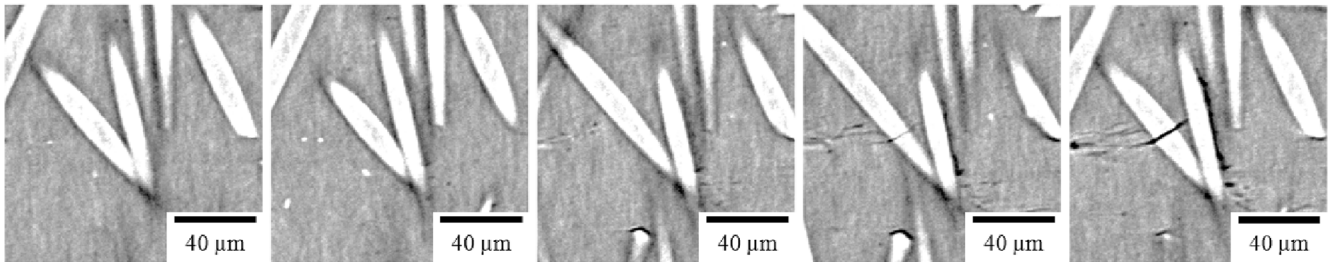
(a) $N/N_R = 0.0\%$ (b) $N/N_R = 20.3\%$ (c) $N/N_R = 40.5\%$ (d) $N/N_R = 60.8\%$ (e) $N/N_R = 99.7\%$ Fig. 12. Debonding - RH50 0° specimen $N_R = 2468$ cycles.

Debonding occurs at the fiber-matrix interface, as illustrated in Fig. 12. It mainly happens along fibers oriented transversely to the macroscopic loading. This mechanism was observed to initiate from damage at fiber ends but, mostly by damage localization along the fiber at the fiber-matrix interface, promoted by a confinement effect between neighbouring fibers. Debonding mostly appears at an advanced stage of the fatigue lifetime (approximately 90 %) and contributes significantly to the meso-crack propagation process. As usually considered, debonding may appear as an adhesive or cohesive process (illustrated in Fig. 13). The nature of debonding appear to be linked to the orientation of the fibers, on the neighbouring fibers (confinement effect) and on the quality of the interface (e.g. regularity of the sizing). In the case of adhesive failure, debonding was clearly initiated by the development of multiple cavitation at the fiber matrix interface. Damage then develops in the form of penny-shape voids (micro-crack similar to the crazes described in the next section) of a typical size of five to ten micron that quickly connect to form an interfacial debonding. It should be noticed that debonding was found to be triggered by cavitation along the fiber-matrix interface. In our case, debonding was mostly a cohesive failure process, promoted by proper chemical fiber-matrix treatments.

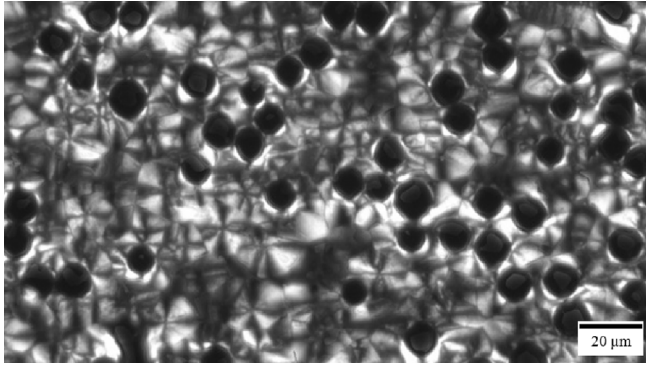
Fig. 16. RH50 0° specimen observed by optical microscopy in cross polarization.

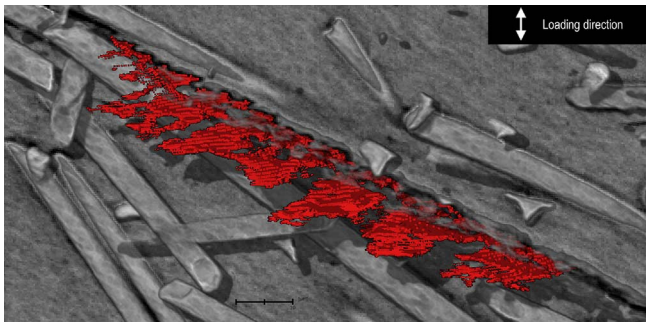
Fig. 17. Craze segmented in a RH50 45° specimen.

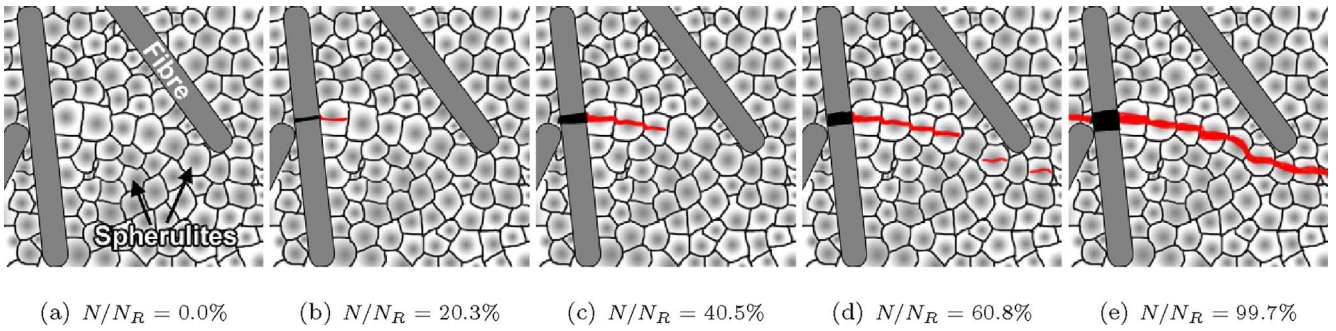
Fig. 19. Microcracks mechanism as a function of spherulite organization. Microcracks are represented in red. (For interpretation of the references to colour in this figure legend, the reader is referred to the Web version of this article.)

Microcracks have only been observed in advanced steps of the fatigue lifetime, as illustrated in Figs. 18 and 19. Microcracks larger than a few hundred microns result from the growth and coalescence of damage markers in highly damaged zones. The propagation rate and the crack path are highly dependent on the local microstructure, and especially on the disposition of damage markers and fiber orientation. If microcracks rely on the junction of elementary damage markers, their local orientation is not systematically transverse to the macroscopic

As for damage initiation, microcracks seem to progress by steps with a size that corresponds to the spherulite size, as illustrated in Fig. 19. This observation is confirmed by the three-dimensional segmentation of microcracks (Fig. 21) as they form in the thermoplastic matrix. Microcracks are also penny shape like volumes, with a diameter close to the spherulite size.
