Sébastien DENNEULIN, Frédéric LEONARDI, Jean-Luc LATAILLADE, Philippe VIOT - The influence of acrylate triblock copolymer embedded in matrix on composite structures' responses to low-velocity impacts - Composite Structures - Vol. 94, n°4, p.1471-1481 - 2012

# The influence of acrylate triblock copolymer embedded in matrix on composite structures' responses to low-velocity impacts

In passive safety structures the use of composite materials has increased significantly recently due to their low specific mass and high energy absorption capacities. The purpose of this experimental study is to describe the macroscopic behaviors of different Kevlar woven composite materials with different kinds of matrix (pure and with acrylate based block copolymer additives: Nanostrength<sup>®</sup>) under low-velocity impact. Tests were performed with a drop weight tower on square plates (100 × 100 mm<sup>2</sup>) clamped by means of a circular fixture. Images were recorded during impact by a high-speed video camera fixed underneath the plate. It was found that Kevlar epoxy composite material with Nanostrength M52N has the best resistance to perforation.

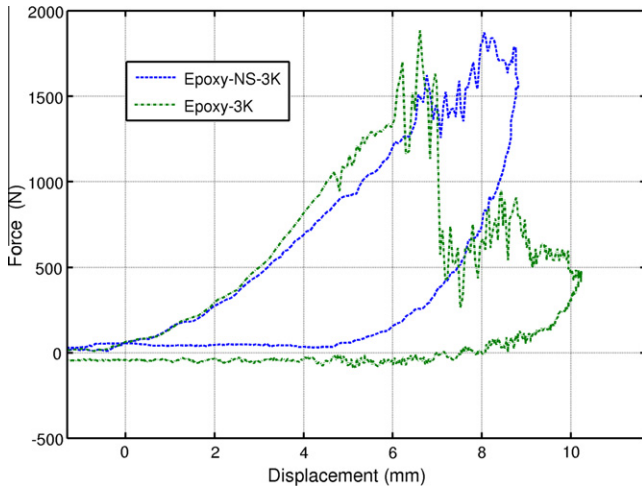
**Fig. 7.** Representative force vs. displacement behavior during impact on Epoxy-NS-3K and Epoxy-3K.

The residual indentations were deduced from impactor displacements (Fig. 7, when the force gets back to zero), and they were 4.0 mm and 7.3 mm for the Epoxy-NS-3K and Epoxy-3K, respectively.

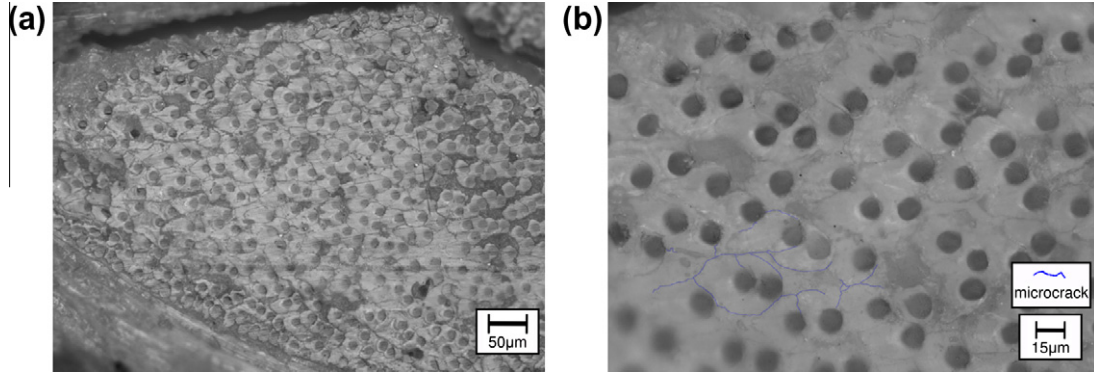
Fig. 13. Micrographs showing the significant rate of micro crack in the yarn located in the last ply of the composite structure.

More accurate observations (Fig. 13) reveal a high density of micro matrix cracks between fibers into the yarn. These are mainly responsible for the dissipated energy. Moreover, a delamination zone over 7.68 mm is revealed between the bottom layer and the middle layer. These two phenomena, micro cracks and delamination, are responsible for the dissipation of the impact energy.
