Pawe H. MALINOWSKI, Luigi SORRENTINO, Davi Silva De VASCONCELLOS, Laurent BERTHE, Pedro Pascual GÓNZALEZ, Laurence CHOCINSKI-ARNAULT, Michel BOUSTIE, Fabienne TOUCHARD, Wiesaw M. OSTACHOWICZ - Study of plant fibre composites with damage induced by laser and mechanical impacts - Composites Part B: Engineering - Vol. 152, p.209-219 - 2018

# Study of plant fibre composites with damage induced by laser and mechanical impacts

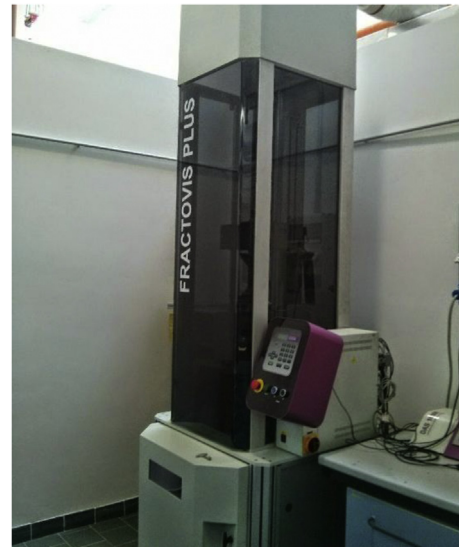
Fig. 6. Mechanical impact test stand.

The investigated samples were impacted by either a falling dart (Fig. 6) and a laser beam (Fig. 7). The mechanical impacts were performed at a velocity below 2 m/s to simulate the typical impact on

Fractovis Plus from CEAST (Pianezza - TO, Italy). The specimens were tested at energies in the range from 1 to 5J. The falling dart mass was constant (1.9265 kg), and the impact energy was changed by changing the impact height. The impact head was hemispherical, 12.7 mm in diameter. Samples damaged with mechanical impacts are coded with an additional 'M' (WA-M, TWA-M, BC3-M, etc.). The laser impact (laser shock) technique is a method that allows to achieve high levels of load inside the materials. It can be used for damage threshold analyses and allows, for example, the simulation of space debris and meteoroids impacts [20], assessment of adhesive bonds quality [21], or fibre/matrix interface study [22]. The laser beam causes the sublimation of the matter on sample surface, and the plasma created induces a reaction force in the form of a pressure shock wave that propagates through the material, thus applying a high tensile loading state (Fig. 8). All the samples were tested at six different laser shock intensities, keeping constant the shock beam diameter (6 mm) and the pulse duration (10.2 ns). Samples tested by the laser are coded with an additional 'L' (WA-L, TWA-L, BC3-L, etc.). Representative samples after each type of impact testing are reported in Fig. 9.

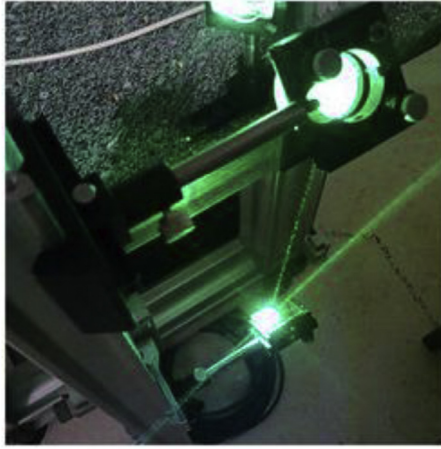
Fig. 7. Laser impact test stand.
