Detection and evaluation of barely visible impact damage in woven glass fabric reinforced polyamide 6.6/6 composite using ultrasonic imaging, X-ray tomography and optical profilometry

Abstract

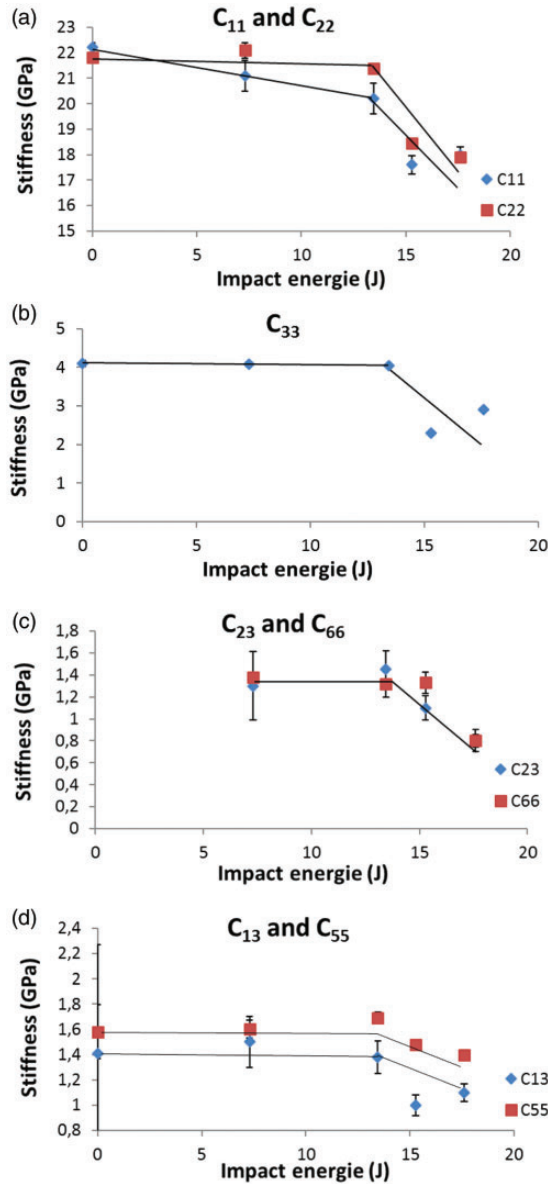
Figure 23. Experimental stiffness components for the samples impacted at energies of 7.30J, 13.45J, 15.28J and 17.60J showing: (a) C_{11} and C_{22} , (b) C_{33} , (c) C_{23} and C_{66} and (d) C_{13} and C_{55} .

Figure 23(a) to (d) represent the experimentally determined stiffness components for the four studied samples. An overall decrease of the stiffness components is noticed starting from 15.28 J. The results are in agreement with those obtained using other techniques. Indeed, one can notice that all the components, namely: C_{11} , C_{22} , C_{33} , C_{13} , C_{55} , C_{23} and C_{66} exhibit a distinguished decrease starting from the energy of 15.28 J. Furthermore, the stiffness reduction of the components C_{11} and C_{13} is more pronounced between 15.28 J and 17.60 J rather than between 7.30 J and 13.45 J.
