INVESTIGATION OF DAMAGE MECHANISMS IN 3D INTERLOCK TEXTILE COMPOSITES UNDER LOW VELOCITY SOFT IMPACT LOADING

Keywords: damage, composite textile, soft impact, micrographic study, variability.

Abstract

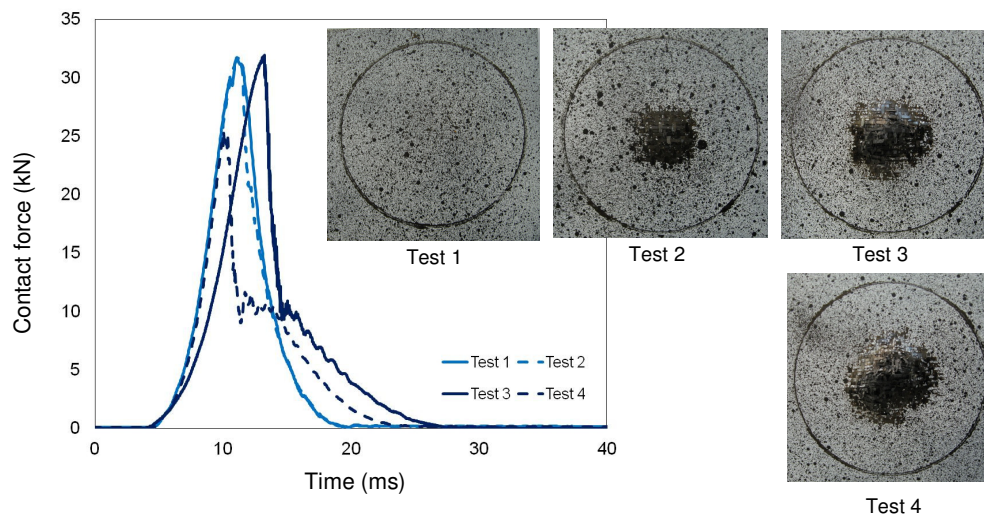
Figure 6. Contact force versus time at 272 J (Interlock 3X 55% woven composite)

The force-time curves obtained for the four tests are presented in Figure 6. The curves for tests 1 and 2 have a rather smooth bell shape which indicates that a low level of damage occurred. The first part of the curves for tests 3 and 4 are smooth but after the peak oscillations reveal that severe damage has occurred. Note that the slopes of the curves are identical before the peak for tests 1, 2 and 4. The different slope observed for test 3 is not yet explained. Pictures of the back side of the plates are shown in the figure. Plate of test 1 has no external visible damage whereas plate of test 2 is clearly damaged on the back side. However, the force-time curves are identical for the two plates. Plates of tests 3 and 4 have been so severely damaged that they have perforated.
