# FATIGUE DAMAGE INVESTIGATION OF PA66/GF30 BY X-RAY MICROTOMOGRAPHY

**Keywords:** Micro-computed tomography, damage mechanisms, fatigue, injection molding.

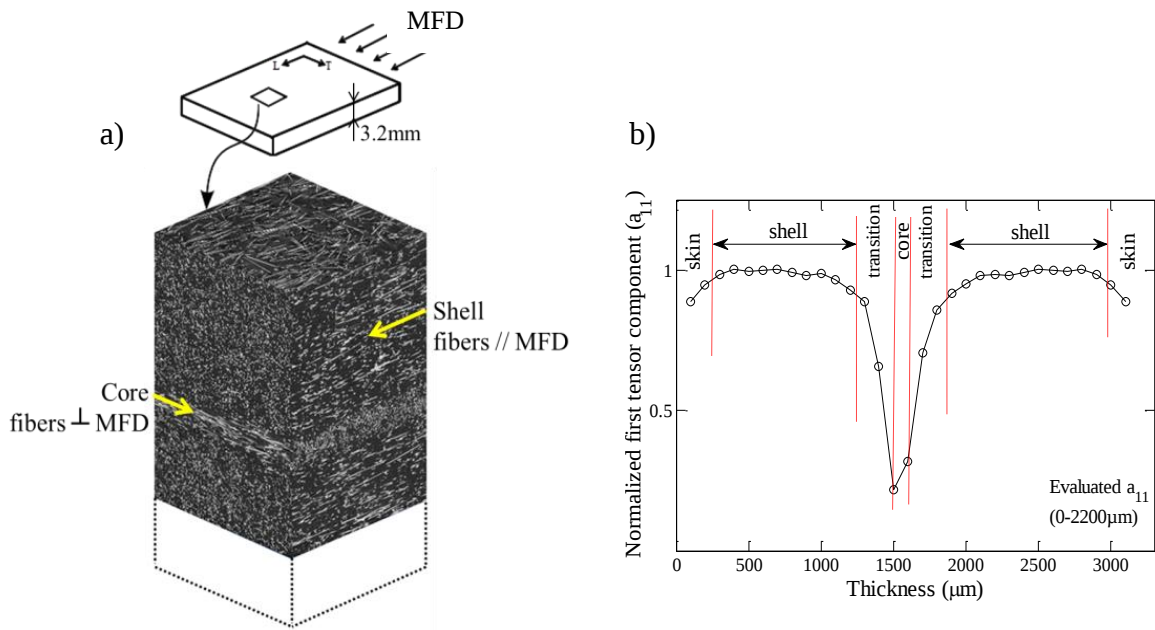
**Figure 1.** Microstructure formation of PA66/GF30; a) fiber orientation description by  $\mu\text{CT}$ , and b) normalized fiber orientation tensor. (MFD = mold flow direction)

Due to the injection process, PA66/GF30 has a skin-shell-transition-core microstructure as shown in Fig. 1. It can be seen that the shell layers, with preferential fiber orientation parallel to the mold flow direction (MFD), are the most dominant ones. Thin core layer is developed and mostly fibers in this layer are oriented transversely to the MFD. Additionally, thin skin layers at the upper and lower specimen surfaces, and the shell-core transition layers are also developed. For further description of PA66/GF30 microstructure, readers can refer to [4,5].

Specimens for fatigue damage characterization were machined in longitudinal direction with respect to the MFD from the rectangular plate produced by injection molding. This extraction condition results in the average fiber orientation in the shell (and *core*) layer that is parallel (and *perpendicular*) to the applied fatigue loading direction.

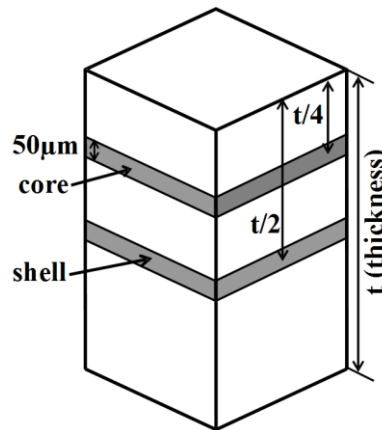
**Figure 2.** Description of the analyzed  $\mu$ CT volumes in the shell and core layer of the composite.

In this work, the void features; the aspect ratio, volume and Euler orientation angle are analyzed. To reduce the number of analyzed voids and to establish a consistent comparison between the void features in the shell and core layer, the evaluation of void characteristics has been performed in a  $50 \mu\text{m}$  volume slice of the shell and core layer of the  $\mu$ CT volume, as described in Fig. 2.

The evolution of the void volume and void aspect ratio with respect to the void orientation angle and number of cycles in the representative  $\mu$ CT volume of the shell and core layer, as described in Fig. 2, are then analyzed. Examining together the void volume and void aspect ratio is important to comprehend both the size and the anisotropic behavior of the voids in relation to their orientation angle and number of cycles. It should be noted that our segmentation technique may lead to a connection of adjacent voids to be detected as a single object. This could result in an improper analysis of the void orientation angle. To avoid this, a separation algorithm was implemented so that the connected voids can be separated into many individual objects. However, while this technique leads to a reliable analysis of void orientation angle, the separation algorithm also generates small voids to be detected as independent objects, notably the ones with small void volumes and void aspect ratio.

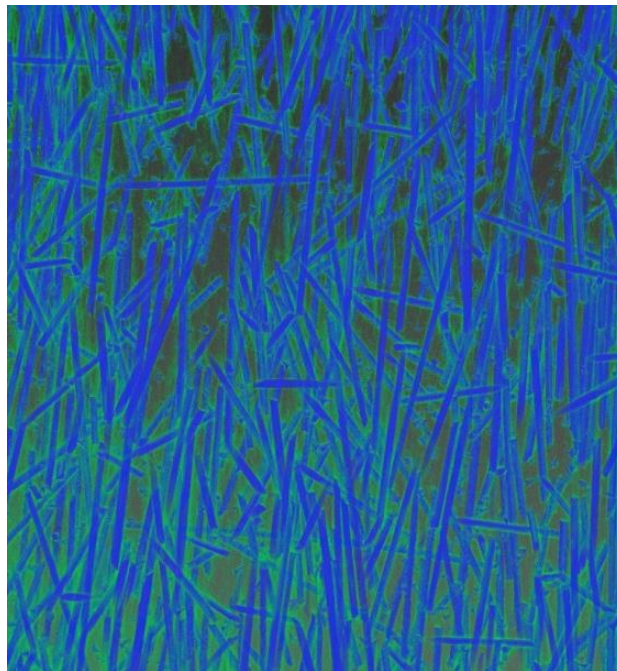
**Figure 3.** Rendered  $\mu$ CT image of fatigue loaded specimen which shows damage in the form of fiber/matrix interfacial debonding. The blue (and *green*) color represents the fiber (and *damage*).

To build a more consistent analysis on damage mechanisms of PA66/GF30, segmentation process which involves separation of the composites' phases (fiber, matrix and damage) has been carried out. Fig. 3 shows the rendered  $\mu$ CT image representing the damage and fibers. One can see that the fiber/matrix interfacial debonding is frequently observed in the fatigue loaded composites. Therefore, this interfacial debonding can be considered as the main fatigue damage mechanisms in dry PA66/GF30.

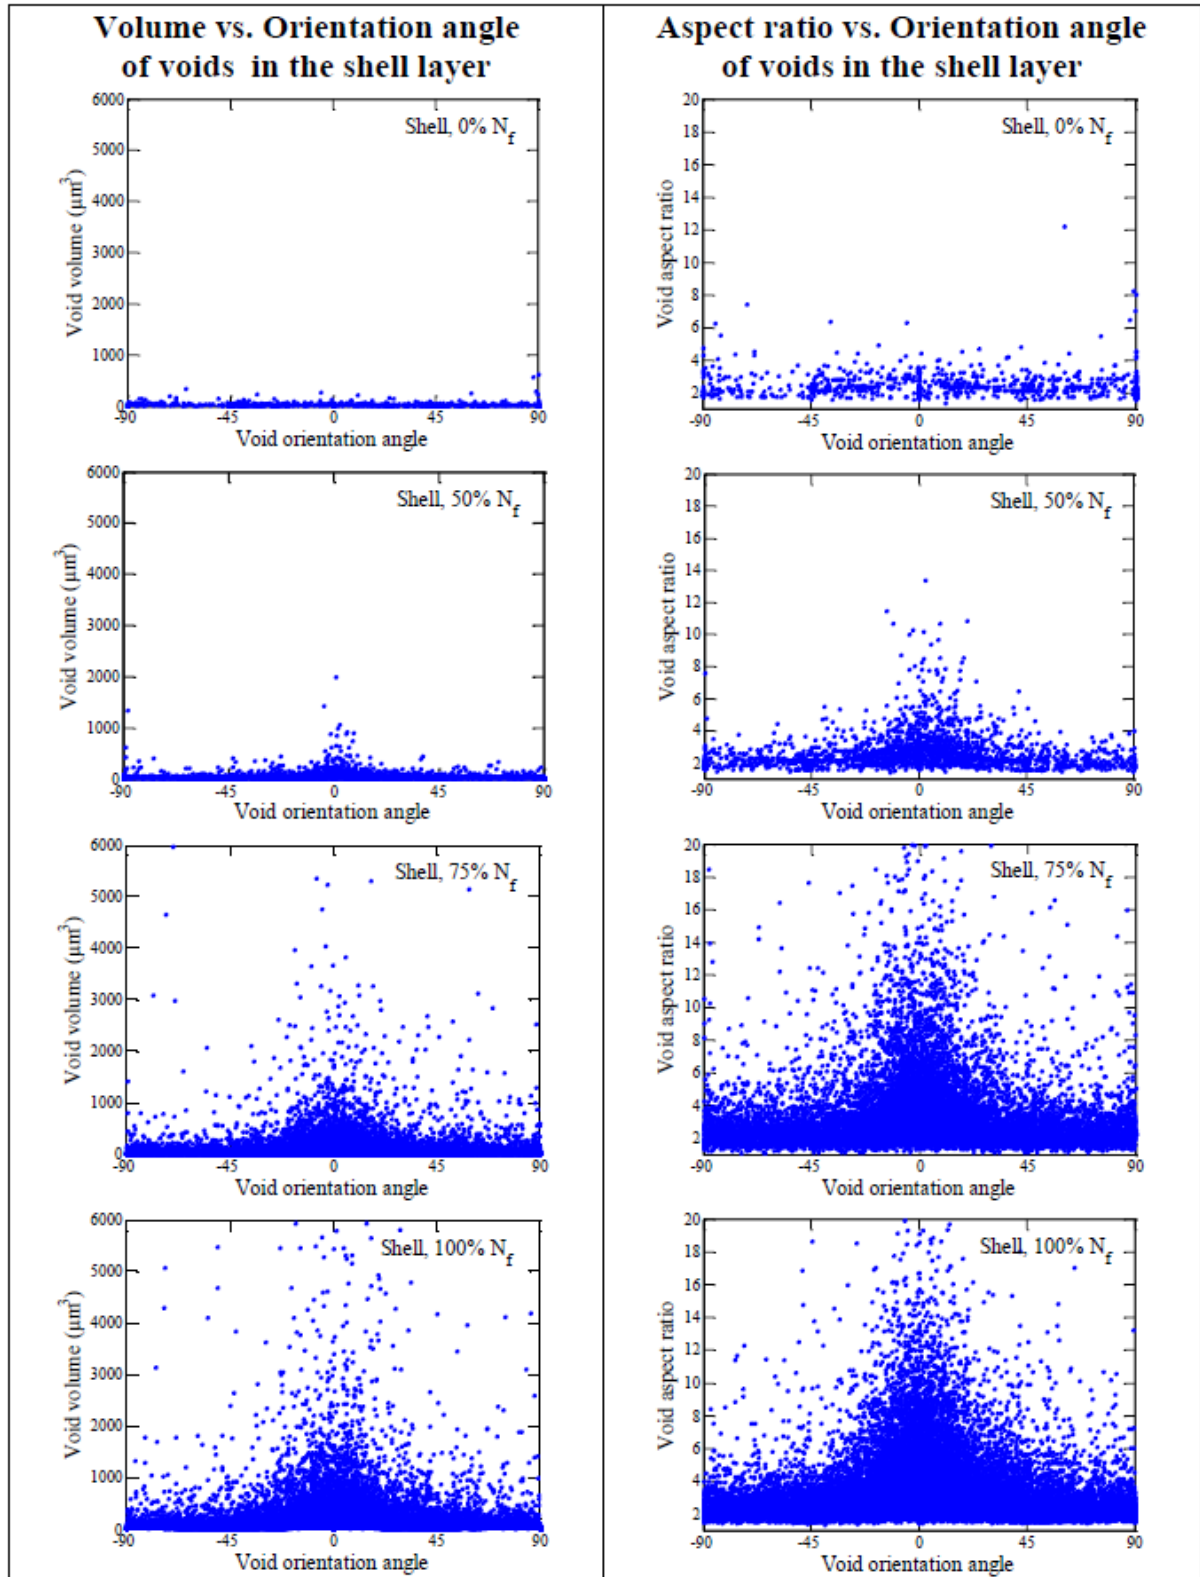
**Figure 4.** Graphs of void volume vs. void orientation angle (*left*) and void aspect ratio vs. void orientation angle (*right*) of the representative  $\mu\text{CT}$  volume of **the shell layer** of the specimens fatigue loaded up to different percentage of fatigue life ( $N_f$ ). The  $0^\circ$  void orientation angle represents the orientation parallel to the MFD and the applied fatigue loading.

Fig. 4 illustrates the evolution of void volume and void aspect ratio with respect to the void orientation angle and number of cycles at the shell layer of specimens fatigue loaded up to different percentages of fatigue life. The figure clearly demonstrates that the void volume increases as the percentage of fatigue life increases. It is worth noticing that voids with low volumes are also observed in the virgin sample, which could be due to the real initial damage

or due to the image artifact. As the percentage of fatigue life increases, the voids with high volume are oriented mainly at around  $0^\circ$ , longitudinal to the fiber orientation as well as to the applied fatigue load direction. The largest void volume evolution is situated at this orientation angle. By visual verification in the rendered  $\mu$ CT volume, as shown in Fig. 3, it was shown that these high void volumes are all situated along the fiber matrix interface. It can be concluded that the damage is mainly in the form of fiber/matrix interfacial debonding.

Moreover, one can see that the voids with low volumes at orientation angle around  $\pm 45^\circ - 90^\circ$  are also slightly increases as the percentage of fatigue life increases. In fact, these voids are also mainly situated along fiber matrix interface. However, these small voids do not follow the fiber orientation angle due to the separation algorithm applied during image processing, as discussed above. Many small void volumes are also situated at fiber ends and in the matrix, which could be due to the image artifacts, or due to the real damage in the form of fiber/matrix interfacial debonding at fiber ends and matrix microcracks.

The evolution of void aspect ratio at the shell layer has also been analyzed (Fig. 4). The void aspect ratio can be used to study the anisotropy degree of the voids, as well as to strengthen the analysis on void volume evolution. One can see from Fig. 4 that the void aspect ratio of voids oriented at around  $0^\circ$  increases as the percentage of fatigue life increases. This evolution is the same as the trend of the void volume which means that the voids enlarges and elongates mainly along fiber interface as the percentage of fatigue life increases.

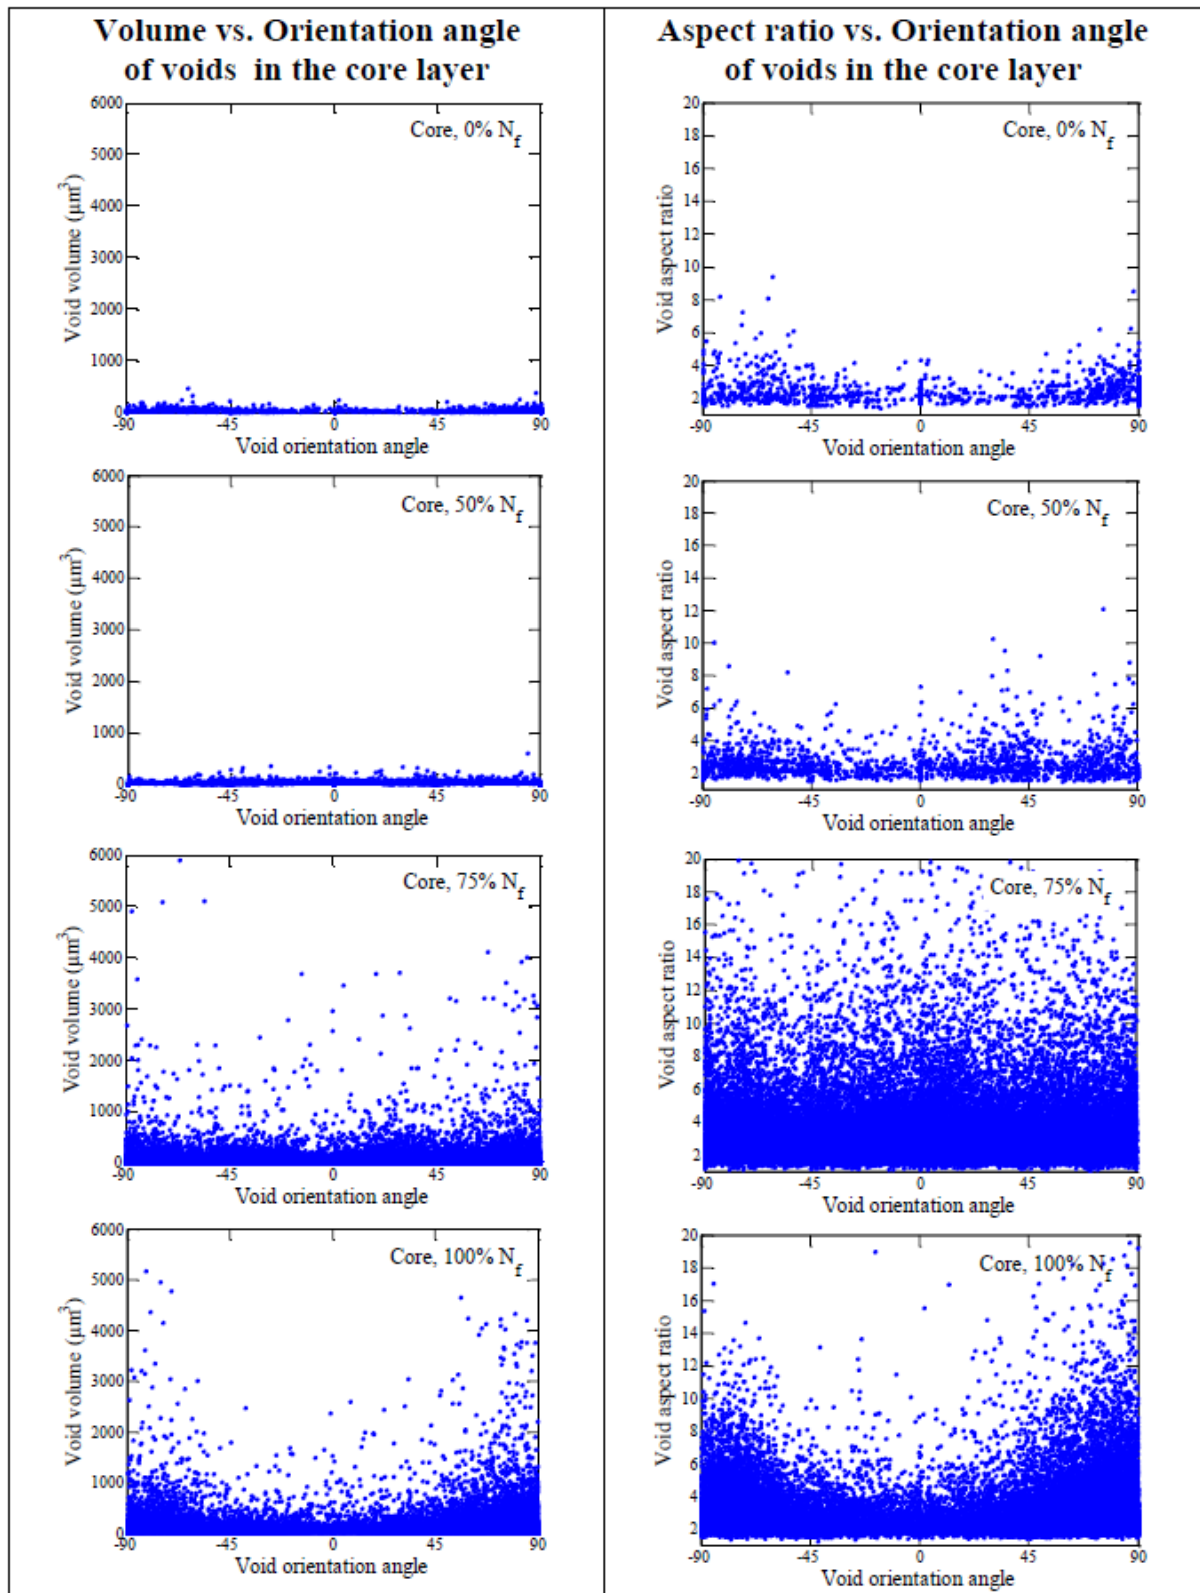
**Figure 5.** Graphs of void volume vs. void orientation angle (*left*) and void aspect ratio vs. void orientation angle (*right*) of the representative  $\mu\text{CT}$  volume of **the core layer** of the specimens fatigue loaded up to different percentage of fatigue life ( $N_f$ ). The  $0^\circ$  void orientation angle represents the orientation parallel to the MFD and the applied fatigue loading.

The evolution of void volume and void aspect ratio with respect to the void orientation angle and number of cycles at the core layer is then analyzed. As seen in Fig. 5, obvious increase of void volume is only remarked at 75% and 100% of fatigue life. It should be noted that the thin core layer for the specimens used in the current study doesn't impart an active role on the load transfer due to its perpendicular configuration with respect to the applied fatigue loading direction. Due to this reason, the voids are only significant at 75% and 100% of fatigue life. At 75% of fatigue life, voids are mainly situated along the fiber interface. However, these voids have no tendency to be oriented into a certain orientation angle. This is affirmed by the trend of void aspect ratio which shows a highly varying aspect ratio without any preferential void orientation. As the number of cycles increases, the void volume increases and elongates along the fiber interface. Therefore, at 100% of fatigue life, voids with high volume and aspect ratio are oriented at around  $90^\circ$ , parallel to the principal fiber orientation of the core layer but perpendicular to the applied fatigue loading direction.
