## Investigation in situ des mécanismes d'endommagement dans un composite polyamide renforcé par des fibres courtes

### *In situ SEM damage mechanisms investigation of short glass fiber reinforced polyamide composite*

MF Arif<sup>1\*</sup>, N Despringre<sup>1</sup>, Y Chemisky<sup>1</sup>, G Robert<sup>2</sup>, F Meraghni<sup>1</sup>

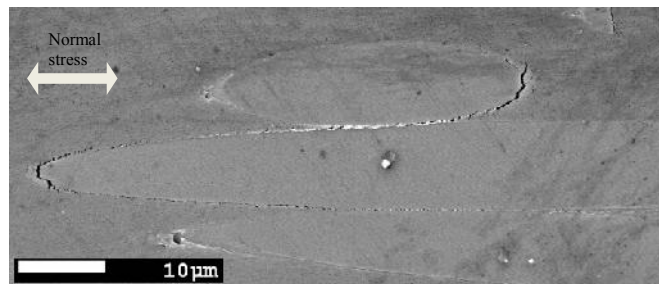
Fig. 1. Damage initiation at fiber end and interface decohesion at the location where fibers are close one another for a load  $P=56\%$  of  $\uparrow_{UTS}$

Results show that the damage mechanisms for both longitudinal and transverse orientations were similar. The damage was initiated from fiber ends and from the locations where the fibers are close one another (Fig. 1).
