# Study of plant fibre composites with damage induced by laser and mechanical impacts

Green composites  
NDT  
Laser shocks  
Terahertz spectroscopy  
Vibrometry  
Impact damage

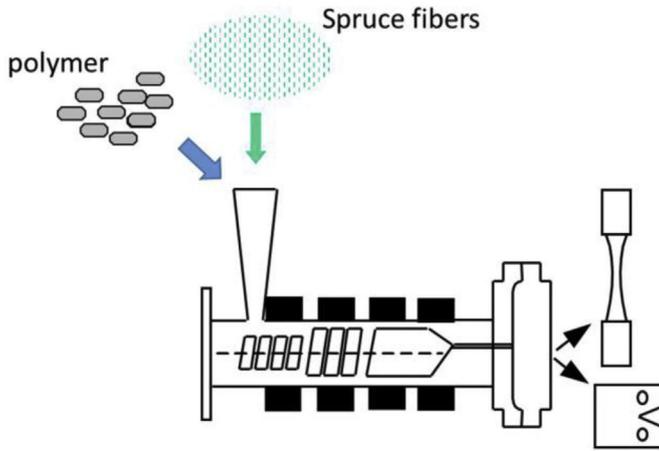
Fig. 1. Extrusion process – Twin screw extruder.

weight in acrylo-butadiene-styrene (ABS) polymer. Spruce fibres were obtained from industrial waste, and exhibited an average length of 800 µm. These fibres were used as received for samples coded as WA and after a thermal treatment at 250 °C for samples coded as TWA. Short fibre samples were manufactured by using an injection moulding machine, which used an extruder to mix and compound the components. Plates were produced by injecting in a mould with a thickness equal to 4 mm. The process is depicted in Fig. 1. Sections of produced samples are shown in Fig. 2, where it is clearly shown the good dispersion of fibres in the polymeric matrix for both WA and TWA systems.

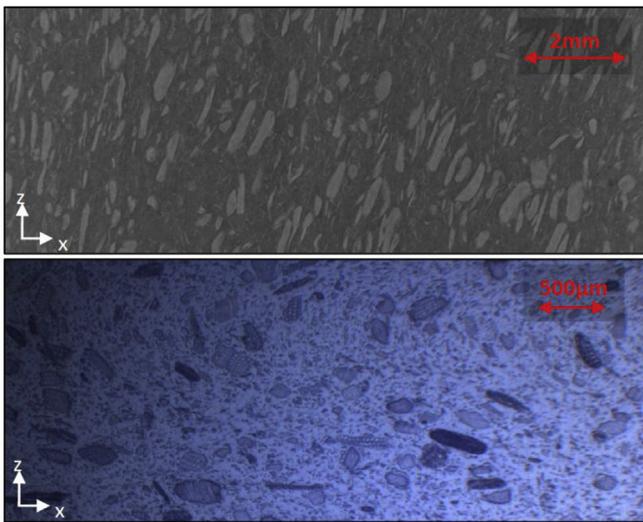
Fig. 2. Tomography of WA (up) and micrograph of TWA (down).

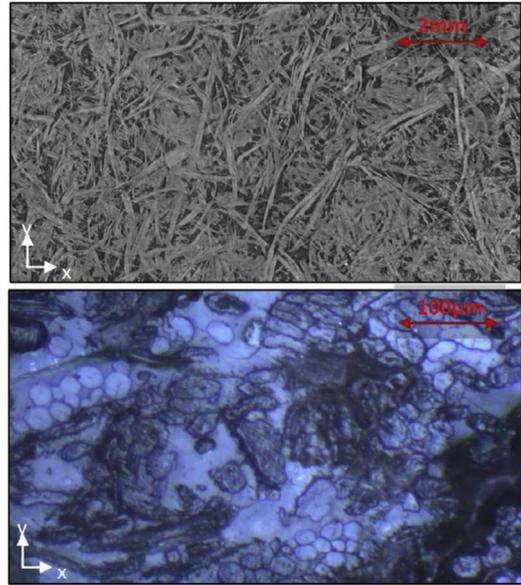
Fig. 4. Tomography of BC3 (up) and micrograph of BC4 (down).

fibres. They were coded as BC3 and BC4. Flax fibres had 60 mm length and the target fibre content by weight was 70%. Two types of thermoplastic polymers were used as matrices: polypropylene (PP), used as a reference from synthetic materials, for BC3 series and polylactide (PLA), a biodegradable polymer derived from renewable resources, for BC4 series. The manufacturing process of BC samples is depicted in Fig. 3, and it is basically a compression moulding fibre impregnation process. The final plate thickness achieved was 2 mm. The fibre dispersion and impregnation was very good, as shown in Fig. 4 for BC3 and BC4 systems.

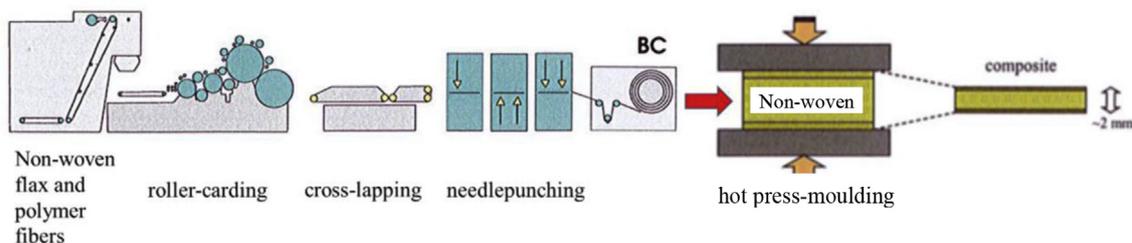
Fig. 3. Manufacturing process of BC3 and BC4.

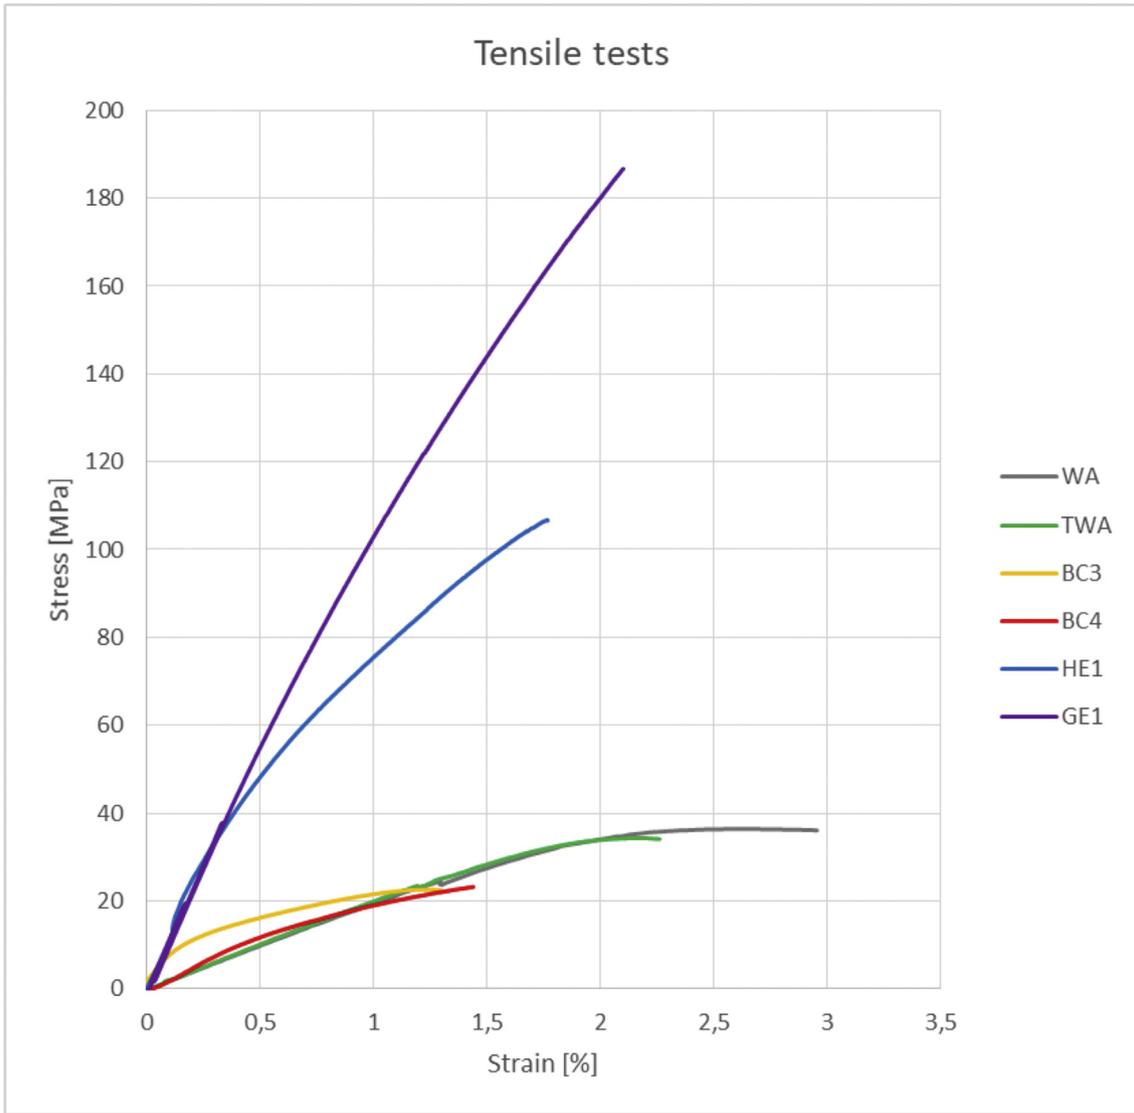
Fig. 5. Tensile test results obtained for the investigated materials.

machine (electromechanical, Instron 4505, USA) equipped with a 100 kN load cell, according to the ASTM D638 standard and the results are shown in Fig. 5. At least 3 samples of each material were tested. Average maximum stress, deformation at maximum stress and elastic modulus values are reported in Table 1. It is evident that the best performing system was based on glass fibres, followed by that based on hemp fibres. As expected, the short fibre reinforced systems were the lowest performing systems, with no apparent difference between

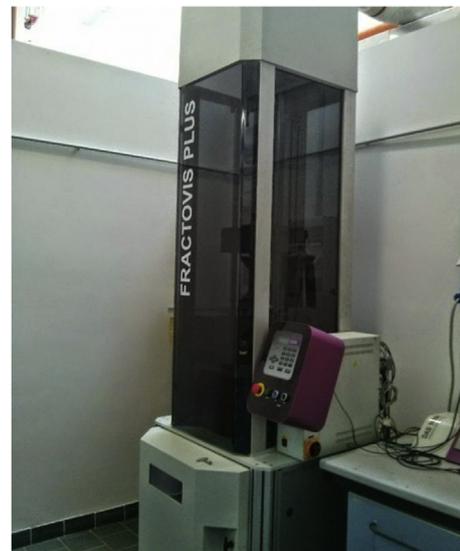
Fig. 6. Mechanical impact test stand.

The investigated samples were impacted by either a falling dart (Fig. 6) and a laser beam (Fig. 7). The mechanical impacts were performed at a velocity below 2 m/s to simulate the typical impact on

Fractovis Plus from CEAST (Pianezza - TO, Italy). The specimens were tested at energies in the range from 1 to 5J. The falling dart mass was constant (1.9265 kg), and the impact energy was changed by changing the impact height. The impact head was hemispherical, 12.7 mm in diameter. Samples damaged with mechanical impacts are coded with an additional 'M' (WA-M, TWA-M, BC3-M, etc.). The laser impact (laser shock) technique is a method that allows to achieve high levels of load inside the materials. It can be used for damage threshold analyses and allows, for example, the simulation of space debris and meteoroids impacts [20], assessment of adhesive bonds quality [21], or fibre/matrix interface study [22]. The laser beam causes the sublimation of the matter on sample surface, and the plasma created induces a reaction force in the form of a pressure shock wave that propagates through the material, thus applying a high tensile loading state (Fig. 8). All the samples were tested at six different laser shock intensities, keeping constant the shock beam diameter (6 mm) and the pulse duration (10.2 ns). Samples tested by the laser are coded with an additional 'L' (WA-L, TWA-L, BC3-L, etc.). Representative samples after each type of impact testing are reported in Fig. 9.

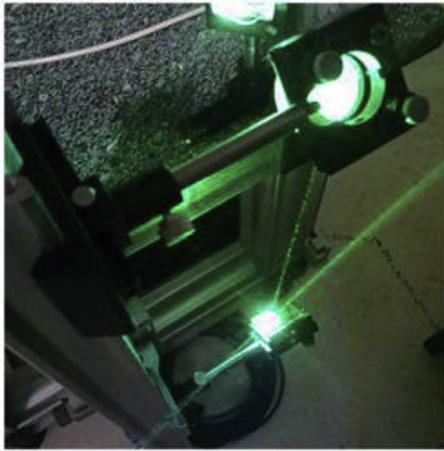
Fig. 7. Laser impact test stand.

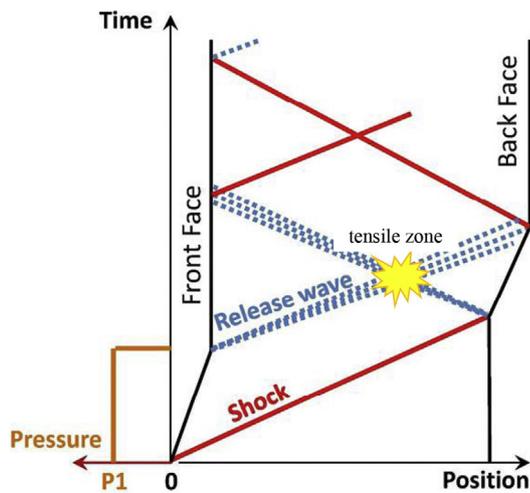
Fig. 8. Laser induced shock wave propagation through a homogeneous material.

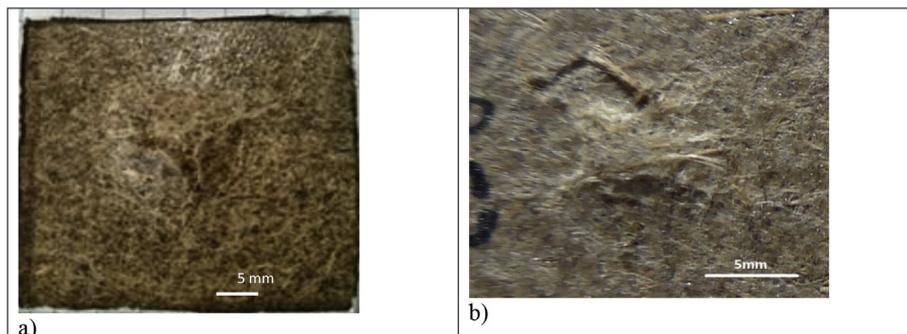
Fig. 9. Backface of BC3 sample impacted mechanically at 5J (a) and by laser at 4.45 GW/cm<sup>2</sup>.

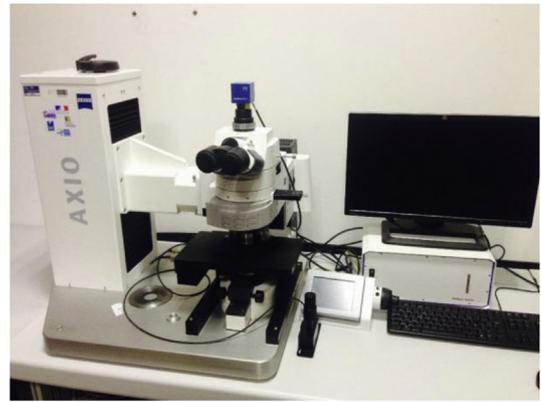
Fig. 10. Back face 3D reconstruction stand.

Back face relief was performed by means of a multidimensional image acquisition setup (Axio Imager Vario Z2 microscope from Zeiss - Germany) (Fig. 10). The dedicated softwares images for a range of equally spaced focus positions, allowing imaging of rough surfaces and 3D reconstructions. This method allows to characterize superficial damage, in particular the depth and geometry. Multidimensional images for selected impacts were captured in order to visualize the 3D surface profiles of the back face damage. A typical result of this analysis is shown in Fig. 11, where the acquisition after a laser impact at 4.47 GW/cm<sup>2</sup> is presented.

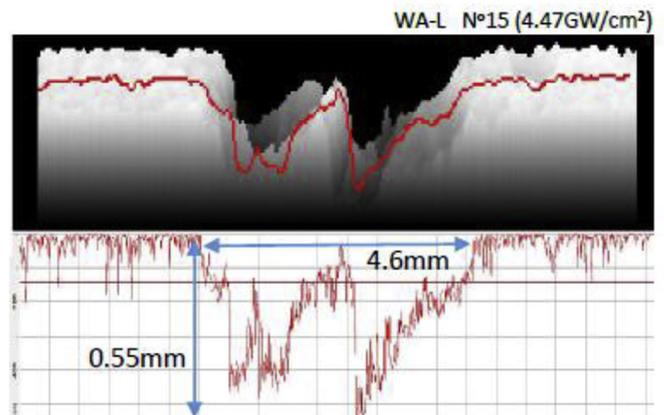
Fig. 11. 3D reconstruction and  $z(x)$  profile of laser impact on WA-L sample with 4.47 GW/cm<sup>2</sup> intensity.

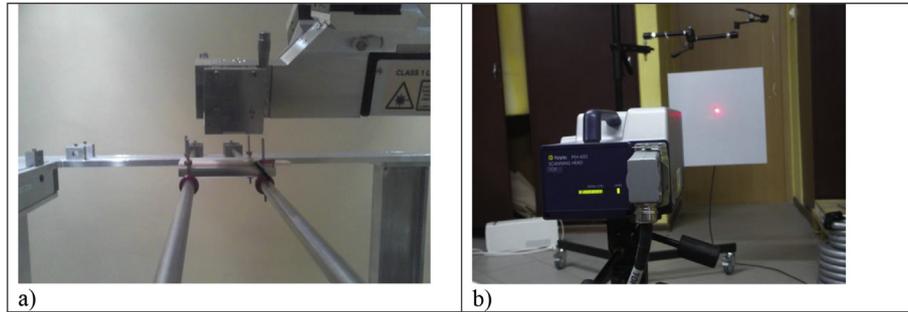
Fig. 12. Terahertz receiver and detector over a clamped sample (a); vibrometer scanning head with laser pointing at sample.

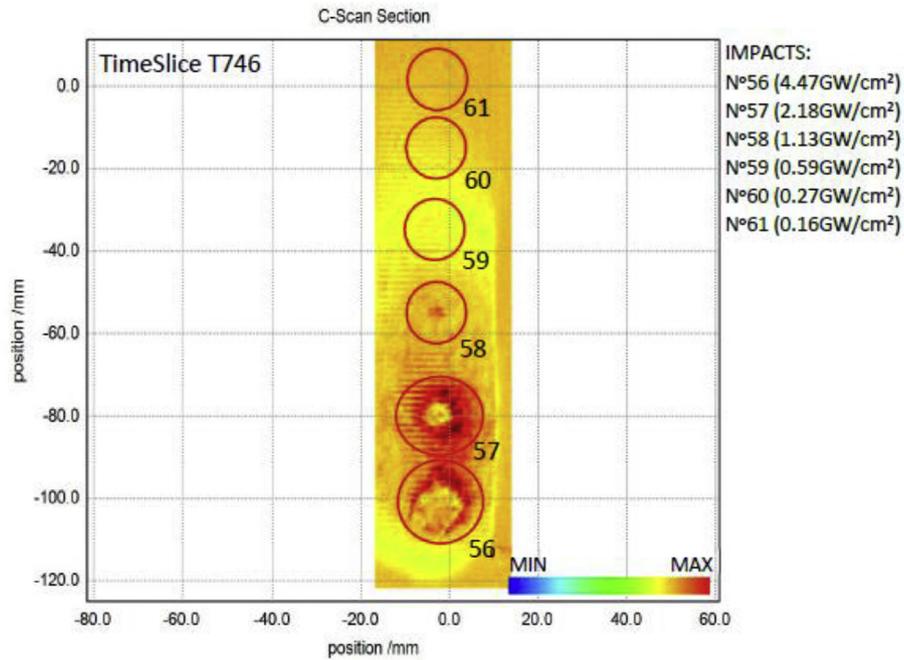
Fig. 13. C-Scan section of BC4-L sample obtained with terahertz spectroscopy.

Terahertz spectroscopy was used because polymer composites made out of electrically not conducting materials can be analysed by using electromagnetic radiations in the terahertz frequency range. Terahertz spectroscopy technique in the time domain (THz-TDS) proved to be a suitable method for the detection of internal defects like delamination in composite materials [23], [24]. According to [25] delaminations and moisture contamination can be visualized using TDS terahertz spectroscopy but the effectiveness depends on depth, matrix material, and size of the defect. The terahertz spectrometer used was TPS Spectra 3000 from Teraview (Cambridge, United Kingdom) with radiation in the 0.1–3 THz range. The spectrometer is equipped with a moving table to apply x-y movements and scan large objects (Fig. 12a). The scanning heads operated in both reflection and transmission modes [23] [24]. The C-scan of a representative sample is depicted in Fig. 13. The sample was impacted with laser at 6 locations, and the most intense damaged locations can clearly be identified (no. 56, 57 and 58).

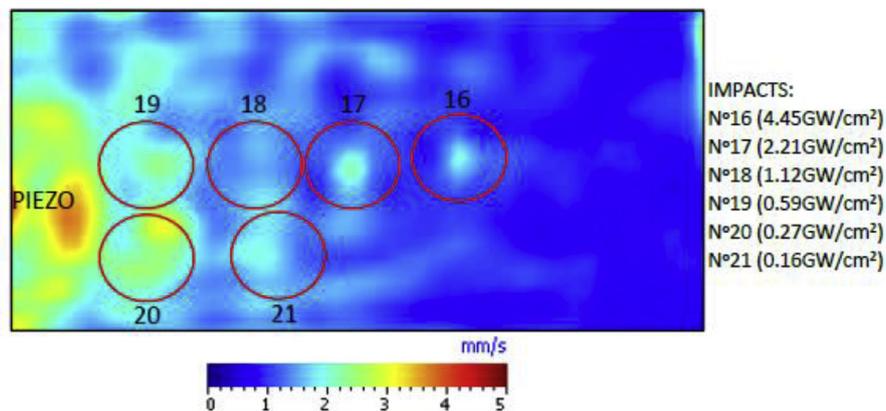
Fig. 14. RMS values obtained with laser vibrometer for TWA-L sample after laser impacts. Wave frequency  $f = 200$  kHz.

analysis of the results was based on a well-established procedure that calculates the root mean square (RMS) value for each point [27]. RMS values are different in damaged and non-damaged regions because guided elastic waves are altered at damage location [28]. The RMS result obtained for TWA-L sample is presented in Fig. 14. The sample was impacted at 6 locations with laser. Depending on the intensity of the laser there is a different RMS detected level. The RMS level is also influenced by the position of the damage with respect to the piezoelectric transducer (PIEZO). The elastic wave going from the transducer to damage location no. 16 has to travel through areas where other damage is present. This causes wave scattering and influences the RMS wave energy detected at the location of damage.

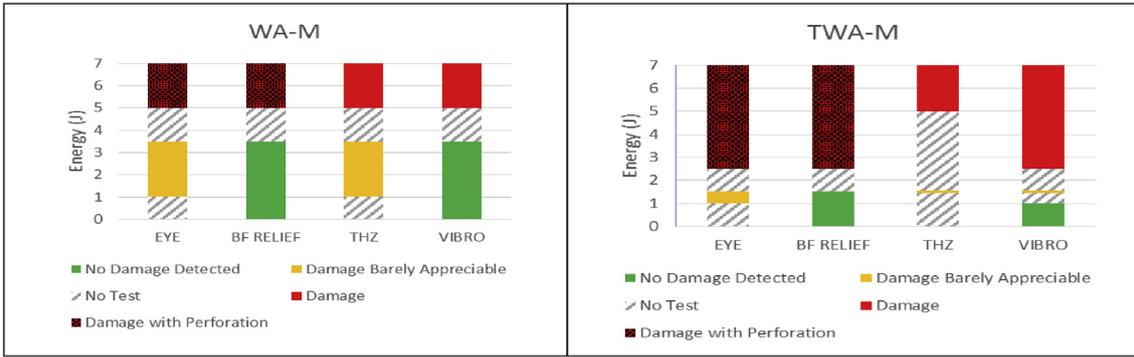
Fig. 15. Damage detection thresholds of WA-M and TWA-M samples.

at 5 J for WA-M and 2.5 J for TWA-M (Fig. 15). Both eye observation and back face relief clearly detected the perforation. The terahertz spectroscopy and vibrometry were not able to detect the perforation and only light damage was shown (marked as light red). Eye observation and THz-TDS techniques were more sensitive than the other two in the detection of damage initiation after an impact at 1.0 J.

The results for samples with medium-length fibres (BC3-M and BC4-M) are depicted in Fig. 16. Damaging was observed already after the impact at 1.0 J and the damage threshold for BC4-M was as for TWA-M sample (Fig. 15), since already after an impact at 2.5 J perforation was detected.

After determining the damage thresholds it was possible to determine the damage size for each sample and each technique. The measured damaged areas on front and back faces are reported in Table 4. It should be noted that only cases that gave clear indication of damage in Fig. 15–17 were considered for being reported. Damage area is higher with higher impact level. In addition, the areas on back surfaces are bigger than on front surfaces.

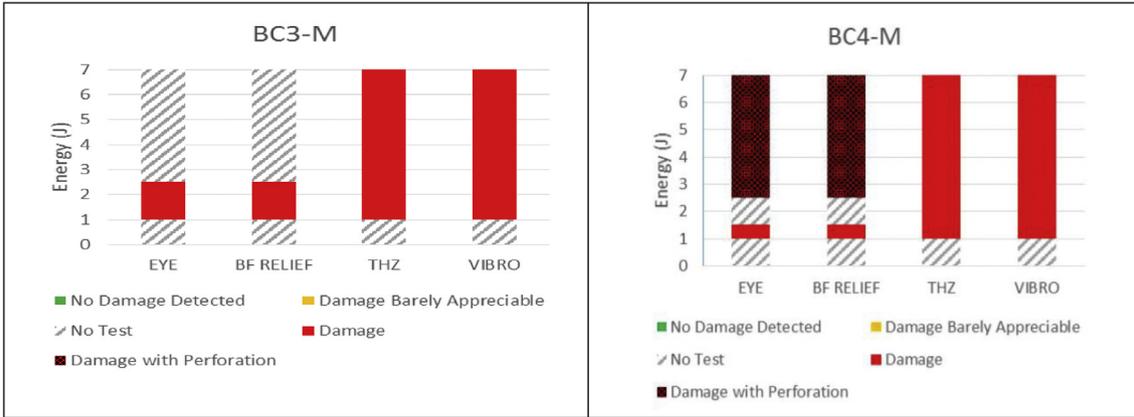
Fig. 16. Damage detection thresholds of BC3-M and BC4-M samples.

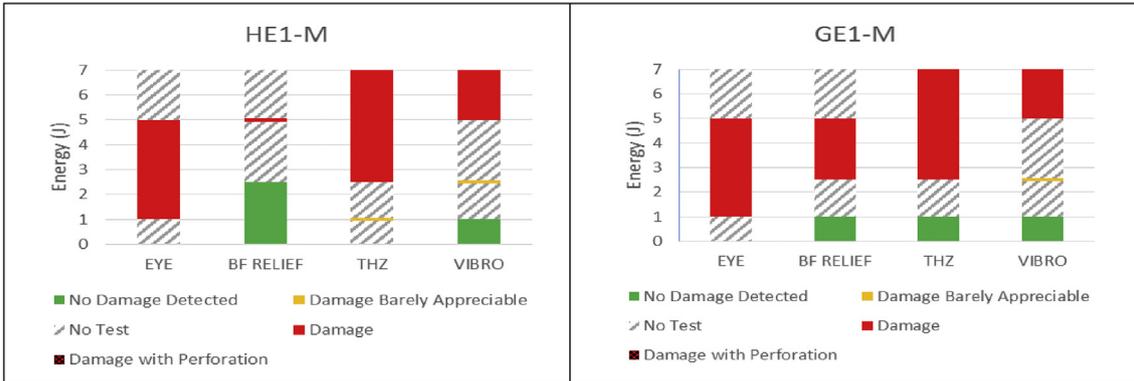
Fig. 17. Damage detection thresholds of HE1-M and GE1-M samples.

Long fibre samples after mechanical impacts (HE1-M and GE1-M) presented a different behaviour (Fig. 17) because in none of the cases perforation was observed, as expected due to the much higher strength of the composites. On the contrary, eye observation indicated clear damage presence already at 1.0 J. The initiation of damage was also observed with the terahertz spectroscopy but only for the sample reinforced with hemp fabric (HE1-M).

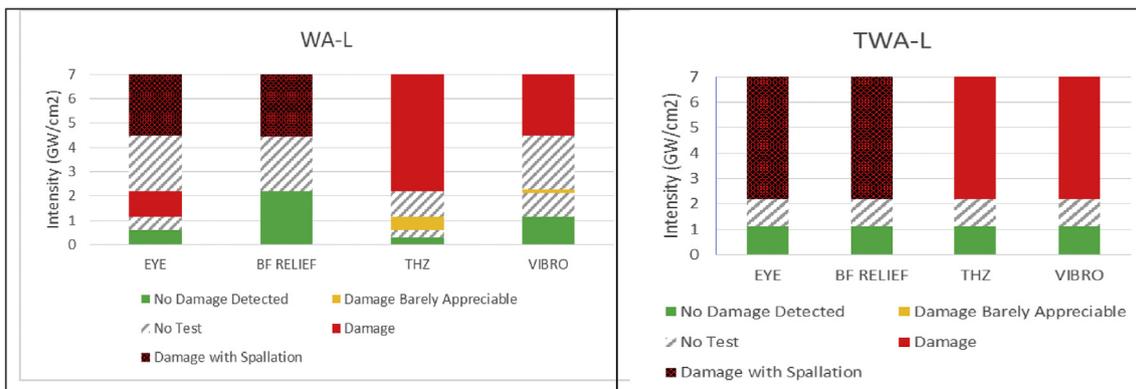
**Fig. 18.** Damage detection thresholds of WA-L and TWA-L samples.

The results for laser impacts on samples with short fibres are presented in Fig. 18. The initiation of damage was observed already below 1 GW/cm<sup>2</sup> using the terahertz-based method in WA-L while in the case of TWA-L no damage was observed by any of the analysis methods after the impact at 1 GW/cm<sup>2</sup>.

After determining the damage thresholds for laser impacts it was possible to estimate the damage size for each sample and each technique. The measured damaged areas on back faces are reported in Table 5. It should be noted that only cases that gave clear indication of damage according to Fig. 18–20 were considered for being reported.

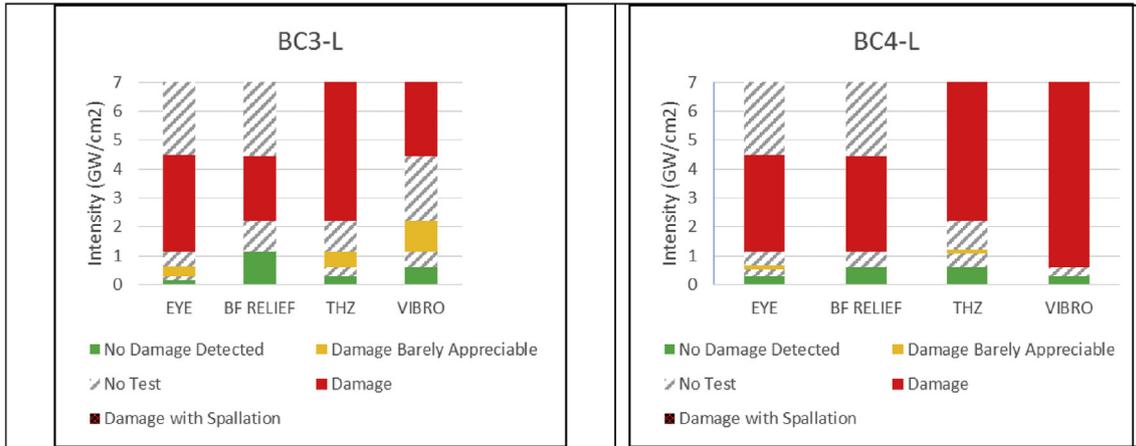
Fig. 19. Damage detection thresholds of BC3-L and BC4-L samples.

Damages below 1 GW/cm<sup>2</sup> were also observed for medium-length samples (Fig. 19). None of the samples experienced spallation for the considered test cases. But it should be noticed that only the terahertz and vibrometry techniques were tested for impacts up to 7 GW/cm<sup>2</sup>, while eye observation and back face relief analyses were performed up to 4.5 GW/cm<sup>2</sup>.

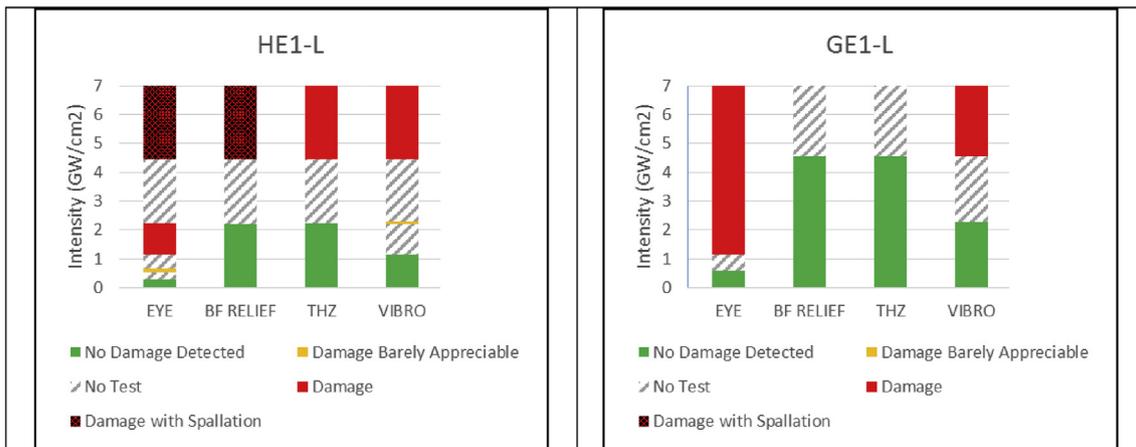
Fig. 20. Damage detection thresholds of HE1-L and GE1-L samples.

In long fibre samples impacted by the laser technique a clear spallation was observed for the hemp reinforced sample above 4 GW/cm<sup>2</sup> (Fig. 20). Eye observation allowed to detect a lower damage threshold for the ‘green’ composite (HE1-L) with respect to the fully synthetic one (GE1-L) since the initiation of damage appeared below 1 GW/cm<sup>2</sup>.

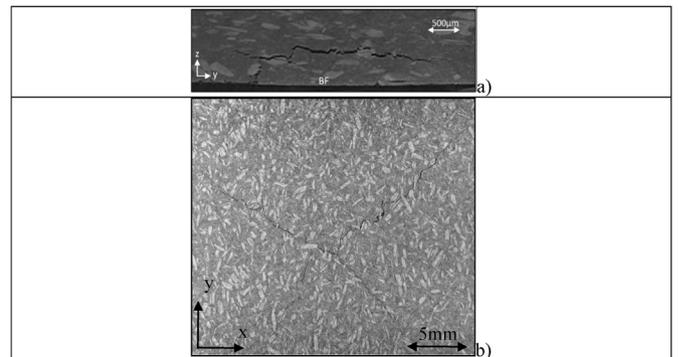
Fig. 21. X-ray micro-computed tomography for a) WA-L sample impacted at 2.19 GW/cm<sup>2</sup>, b) WA-M sample impacted at 2.5J.

Systems reinforced with short and medium length fibres already showed clear damages after the impact at 1 J. A cross-shaped damage is visible in the z-plane of the WA-M tomographic image (Fig. 21b), while in the x-plane some cracks are visible, propagating through matrix and fibres up to the back face. Tomographs in x-plane of BC3-M at 1J showed large deformation induced by the mechanical impact (Fig. 22). The deformation of BC3-M was confirmed by the microscope observations, as well as for BC4-M impacted at 1J. In addition, areas near the back face presenting debonding at the fibre-matrix interface were also detected.

In regard to laser impacts, the tomographic analysis of the WA-L system impacted at 2.19  $\text{GW}/\text{cm}^2$  showed damaging near the back face (Fig. 21a). In particular, cracks propagating through matrix and fibres were detected. Tomographs of samples impacted at lower laser intensities (0.27, 0.59 and 1.13  $\text{GW}/\text{cm}^2$ ) didn't show any damage. Micrographs of TWA-L impacted at 2.19  $\text{GW}/\text{cm}^2$  showed a similar behaviour with respect to WA-L, hence cracks propagated through both matrix and fibres. However, quantitatively TWA-L presents more serious damage, because the cracks were longer and the sample was close to spallation. Impacts on medium fibre length composites showed different degrees of deformation. For example, the BC4-L internal damage after the 2.18  $\text{GW}/\text{cm}^2$  impact showed a similar damage with respect to the mechanical impacts, presenting areas with debonding at the fibre-matrix interface. HE1-L was analysed after 2.24  $\text{GW}/\text{cm}^2$  and 4.46  $\text{GW}/\text{cm}^2$  impacts. Matrix cracks and cracks at the yarn-matrix interface were observed near the back face in the first case, while spallation and fibre failure additionally occurred after the higher energy impact, as clearly evidenced by the tomographic analysis. Tomographs of GE1-L did not show any damage after impacts at several intensities (0.60, 1.15, 2.25, 4.55  $\text{GW}/\text{cm}^2$ ). However, the microscope observation for 4.55  $\text{GW}/\text{cm}^2$

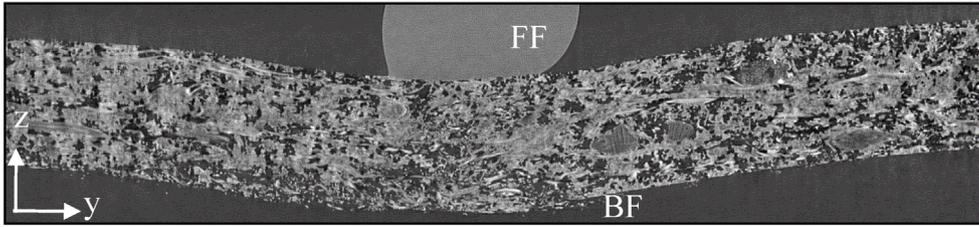
Fig. 22. X-ray micro-computed tomography for BC3-M sample impacted at 1J.
