Study of plant fibre composites with damage induced by laser and mechanical impacts

Paweł H. Malinowski^{a,*}, Wiesław M. Ostachowicz^a, Fabienne Touchard^b, Michel Boustie^b, Laurence Chocinski-Arnault^b, Pedro Pascual Gonzalez^b, Laurent Berthe^c, Davi Silva de Vasconcellos^d, Luigi Sorrentino^d

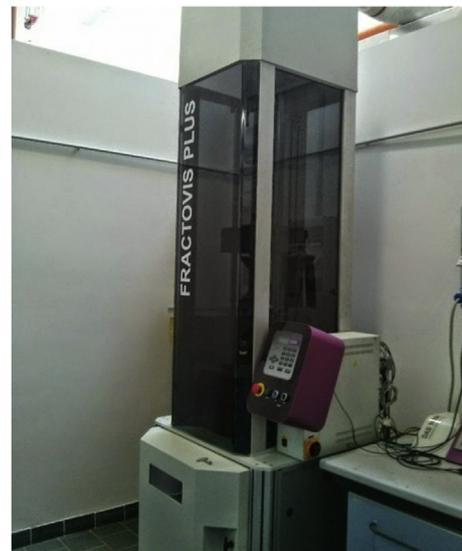
Fig. 6. Mechanical impact test stand.

The investigated samples were impacted by either a falling dart (Fig. 6) and a laser beam (Fig. 7). The mechanical impacts were performed at a velocity below 2 m/s to simulate the typical impact on

Fractovis Plus from CEAST (Pianezza - TO, Italy). The specimens were tested at energies in the range from 1 to 5J. The falling dart mass was constant (1.9265 kg), and the impact energy was changed by changing the impact height. The impact head was hemispherical, 12.7 mm in diameter. Samples damaged with mechanical impacts are coded with an additional 'M' (WA-M, TWA-M, BC3-M, etc.). The laser impact (laser shock) technique is a method that allows to achieve high levels of load inside the materials. It can be used for damage threshold analyses and allows, for example, the simulation of space debris and meteoroids impacts [20], assessment of adhesive bonds quality [21], or fibre/matrix interface study [22]. The laser beam causes the sublimation of the matter on sample surface, and the plasma created induces a reaction force in the form of a pressure shock wave that propagates through the material, thus applying a high tensile loading state (Fig. 8). All the samples were tested at six different laser shock intensities, keeping constant the shock beam diameter (6 mm) and the pulse duration (10.2 ns). Samples tested by the laser are coded with an additional 'L' (WA-L, TWA-L, BC3-L, etc.). Representative samples after each type of impact testing are reported in Fig. 9.
