Study of plant fibre composites with damage induced by laser and mechanical impacts

Paweł H. Malinowski^{a,*}, Wiesław M. Ostachowicz^a, Fabienne Touchard^b, Michel Boustie^b, Laurence Chocinski-Arnault^b, Pedro Pascual Gonzalez^b, Laurent Berthe^c, Davi Silva de Vasconcellos^d, Luigi Sorrentino^d

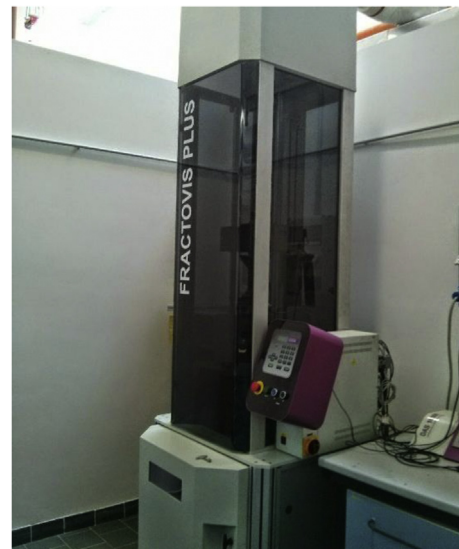
Fig. 6. Mechanical impact test stand.

The investigated samples were impacted by either a falling dart (Fig. 6) and a laser beam (Fig. 7). The mechanical impacts were performed at a velocity below 2 m/s to simulate the typical impact on

Fractovis Plus from CEAST (Pianezza - TO, Italy). The specimens were tested at energies in the range from 1 to 5J. The falling dart mass was constant (1.9265 kg), and the impact energy was changed by changing the impact height. The impact head was hemispherical, 12.7 mm in diameter. Samples damaged with mechanical impacts are coded with an additional 'M' (WA-M, TWA-M, BC3-M, etc.). The laser impact (laser shock) technique is a method that allows to achieve high levels of load inside the materials. It can be used for damage threshold analyses and allows, for example, the simulation of space debris and meteoroids impacts [20], assessment of adhesive bonds quality [21], or fibre/matrix interface study [22]. The laser beam causes the sublimation of the matter on sample surface, and the plasma created induces a reaction force in the form of a pressure shock wave that propagates through the material, thus applying a high tensile loading state (Fig. 8). All the samples were tested at six different laser shock intensities, keeping constant the shock beam diameter (6 mm) and the pulse duration (10.2 ns). Samples tested by the laser are coded with an additional 'L' (WA-L, TWA-L, BC3-L, etc.). Representative samples after each type of impact testing are reported in Fig. 9.

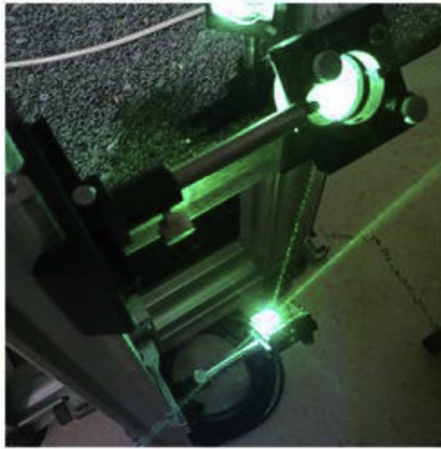
Fig. 7. Laser impact test stand.
