Héloïse ROLLAND, Nicolas SAINTIER, Ilan RAPHAEL, Nicolas LENOIR, Andrew KING, Gilles ROBERT - Fatigue damage mechanisms of short fiber reinforced PA66 as observed by in-situ synchrotron X-ray microtomography - Composites Part B: Engineering - Vol. 143, p.217-229 - 2018

# Fatigue damage mechanisms of short fiber reinforced PA66 as observed by in-situ synchrotron X-ray microtomography

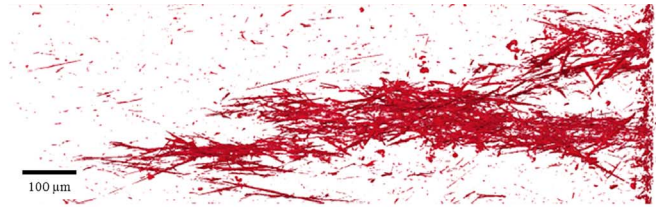
(a) Slice (fibers oriented at 90°)

(b) Damage (fibers oriented at 90°)

Fig. 26. Side view of mesocracks - RH50 90° specimen.
