Fatigue damage mechanisms of short fiber reinforced PA66 as observed by in-situ synchrotron X-ray microtomography

H. Rolland^a, N. Saintier^{a,*}, I. Raphael^{a,d}, N. Lenoir^b, A. King^c, G. Robert^d

ABSTRACT

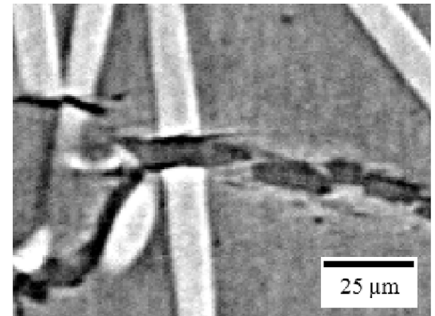
(a) Initial state - $N/N_R = 0.0\%$

(b) fiber failure under cyclic loading - $N/N_R = 40.5\%$

(c) Damage evolution under cyclic loading - $N/N_R = 99.7\%$

(d) Initial state - $\varepsilon/\varepsilon_R = 0.0\%$

(e) fiber failure under monotonic loading - $\varepsilon/\varepsilon_R = 38.9\%$

(f) Damage evolution under monotonic loading - $\varepsilon/\varepsilon_R = 98.1\%$

Fig. 9. Fiber failure evolution according to the loading.

surrounding matrix. It is worth noting that when a fiber breaks, contrary to observations made for monotonic testing, the damage does not grow spherically but grows in the form of a microcrack transversely to the macroscopic loading as illustrated in Fig. 9, or by debonding and coalescence as in Fig. 7(e). These microcracks can also be found on the fracture surface as illustrated by SEM fractography given Fig. 10. Microcracks generated by the fiber failure appear as a disk around fibers, whether it is in ductile zone (see Fig. 10(a)) or in brittle zone (see Fig. 10(b)). These microcracks are due to high stress and strain concentration in the fiber failure zone. The higher criticality of fiber failure compared to fiber ends damage is illustrated in Fig. 11, where the microcracks are developing at the level of the fiber failure instead of fiber ends.

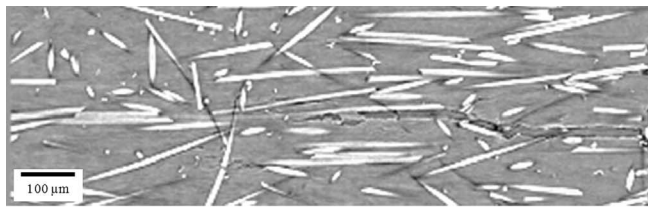
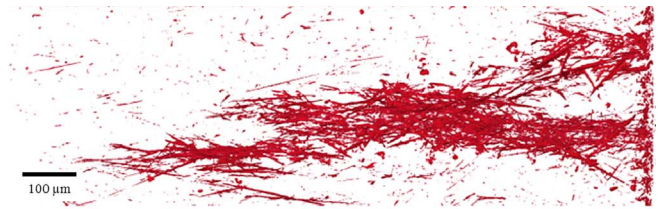
(a) Slice (fibers oriented at 90°)

(b) Damage (fibers oriented at 90°)

Fig. 26. Side view of mesocracks - RH50 90° specimen.

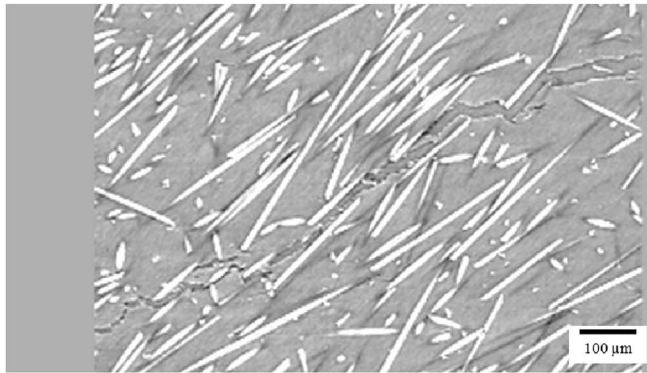
(a) Slice (fibers oriented at 45°)

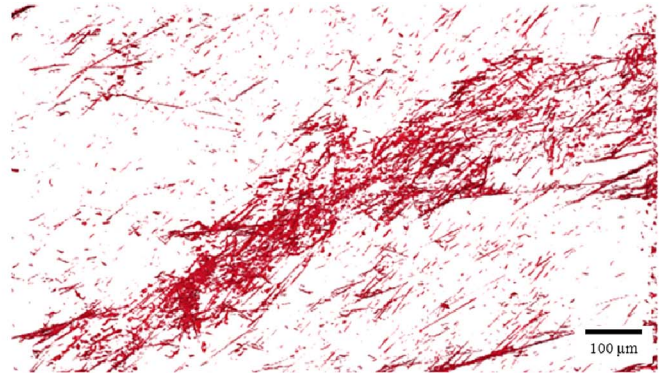
Fig. 27. Side view of mesocracks - RH50 45° specimen.

(b) Damage (fibers oriented at 45°)

In the case of 45° specimen, fibers of both shell and core form an angle of 45° with the macroscopic loading direction. This orientation leads to differences of crack propagation. The mesocrack is mainly based on damage at the interface: debonding and damage at fiber ends, as presented in Fig. 27. From the interface of one fiber to another, the propagation through the matrix is mainly transverse to the macroscopic loading.
