Ilan RAPHAEL, Nicolas SAINTIER, Gilles ROBERT, Jérémy BEGA, Lucien LAIARINANDRASANA - On the role of the spherulitic microstructure in fatigue damage of pure polymer and glass-fiber reinforced semi-crystalline polyamide 6.6 - International Journal of Fatigue n°126, p.44-54 - 2019

# On the role of the spherulitic microstructure in fatigue damage of pure polymer and glass-fiber reinforced semi-crystalline polyamide 6.6

Fatigue damage  
Composite material  
Semi-crystalline polymer  
Oriented spherulites

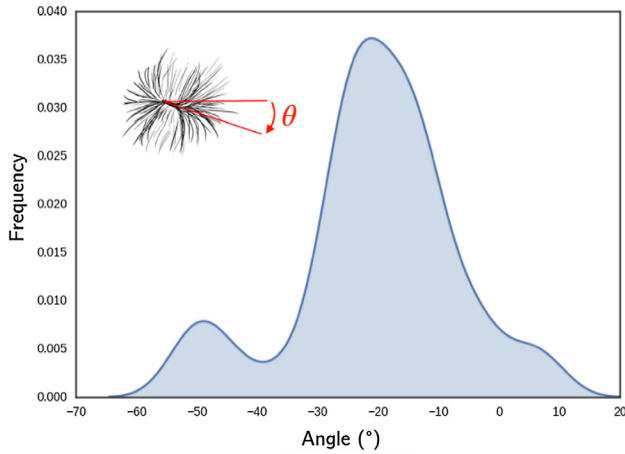
Fig. 12. Orientation of the 40 nuclei observed on 3 different PA66 specimens after fatigue testing.

The orientation of the nuclei with respect to the horizontal can be measured on the images (Fig. 12). As they seem to be preferentially
