Detection and evaluation of barely visible impact damage in woven glass fabric reinforced polyamide 6.6/6 composite using ultrasonic imaging, X-ray tomography and optical profilometry

Abstract

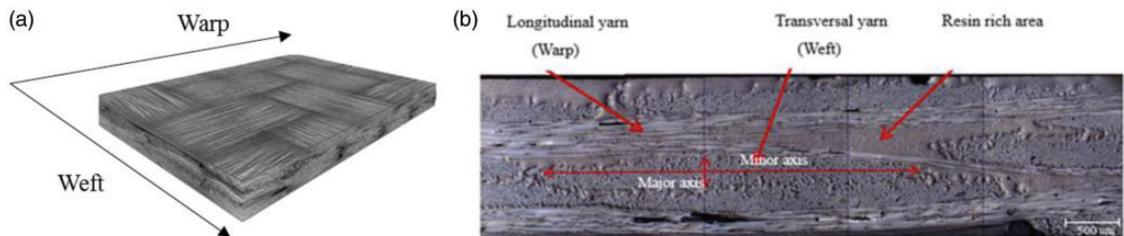
Figure 1. Mesostructure (a) and microstructure microscopic observation (b) of the woven glass fabric-PA66-6 composite showing warp and weft orientation (Pomarède et al., 2018).

The Table 1 provided by DuPont de Nemours presents the density, the Young modulus (E) and the ultimate strength (σ_{UTS}) and strain (ε_{UTS}) of the studied composite material. The microstructure and the architecture of the material reinforcement are presented in Figure 1.

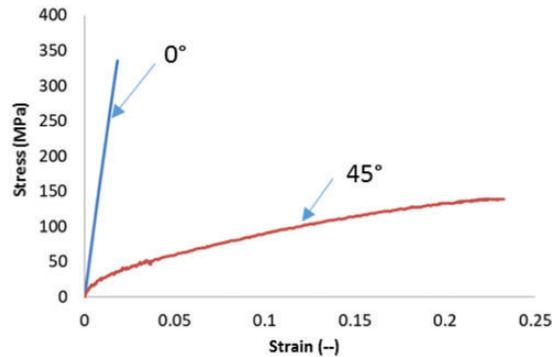
Figure 2. Typical stress-strain responses of the woven glass fabric-PA66-6 composite under tensile loading in 0° and 45° directions (Pomarède, 2018).

Pomarède (2018) studied the tensile response of the PA6.6/6 reinforced composite under two configurations 0° and 45°. It is shown that the mechanical behaviour is highly influenced by the fibres' orientation. Indeed, under tension loading, the 0° configuration behaves as a linear and brittle while at 45° configuration shows a nonlinear ductile response due to the matrix rheology. Typical stress-strain curves showing the response of the woven glass reinforced PA6.6/6 at 0° (or 90°) and that at 45° directions are given in Figure 2. The components of stiffness matrix are determined experimentally using ultrasonic bulk waves (Pomarède, 2018) and are compared with those obtained numerically using periodic homogenization (Praud, 2018) as represented in Table 2.

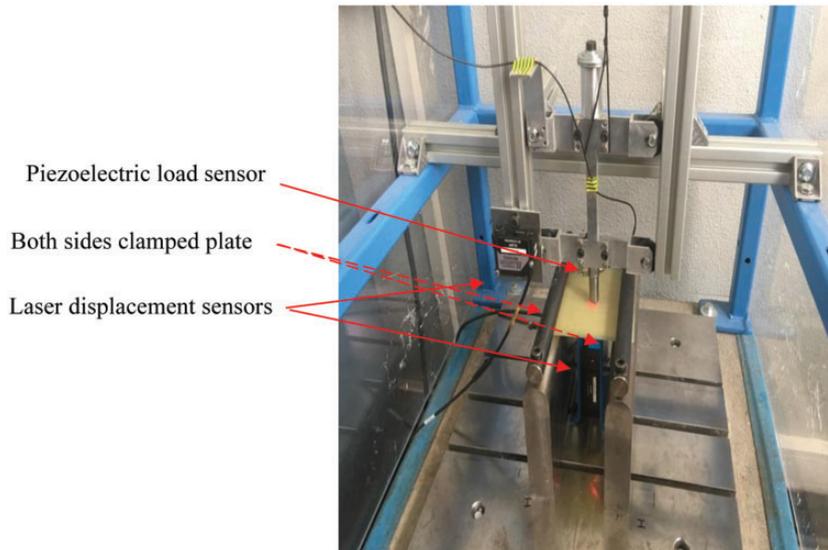
Figure 3. The experimental device used to perform drop weight impact tests showing: a piezoelectric load sensor, a first laser displacement sensor that monitors the displacement of the striker and a second one placed under the clamped sample to record the deflection.

Impact tests are performed using a drop tower equipped with a 1.02 Kg striker having a 16 mm diameter hemispherical end. The experimental device, shown in Figure 3, consists of a piezoelectric load sensor and two laser displacement sensors, as well as a data acquisition system. The plates are clamped at both ends as illustrated in Figure 3, and the impactor strikes the plates in their centre. The displacement of the sample is subsequently measured under the impacted plate using a laser displacement sensor. The acquisition of the striker's (impactor) displacement, the displacement of the centre of plate, and the contact force are measured for data analysis. The main objective of this project is to study the BVID and its detectability in rectangular cross-sections samples made of thermoplastic polymer (PA6.6/6) reinforced glass woven fabric composite. For that matter, four impact energy levels are considered by varying the drop height in such a way to remain in the BVID domain. The four impact energy levels resulting from the variation of the drop height are: 7.30 J, 13.45 J, 15.28 J, and 17.60 J.

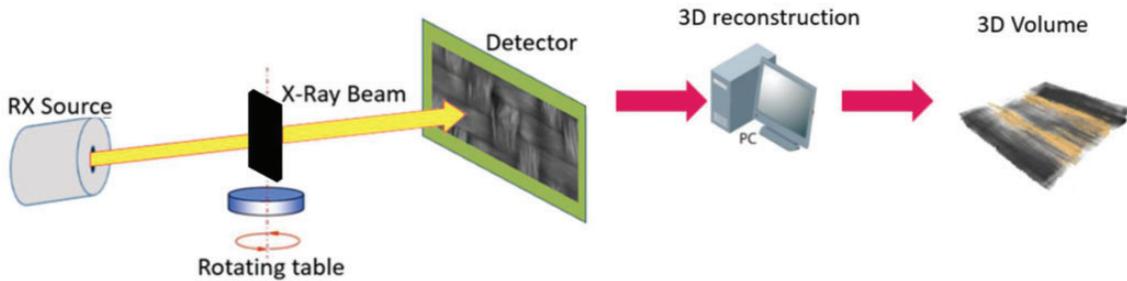
Figure 4. Principle of X-Ray tomography technique: the investigated object is first positioned on a rotating table; the X-Rays penetrate it and are then projected on a flat detector.

distinguishes the different damage mechanisms and traces the propagation path of the induced damage with a suitable spatial resolution. Following the principle of the X-Ray tomography detailed in

Figure 4, the X-Ray beam penetrates the sample, which is positioned on a rotating table and is then projected on a flat panel detector. Its ability to provide internal information about the investigated area makes the technique more suitable and helpful compared to other in-situ investigation methods. A voxel size is set to $12\mu\text{m}$ corresponding to the resolution of the observation. It represents a good compromise in terms of accuracy up to the level of the fibre diameter ranging from 10 to $15\mu\text{m}$. Radiographic images recorded at different rotation angles and thicknesses are then processed for the 3D volume reconstruction of the targeted area of the sample. The data post-processing and the 3D reconstruction of the area of interest are achieved using X-Act software. AVIZO software is employed afterward to significantly reduce the amount of noise in the reconstructed images employing the median filter and the related thresholding levels that the software provides.

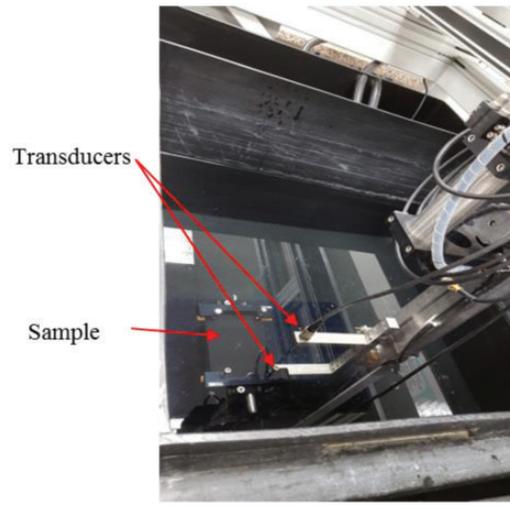
Figure 5. Transmission C-scan setup showing a clamped sample immersed in a tank filled with water and two 10 MHz transducers that scan the sample following a serpentine path.

It should be noted that in both cases, the entire measuring system (transducers and plates) is immersed in a water-filled tank (Figure 5). Unlike air, the water as a coupling fluid has the advantage for providing better ultrasound coupling.

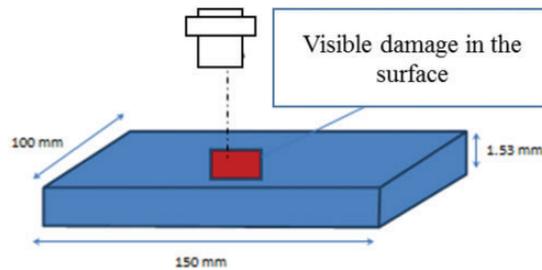
Figure 6. Pulse/echo C-scan configuration using one single 10 MHz transducer that plays the role of both the emitter and the receiver.

Reflection C-scan is performed to obtain further information concerning in-thickness damage propagation. A single focused 10 MHz piezoelectric transducer is used for this purpose. The latter emits an ultrasonic wave that is reflected when encountering defects or inhomogeneities and is later recorded and analysed. The samples are positioned in such a way that the impacted surface is facing the transducer (Figure 6). C-scan images corresponding to the scanned area are later presented.

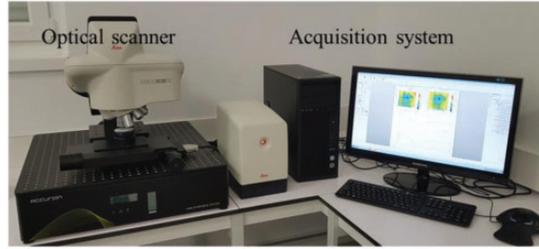
Figure 7. Leica DCM3D device showing the optical scanner and the acquisition system.

An optical profilometry method is performed to confirm the accuracy of this measurement. A LEICA DCM3D (Figure 7) is employed with $\times 5$ magnification, imaging an area of 27×20.23 mm. Each sample is scanned according to predefined steps during which each point of

the surface crosses the focal plane. The magnification leads to a resolution along X and Y of $0.94\ \mu\text{m}$, and the vertical resolution less than $150\ \text{nm}$.

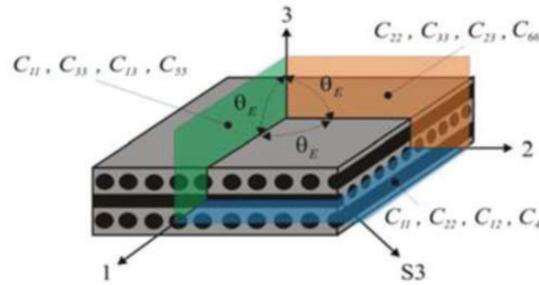
Figure 8. Schematic representation of the considered planes to perform the experimental stiffness measurements in composites (Hufenbach et al., 2006).

Due to the low thickness of the samples (1.53 mm), the ultrasonic measurements are achieved in two principle planes, namely: 1–3 and 2–3 as shown in Figure 8. These measurements lead to the computation of seven out of nine of the stiffness constants.

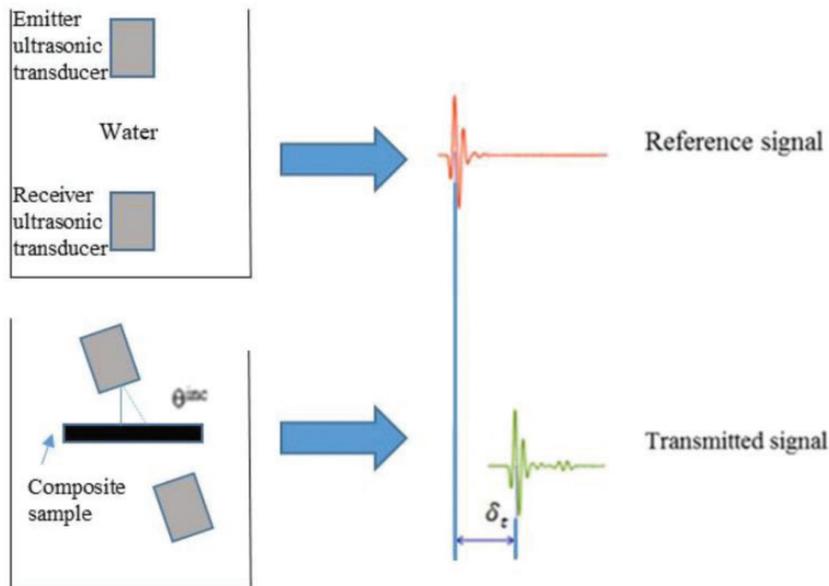
Figure 9. Illustration of the measurement of the time delay [Inspired from perso.univ-lemans.fr].

For each angle in each considered plane, the experimental velocity of the wave propagating in the sample is retrieved by estimating the time delay δ_t using the principle illustrated on Figure 9. The time delay represents the difference between the time of flight (TOF) of the ultrasonic wave in the water i.e without the sample and the TOF of the wave with the sample.

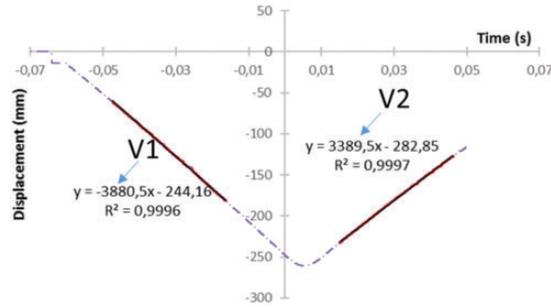
Figure 10. Impactor's displacement- time curve for the sample loaded at 7.30 J detailing the followed method to compute the absorbed energy.

v_1 and v_2 are respectively the impact and the rebound velocities. They are determined as the slopes of respectively the first part and the second part (rebound) of the displacement-time curve, as illustrated in Figure 10.

All estimated velocities correspond to the slope of the best straight line fitted through the real values, where the regression's coefficient is close to 1. Figure 10 presents an example of the sample impacted at 7.30 J where the velocities are estimated using the displacement-time curve of the impactor. The calculated impact parameters are listed in Table 3. As expected, one can notice that the absorbed energy increases with impact energy show in Figure 11(c). Indeed, damage severity and formation can be directly linked to the increase of the absorbed energy. Figure 11 presents deflection-time (a) and contact force-time (b) curves, respectively, for the four impact energy levels. On all curves (force and displacement), a noticeable shift of the amplitude between the response at 7.30 J and the response at the rest of the impact energy levels could be easily observed. Figure 11(a)

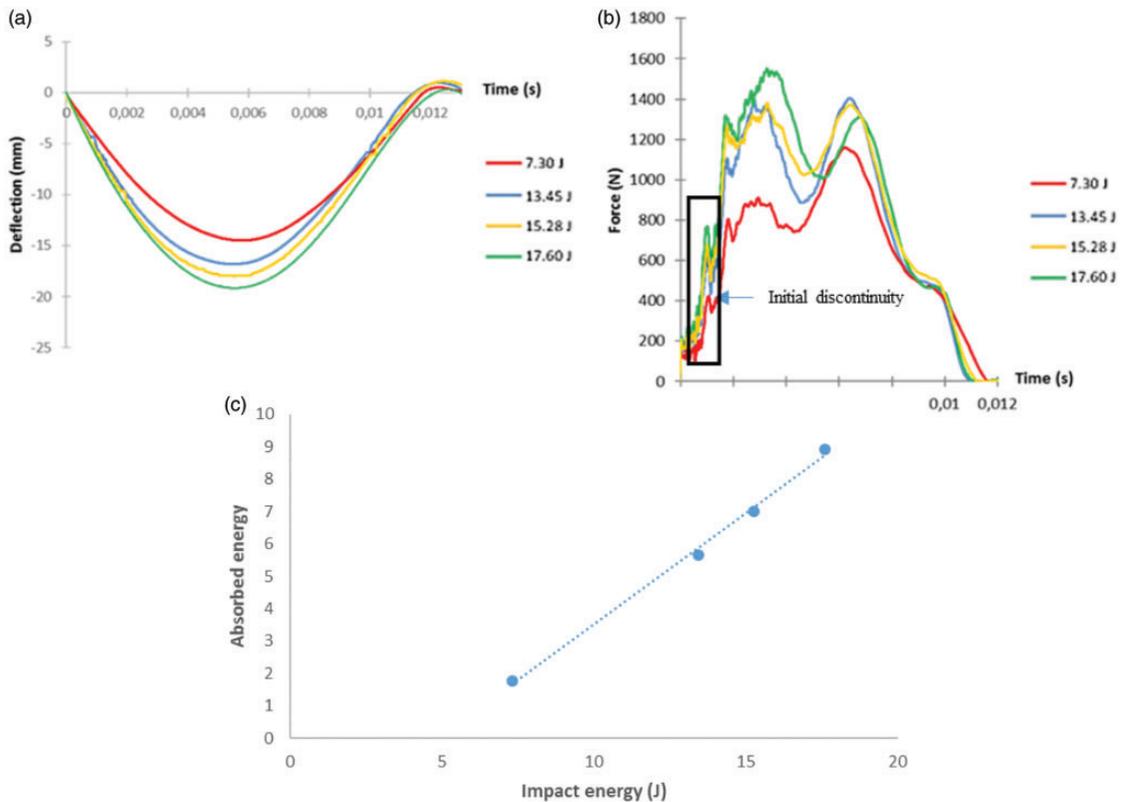
Figure 11. (a) Displacement -time curves and (b) force-time curves for the four considered drop weight energies, (c) the absorbed energy-impact energy.

illustrates the aforementioned displacement-time curves. One should mention that for the curve referring to the sample loaded at 17.60 J, a regression is achieved due to difficulties inherent to the acquisition (saturation of the sensor at certain areas). As expected, the maximum deflection of the impacted specimen grows with the impact height. On Figure 11(b), the maximum contact force increases along with the growth of the impact energy. In all force-time histories, oscillations and discontinuities of high and low frequencies are observed. The first type of oscillations can be attributed to the natural frequencies of the impactor and are known as “impactor ringing.” The severity of the oscillations increases if the parts constituting the impactor are not rigidly attached

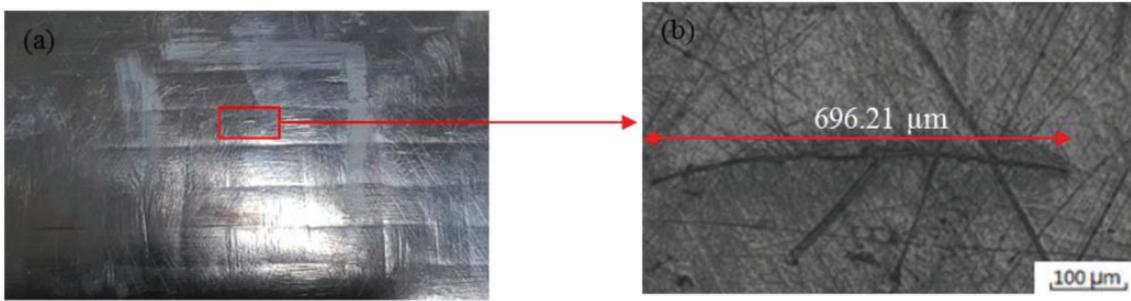
Figure 12. Images of the micro crack seen on the back of the plate damaged at 13.45 J: (a) naked eye observation (b) image obtained using an optical microscope.

The first observed damage stage is on the specimen impacted at an energy level of 13.45 J. This damage appeared as a small opening on the non-impacted side, barely visible to the naked eye. To investigate the small damage closely on the plate impacted at 13.45 J, an observation using the optical microscope is performed. Figure 12 exhibits the obtained images of the superficial damage with a dimension of 696.21 μm . However, on the samples impacted at 15.28 J and 17.60 J, cracks propagating longitudinally and transversely leading to fibre breakage are easily observed (Figure 13).

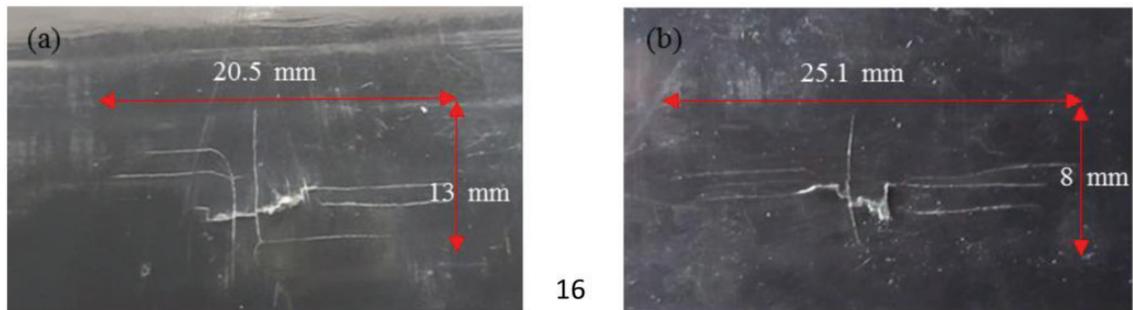
Figure 13. Dimensions of the damage occurring on the impacted samples loaded at energy of (a) 15.28 J and (b) 17.60 J observed by naked eye.

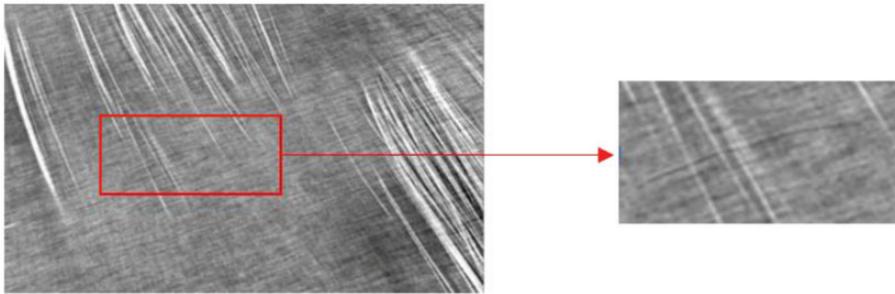
Figure 14. X-ray tomography observations performed on the samples impacted at an energy level of 13.45 J showing the matrix micro-crack.

Several damage phenomena are observed on the 3D reconstruction. The severity of the damage grows at increased impact energy. On the plate impacted at 7.30 J, no damage is observed. Indeed, impact energy of the magnitude of 7.30 J appears to be not sufficient for bring about a permanent internal damage in the material. Figures 14 to 16 represent the images resulting from X-Ray tomography inspection for each impacted sample. On the plate impacted at 13.45 J, shown in Figure 14, a small crack is noticed to be superficial. For the other two plates (15.28 J and 17.60 J), damage reaching fibres-breakage is observed (Figures 15 and 16).

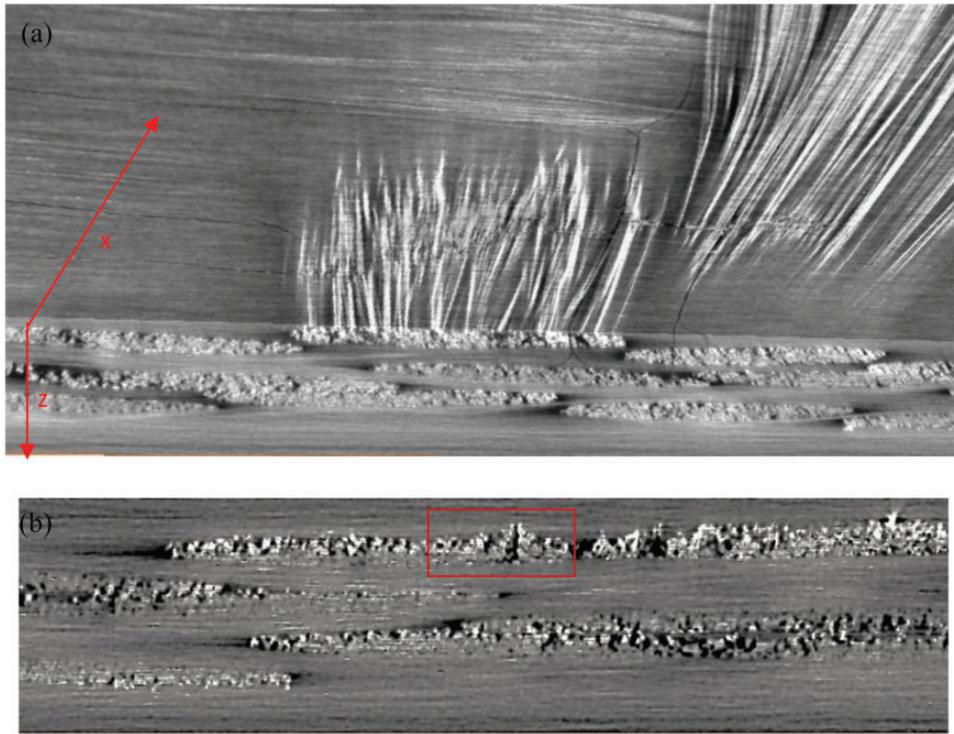
Figure 15. X-ray tomography observations performed on the samples impacted at an energy level of 15.28J showing (a) the crack network and (b) a transversal crack and delamination.

delamination that spread around the yarns. This damage mechanism is called pseudo-delamination. It is highly relevant to note that in a laminate composite made of plies having the same fibre orientation, no delamination could occur on the interface between the layers (Abrat, 1998). As shown in Figure 15, some cracks penetrate the yarns of the second ply but do not extend to the third layer. It should be highlighted that matrix cracks, and the resulting delamination engender defects inside the samples. The latter, when exposed to X-Rays, appear as black areas that constitute the crack network.

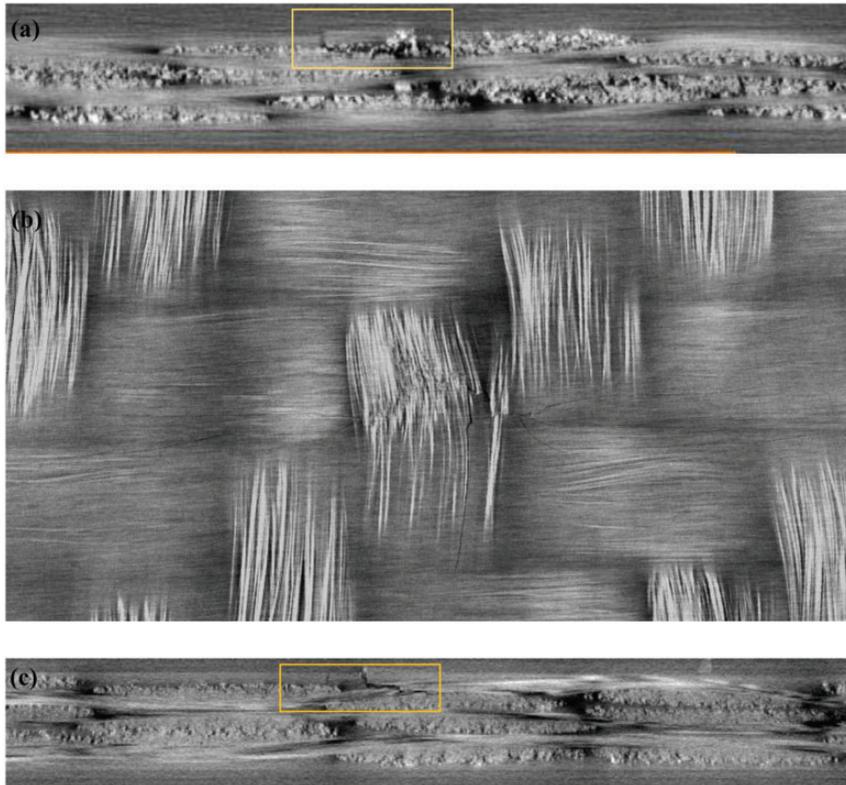
Figure 16. X-ray tomography observations performed on the samples impacted at an energy level of 17.60 J showing (a) a local uprising of the fibres localized between two transversal crack, (b) the crack network and (c) delamination and stair-shape failure.

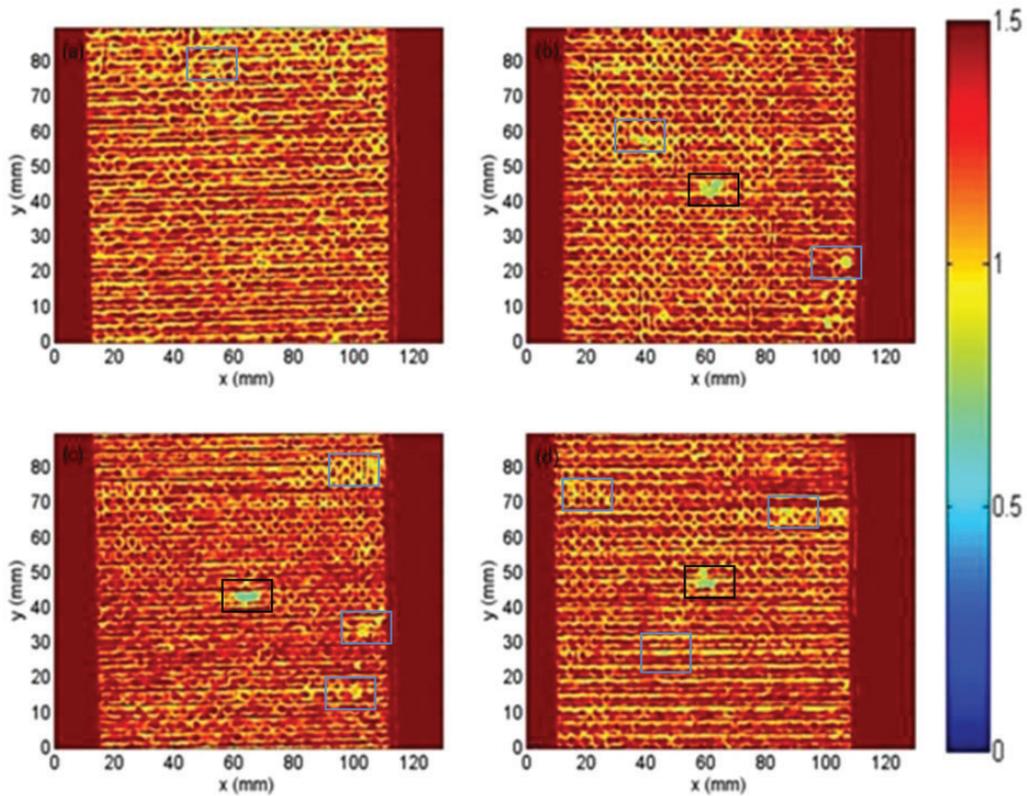
Figure 17. Transmission C-scan results for the four samples damaged respectively at: 7.30 J (a), 13.45 J (b), 15.28 J (c) and 17.60 J (d) using the 10 MHz transducers.

As specified in the Ultrasonic C-scan imaging section, two types of ultrasonic C-scan tests are carried out on the loaded samples, namely transmission and reflection tests. Results of ultrasonic C-scan are represented as cartographies of amplitude (Figures 17 and 18). The isocolor map reflected the variation of the maximal amplitude on the various areas of the scanned surface. The blue color corresponds to an attenuated signal and therefore small amplitude. These blue areas indicate the zones with high probability to contain damage, while the red areas reveal the zones where the signal amplitude reached its maximum value.

Figure 17 demonstrates the results of C-scans in transmission. Relatively small areas at the edges and inside the plates showed an attenuation that indicates a low amount of damage. It can be presumed that the latter was introduced during the cutting process or manufacturing. Thus, it is considered irrelevant and is neglected in the sequel.

For the sample submitted to a 7.30 J impact, no potential damage is noticed on the scan image. At 13.45 J, 15.28 J and 17.60 J impact energies, all C-scan in transmission images exhibited signal attenuation that is localized near the impact region. No difference in term of damage dimension is observed. That said, it is highly challenging to differentiate between the three plates.

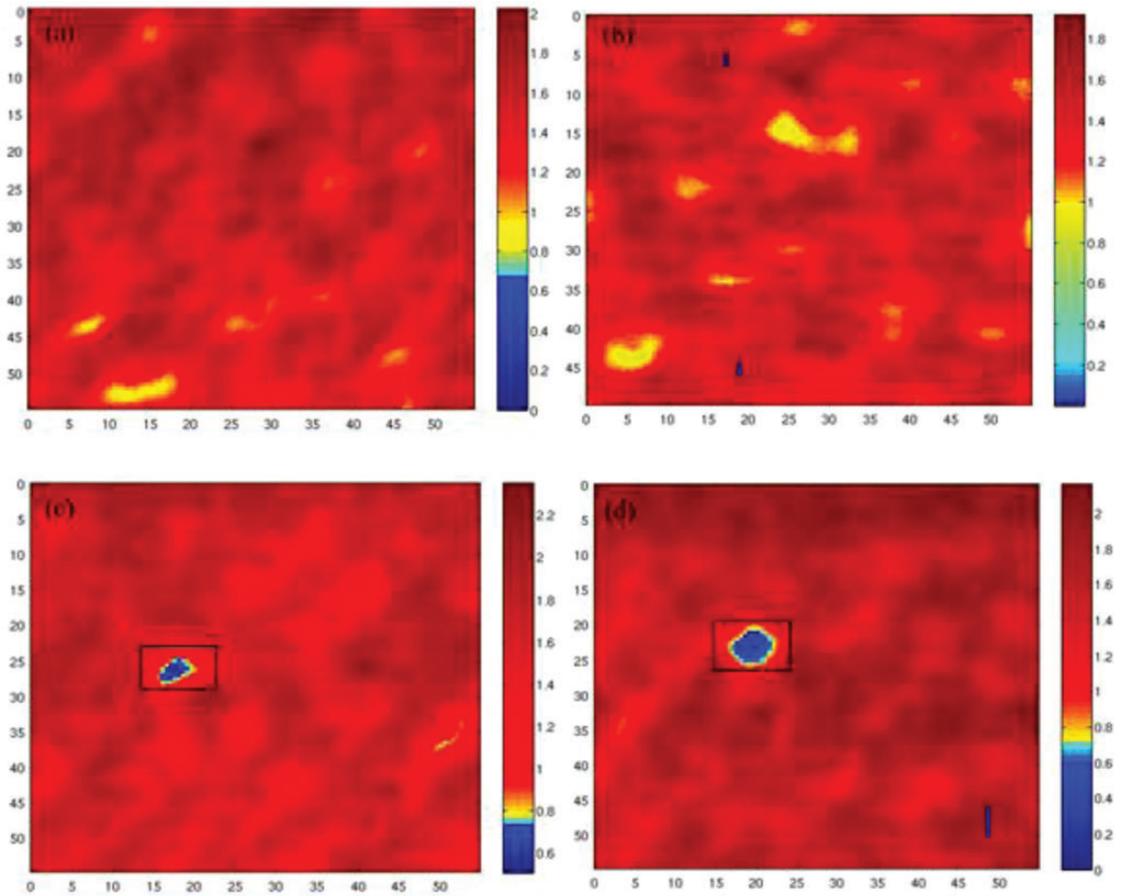
Figure 18 shows the results of reflection C-scans. The color scale is adjusted to focus more on the areas of amplitude attenuation. Pulse/echo C-scan results (Figure 18(c) and (d)), for 15.28 J and 17.60 J as energy level) presented damage surface evolution when the impact energy increased. On

Figure 18. Pulse/echo C-scan results for the four impacted samples: (a) 7.30 J, (b) 13.45 J, (c) 15.28 J and (d) 17.60 J using a 10 MHz transducer.

the other hand, no defect is detected for the two samples damaged at 7.30 J and 13.45 J. In Table 4, the detected defect dimensions are shown. For an energy level of 15.28 J, the damaged area observed on the C-scan image corresponds to a dimension of 5 mm, while for the plate corresponding to an energy level of 17.60 J, the dimension is 7 mm. These given measures might only represent the area with severe damage due to the limited spatial resolution of such imaging method (300 μm).

In conclusion, ultrasonic C-scan imaging provides sufficient information concerning the detection of macroscopic damage. However, it is not accurate for measuring the defect dimensions. Moreover, pulse/echo C-scan cannot be considered as a highly reliable method regarding microscopic damage detection, especially when the damage does not exhibit an in-thickness propagation.

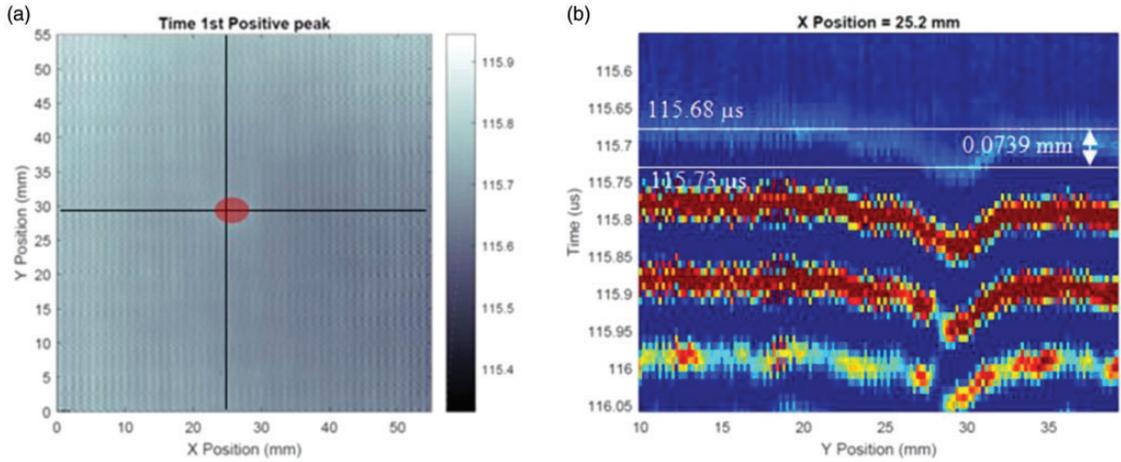
Figure 20. (a) Representation of the cartography corresponding to the time of arrival of the first positive peak, (b) B-scan on the impacted at an energy level of 17.60 J.

Ultrasonic measurement. An estimation of the dimension of the indent (Figure 19), using ultrasonic inspection, is performed in this sub-section. To do so, the time of arrival corresponding to the first positive peak on the C-scan in reflection is extracted and is illustrated on an isocolor map. In order to explain the procedure, only one example relative to the sample damaged at an energy level of 17.60 J is presented in Figure 20. Information about the depth of the indent is calculated by measuring the difference between the time of arrival corresponding to the impacted area and the one

corresponding to the non-impacted area. Knowing that the wave propagation velocity is of 1478.8 m/s in water, an estimation of the travelled distance for the four plates is given in Table 5. These distances correspond to the depth of the indent (Figure 20(b)). A substantial increase of PI dimensions, depth, and diameters, is noticed when elevating the impact energy between 13.45 J and 15.28 J. However, a slight difference from 15.28 J to 17.60 J is noted. Nevertheless, ultrasonic measurement of the PI comes with significant uncertainty as mentioned in Table 5.

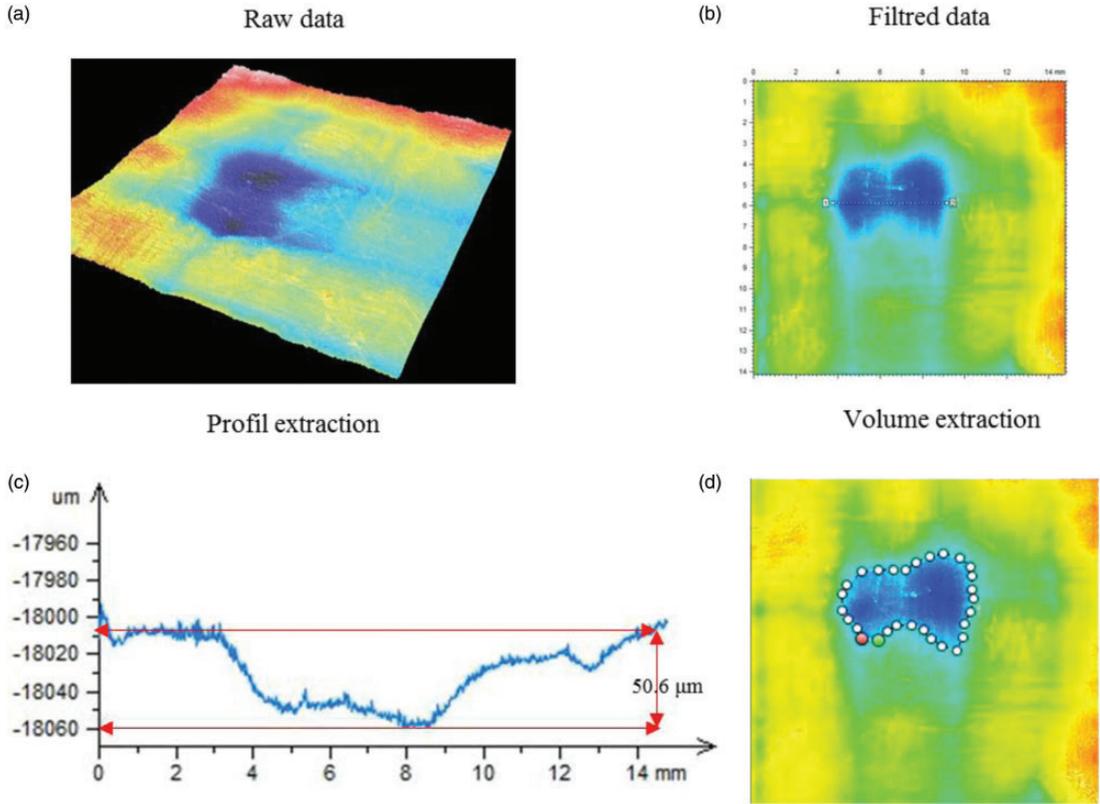
Figure 21. Detailed processing procedure using Leica Maps performed on the plate impacted at 15.28J: (a) raw data, (b) filtered data, (c) profile extraction and (d) volume extractions.

Optical imaging profilometry: Validation of experimental measurement. A second technique is performed to assess the previous results obtained by the ultrasonic method. It consists of optical profilometry. The scans are carried out following the procedure previously detailed in the Permanent indentation (PI) measurement section. The raw data are then obtained and several post-processing procedures are performed using Leica Maps software as depicted in Figure 21(a). First, a filter, Figure 21(b) is used to elevate the surface around the impacted area and to separate the roughness from the waviness. The primary purpose is to identify the location of the indentation area and then the PI is accurately measured. In fact, the profile is extracted in the line corresponding to the deepest area. This latter provides information about the depth of the permanent indentation Figure 21(c). Finally, by selecting the area of interest point by point, the software calculates the volume of the permanent

indentation Figure 21(d). Information relative to the depth, the diameter and the volume of the scanned area is presented in Table 6.

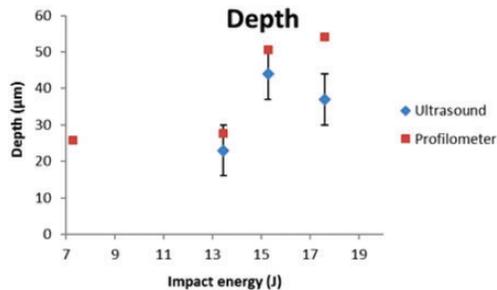
Figure 22. Comparison between the results obtained using both ultrasound-based method and profilometry for the four samples impacted respectively at energies of: 7.30, 13.45, 15.28 and 17.60J.

A comparison between the results provided by the two methods, ultrasound-based method, and optical profilometry, is established and represented in Figure 22. The comparison shows a good correlation between the two methods as well as a satisfying accuracy for the ultrasound-based method.

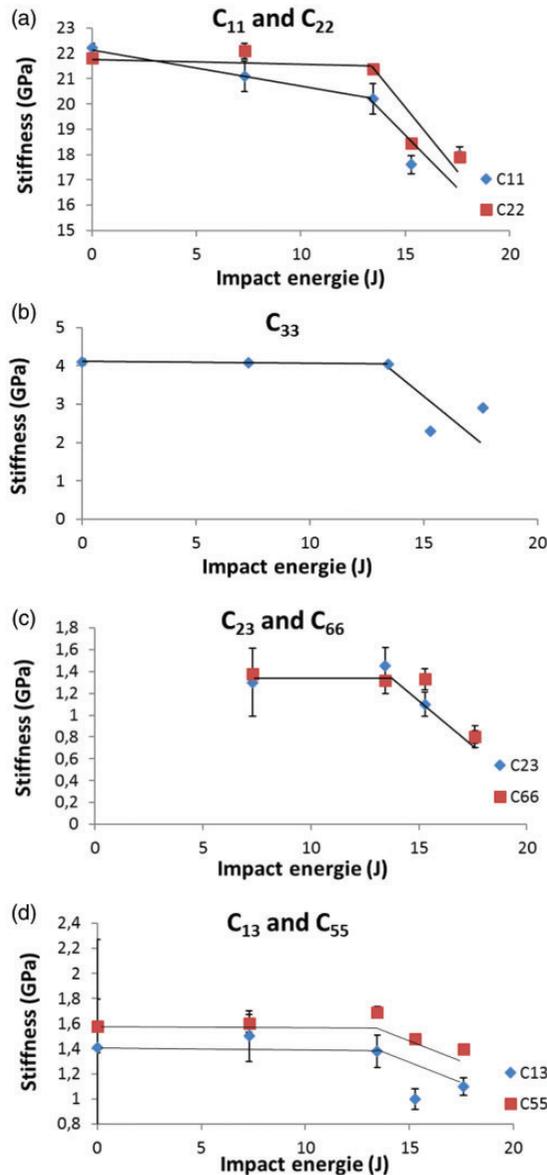
Figure 23. Experimental stiffness components for the samples impacted at energies of 7.30J, 13.45J, 15.28J and 17.60J showing: (a) C_{11} and C_{22} , (b) C_{33} , (c) C_{23} and C_{66} and (d) C_{13} and C_{55} .

Figure 23(a) to (d) represent the experimentally determined stiffness components for the four studied samples. An overall decrease of the stiffness components is noticed starting from 15.28 J. The results are in agreement with those obtained using other techniques. Indeed, one can notice that all the components, namely: C_{11} , C_{22} , C_{33} , C_{13} , C_{55} , C_{23} and C_{66} exhibit a distinguished decrease starting from the energy of 15.28 J. Furthermore, the stiffness reduction of the components C_{11} and C_{13} is more pronounced between 15.28 J and 17.60 J rather than between 7.30 J and 13.45 J.

More pronounced damage is detected for the samples impacted at 15.28 J and 17.60 J. Thus, damage extending to the second layer of the composite is observed. The cracks propagated through the matrix breaking the yarns (longitudinal and transversal) leading to the creation of delamination. On the impacted side, the measure of the permanent indentation using B-scan imaging show a critical increase starting from 15.28 J. The verification of these measures by optical profilometry lead to an agreement between the two used methods. An overall decrease of the stiffness components is noticed starting from 15.28 J.
