The influence of acrylate triblock copolymer embedded in matrix on composite structures' responses to low-velocity impacts

Sébastien Denneulin^{a,*}, Philippe Viot^a, Frédéric Leonardi^b, Jean-Luc Lataillade^a

A B S T R A C T

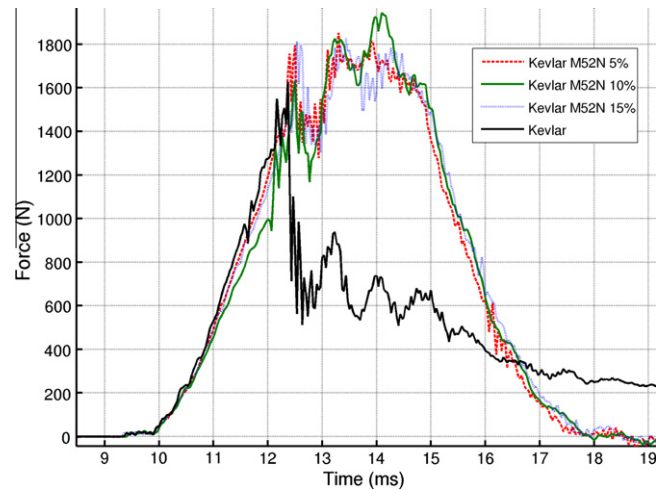
Fig. 6. Force vs. time curves during the impact test with impact conditions 1. One representative test for 0%, 5%, 10%, and 15% of M52N.

In order to choose the best percentage of M52N copolymer, three types of composite plate are tested. The first impact conditions are used and the contact force vs. time is presented in Fig. 6. A significant improvement is noticed, whatever the percentage of M52N is compared to the Epoxy-3K. However, damage is revealed on 10% of the M52N (Fig. 9) composite plate, which is much less severe than the others. Finally, the composite plate with 10% M52N has been chosen for all further investigations.
