# In situ damage mechanisms investigation of PA66/GF30 composite: Effect of relative humidity

M.F. Arif<sup>a</sup>, F. Meraghni<sup>a,\*</sup>, Y. Chemisky<sup>a</sup>, N. Despringre<sup>a</sup>, G. Robert<sup>b</sup>

## A B S T R A C T

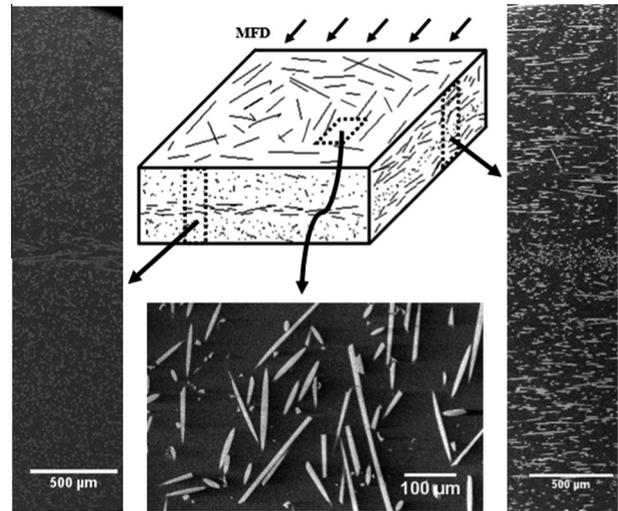
Fig. 1. Skin-shell-core microstructure formation developed through the thickness of the composite due to the injection molding process.

The material for this study is Technyl® A218V30, a commercial grade of PA66/GF30 supplied by Solvay Engineering Plastics-France. The material was prepared by compounding the polyamide pellets and glass fibers in a twin-screw extruder. Subsequently, the PA66/GF30 compound was transferred into an injection molding machine, resulting in a 3.2 mm thickness of rectangular plate. The polished surfaces of the top and the through-thickness zones of machined specimen from the central region of injected plate were observed by scanning electron microscope (SEM). As described in Fig. 1, this material has a specific microstructure

characterized by a well-defined skin-shell-core layer formation. This microstructure was only noticed through the thickness of the material and no microstructure heterogeneity was found through the width and length of the rectangular plate. This type of formation has been frequently observed in a thin plate structure of thermoplastic composites manufactured by injection molding process [28–30].

The skin layers, the upper and lower specimen surfaces, are randomly oriented and they represent about 5% of the plate thickness. The shell layers, with preferential orientation longitudinal with respect to the mold flow direction (MFD), are the most dominant layers. Indeed, they represent about 90% of the plate thickness. The core layer fills up to 5% of the plate thickness and mostly fibers in this layer are oriented perpendicular to MFD (Fig. 1).

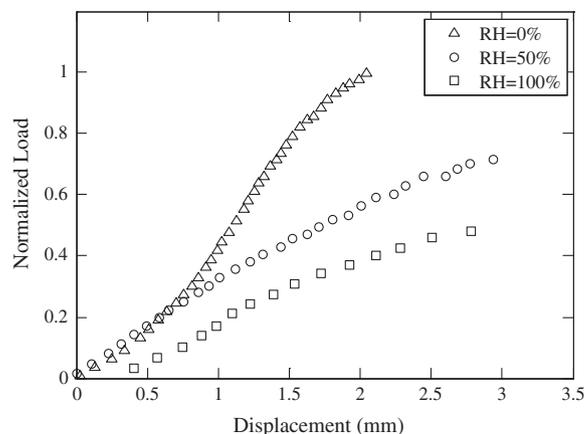
Fig. 2. Normalized load vs. displacement curve of PA66/GF30 specimens with variation of relative humidity.

Fig. 2 shows the normalized load – displacement responses of the in situ SEM three-point bending tests of PA66/GF30 specimens conditioned at various RH conditions. For each specimen, the relative ultimate loads before failure were recorded. Flexural strength ( $\sigma_f$ ) was defined, for each RH content, as the maximum flexural stress in the specimen at the ultimate load according to ISO 178 standard. Relative flexural stress was defined to be the ratio of flexural stress in the area of observation with respect to the flexural strength. As described in Fig. 2, the RH content highly influences the mechanical properties of PA66/GF30. Flexural strength and stiffness of PA66/GF30 decreases with the increase of RH. The noticeable differences on the strength and modulus of PA66/GF30 by variation of RH are assumed to be due to damage and plasticization effect. Indeed, the RH = 0%, 50% and 100% specimens represent the conditions where the composites are respectively in glassy ( $T_g > T_{\text{room}}$ ), glass transition ( $T_g \approx T_{\text{room}}$ ) and rubbery states ( $T_g < T_{\text{room}}$ ) [26,27]. Strain to failure in RH = 50% and 100% specimens are higher than that in RH = 0% specimen, whereas no significant difference is observed between the strain to failure at RH = 50% and 100% specimens. While the increase of strain to failure due to higher RH is noticeable for pure polyamide 66, this phenomenon is not strongly marked for fiber reinforced composite material [32].

The damage mechanisms observed in PA66/GF30 are strongly affected by the moisture content variation. The flexural strength is reduced with increasing moisture content, which is assumed to be due to the combination of damage and polyamide plasticization effects (Fig. 2). Consistent results are also observed regarding to the qualitative observation of the number of damaged zone on the composites surface which shows that the higher RH results in higher damage level, at every stage of the loading. Moreover, Fig. 14 shows a comparison of damaged area for the three specimens with different moisture content at high relative flexural stress near to the failure. It is obvious that the number of damaged area increases while increasing the moisture content. The presence of water molecules inside the composite can reduce the mechanical performances of the polyamide as well as the fiber-matrix interfacial properties due to the plasticization effect and the mismatched fiber-matrix expansion during the ageing period. This might bring about a change in the overall mechanical and damage properties of PA66/GF30.

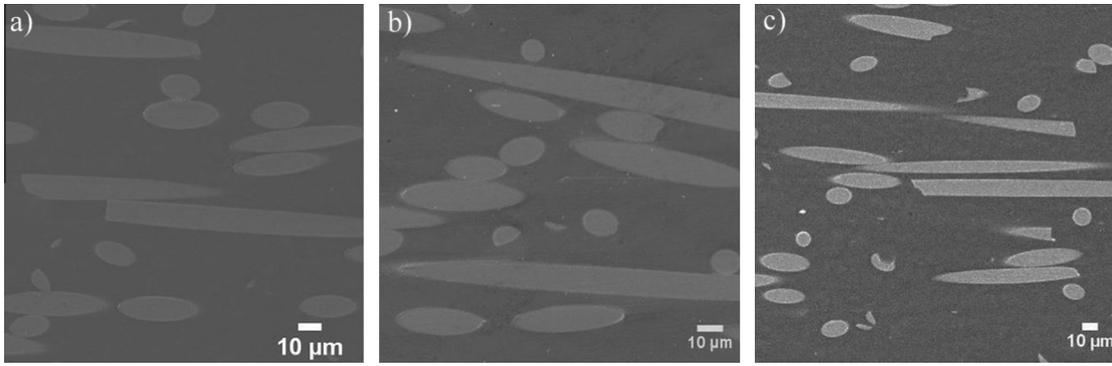
**Fig. 3.** Local views of virgin surface (at zero level stress) of PA66/GF30 specimen for the three RH contents: (a) RH = 0%, (b) RH = 50% and (c) RH = 100%. One can notice that no indication of initial damage is detected regardless of the RH conditions.

(a) RH = 0% specimen: Fig. 3 shows typical microstructure observed on the thickness surface specimen before applying any load. For the three studied RH conditions (RH = 0%, RH = 50% and RH = 100%), the local views, corresponding respectively to Fig. 3a–c confirm that no indication of initial damage is observed regardless of the RH conditions.

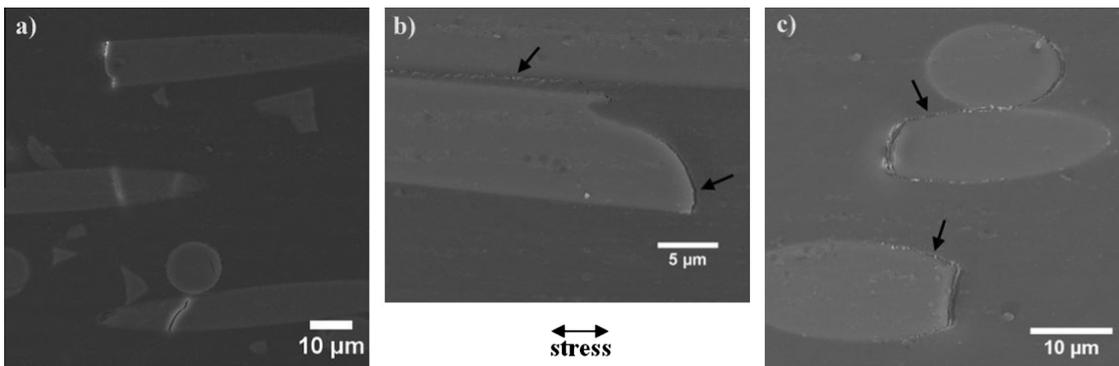
**Fig. 4.** PA66/GF30, RH = 0% specimen, (a) damage at fiber end and fiber breakages at 33%  $\sigma_f$ , (b) damage at fiber end and high plastic deformation between two adjacent fibers at 48%  $\sigma_f$ , and (c) damage propagation along fiber-matrix interface at 85%  $\sigma_f$ .

While the load increases, the damage on RH = 0% specimen starts to be noticeable at around 33%  $\sigma_f$ . Damage initiations in the form of interfacial debonding at fiber end and fiber breakages are observed (Fig. 4a). It can be noticed in Fig. 4b that the matrix

deformation between the fibers that are close to each other is larger than the other zones of matrix. It is assumed that the damage can also initiate from this location due to the local stress concentration. As the load increases, damage propagation along fiber-matrix interface (Fig. 4c) and fiber breakages at new locations are observed. At high relative flexural stress (95%  $\sigma_f$ ), matrix microcracks occur at location where broken fibers are close to each other (Fig. 14a).

For RH = 0% specimen where the water uptake is zero, the damage initiates at high load level and the damage remains confined and low. The damage has been notably observed in the form of fiber-matrix interfacial decohesions and fiber breakages (Fig. 4). This indicates that the RH = 0% specimen exhibits good interfacial properties compared to both other RH conditions. This is mainly due to the absence of water content and small level of interfacial decohesion while stress level increases. The good interfacial properties insure a stress distribution in the fibers when the composite is subjected to mechanical loading. This aspect increases the probability of occurring of fiber breakages and thus it is possible to observe few fiber breakages at the damage onset corresponding to 33% of  $\sigma_f$ . As this is only the damage initiation, the number of fiber breakages is very limited and confined in few locations of the investigated zone. This is common in short fiber reinforced composites due to their aspect ratios, local orientation with respect to the macroscopic applied stress and the local multi-axial stress concentration. At high relative flexural stress, matrix microcracks initiate at locations where broken fibers are close to each other (Fig. 14a). Fiber breakage induces stress redistribution into the matrix and surrounding fibers. Since locations where fibers are close to each other also generate local stress concentration, the matrix microcracks and another breakage of the adjacent fibers would occur. These matrix microcracks then propagate in a brittle way (Fig. 11).

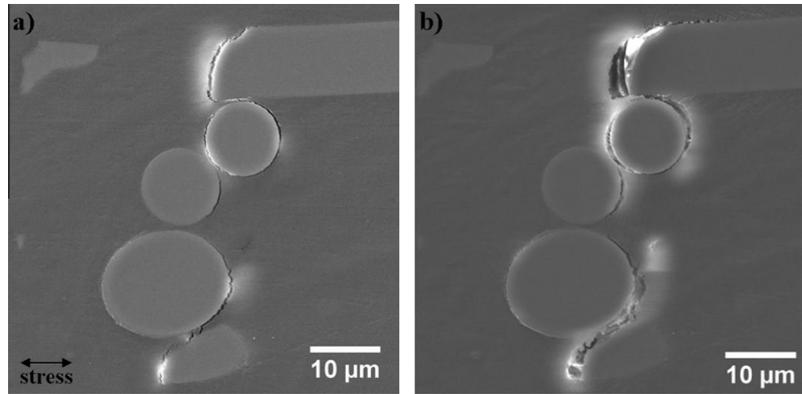
**Fig. 5.** PA66/GF30, RH = 50% specimen, (a) damage initiation at 30%  $\sigma_f$  and (b) damage propagation at 83%  $\sigma_f$ .

(b) *RH = 50% specimen:* Fig. 5a shows the surface of the specimen conditioned at RH = 50% subjected to a 30%  $\sigma_f$ . It can be seen that the damage is initiated in the form of interfacial debonding. However, it must be noticed that this damage initiation is not only observed at fiber ends but also at many locations where fibers are close to each other. The damage then propagates along the fiber-matrix interface, occurring both through the in-plane and out-of-plane directions, as shown in Fig. 5b. Some fiber breakages are evidenced at high relative flexural stress. However these fiber breakages are statistically small and hence cannot be considered predominant in terms of damage level. At high relative flexural stress (98%  $\sigma_f$ ), matrix microcracks are observed (Figs. 5, 6, 7 and 14b). In addition, locally strained zone around fiber and cohesive fiber-matrix interface debonding are also evidenced, as shown in Figs. 6 and 7.

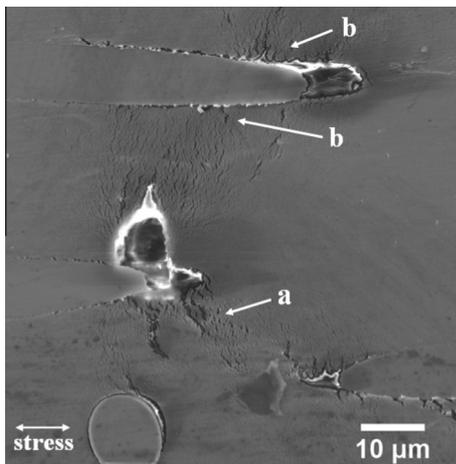
**Fig. 6.** PA66/GF30, RH = 50% specimen at 98%  $\sigma_f$ , (a) matrix microcracks and (b) locally strained zones around fiber.

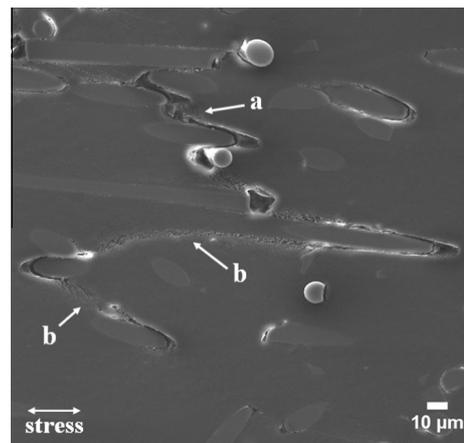
**Fig. 8.** PA66/GF30, RH = 100% specimen at 98%  $\sigma_f$ , (a) matrix microcracks and (b) matrix deformation band.

fiber-matrix interfaces accompanied with locally strained zone around the fibers are also frequently observed at high relative flexural stress (98%  $\sigma_f$ ), as shown in Figs. 8, 9 and 14c. Matrix deformation band is the zone where local matrix deformation is high. Compared to RH = 50% specimen, the RH = 100% specimen possesses significantly higher number of damaged area and higher occurrence of matrix microcracks and matrix deformation bands (Fig. 14c). The sequential images of the RH = 100% specimen from its initial state to the stress level right before the final failure which describes completely the whole chronology of damage mechanisms in RH = 100% specimen can be seen in Fig. 10.

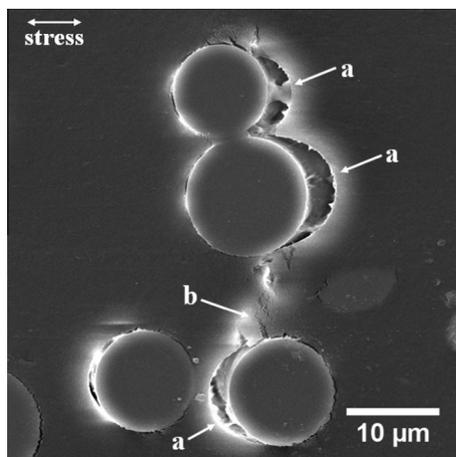
**Fig. 7.** PA66/GF30, RH = 50% specimen at 98%  $\sigma_f$ , (a) fiber-matrix interface debonding and (b) matrix microcracks.

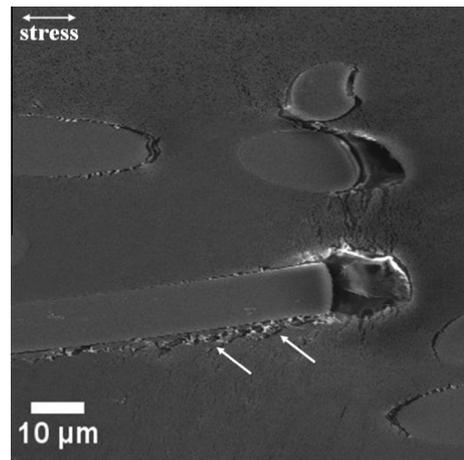
**Fig. 9.** Locally strained zone around fiber of PA66/GF30, RH = 100% specimen at 98%  $\sigma_f$  (indicated by arrow lines).

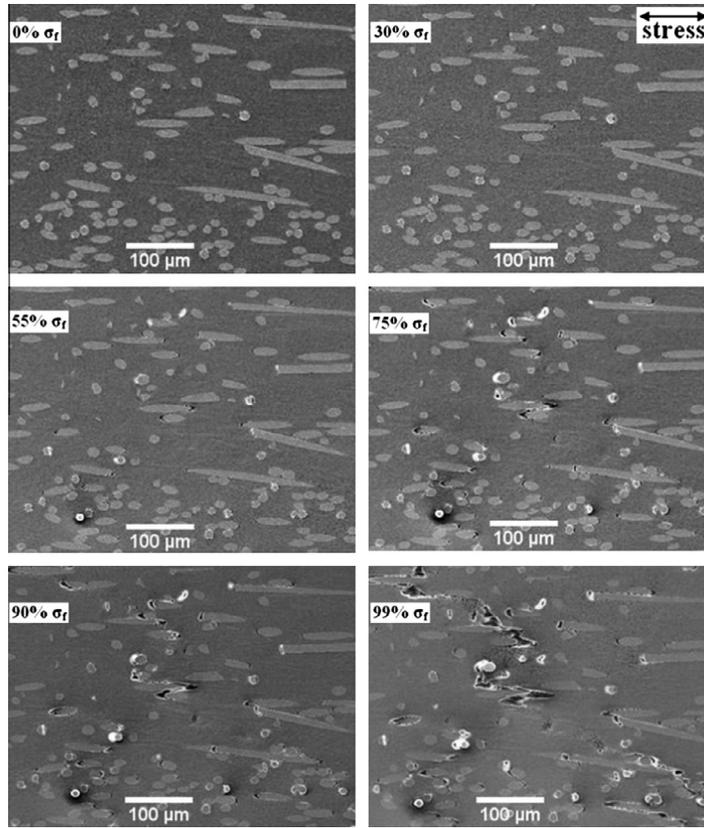
Fig. 10. SEM image sequences representing damage evolution of PA66/GF30, RH = 100% specimen from the virgin state to the stage prior to failure.

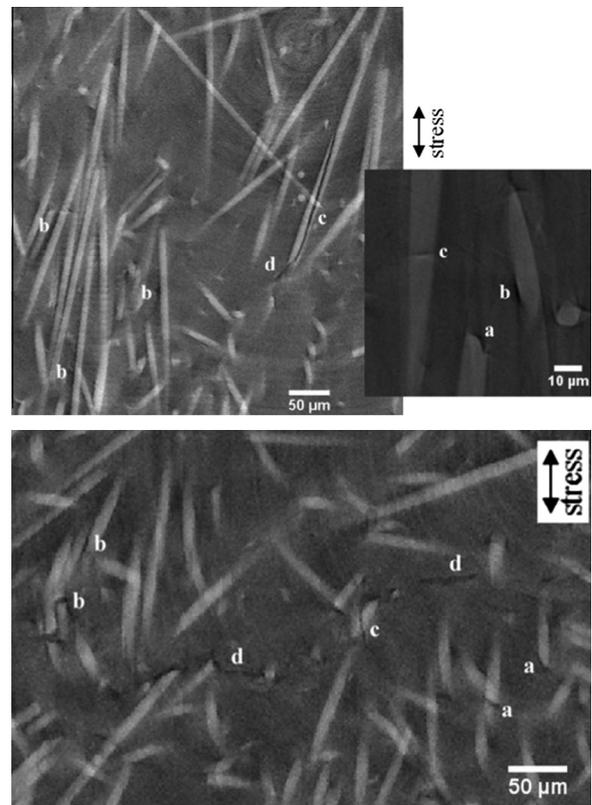
Fig. 11. Damage mechanisms observed by  $\mu$ CT in tensile specimen of PA66/GF30, RH = 0%: (a) debonding at fiber ends, (b) debonding at fiber-matrix interfaces, (c) fiber breakages and (d) matrix microcracks.

not show any noticeable damage for this non-tested sample. It confirms thus that the damage mechanisms evidenced on samples extracted from specimens loaded up to failure (Figs. 11 and 12) are induced by the applied stress. Consequently, they cannot be ascribed to a degradation induced by the injection process or to that induced by the machining during the  $\mu$ CT samples preparation.

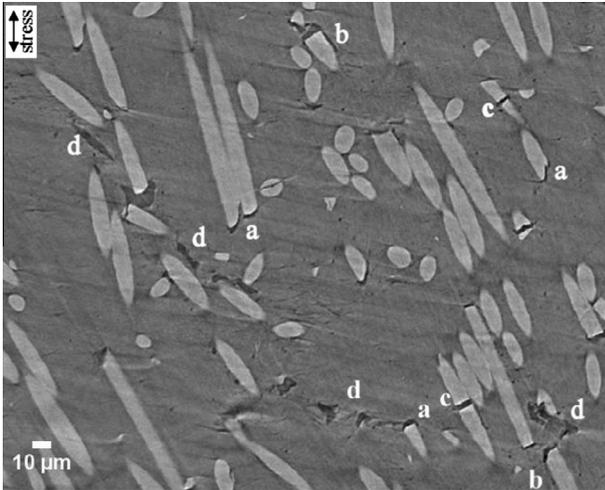
**Fig. 12.** Damage mechanisms observed by  $\mu$ CT in tensile specimen of PA66/GF30, RH = 50%: (a) debonding at fiber ends, (b) debonding at fiber-matrix interfaces, (c) fiber breakages and (d) matrix microcracks.

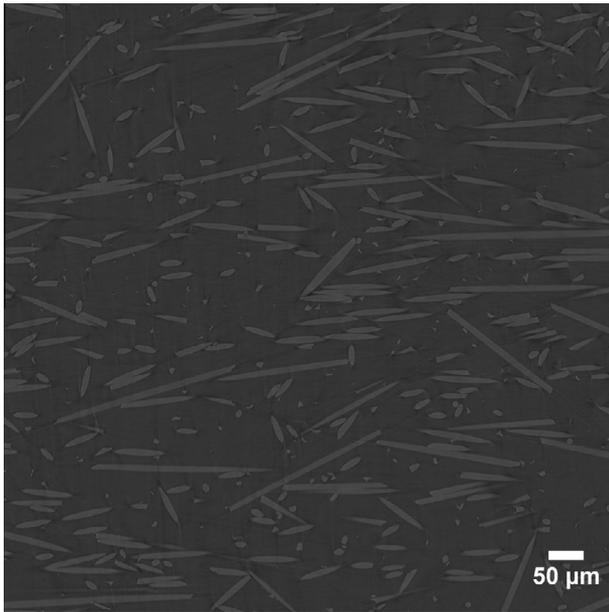
**Fig. 13.** An overview of  $\mu$ CT observation carried-out on a virgin sample (non-tested) extracted from an injected plate of PA66/GF30, RH = 0%. Noticeable damage, which can be induced by injection process or sample cutting preparation, is not observed.

For a purpose of qualitative comparison of these investigations with those on a virgin sample (non-tested),  $\mu$ CT observations have been performed on a non-tested sample extracted from an injected plate (as received). Fig. 13 performed at a resolution of 0.7  $\mu$ m does

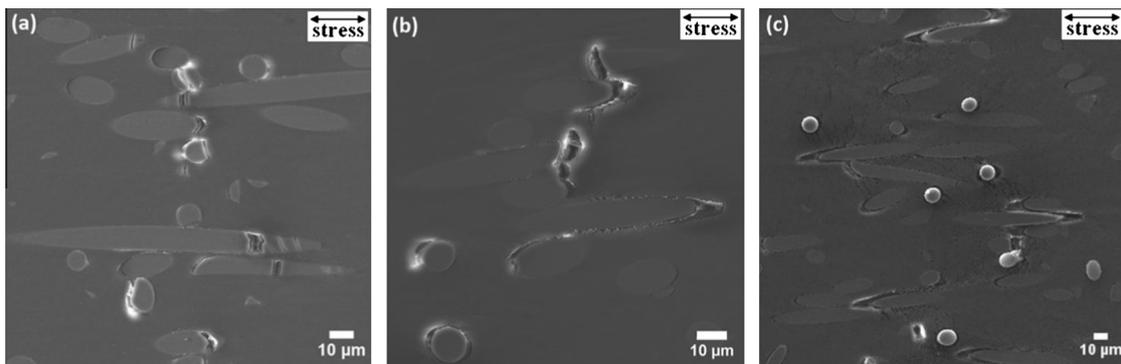
**Fig. 14.** Damage mechanisms of PA66/GF30 at different RH content, (a) fiber breakages and matrix microcracks at 95%  $\sigma_f$  of RH = 0%, (b) matrix microcracks at 98%  $\sigma_f$  of RH = 50%, (c) matrix microcracks and matrix deformation bands at 98%  $\sigma_f$  of RH = 100%.

The specimens with RH = 50% and RH = 100% exhibit many fiber-matrix interfacial decohesions, with localized strained matrix around the decohesion zones. The difference between both RH levels is the lower damage level of RH = 50% specimen than that of RH = 100% specimen (Fig. 14b and c). Matrix microcracks that preferably propagate in a ductile way are observed both in RH = 50% and 100% specimens. Matrix deformation bands, which indicate high local deformation of matrix are observed frequently in RH = 100% specimen (Figs. 8 and 14c). However, this occurrence is not dominant for RH = 50% specimen. It is noted that a high moisture induces a high plasticization effect, which could explain
