Detection and evaluation of barely visible impact damage in woven glass fabric reinforced polyamide 6.6/6 composite using ultrasonic imaging, X-ray tomography and optical profilometry

Abstract

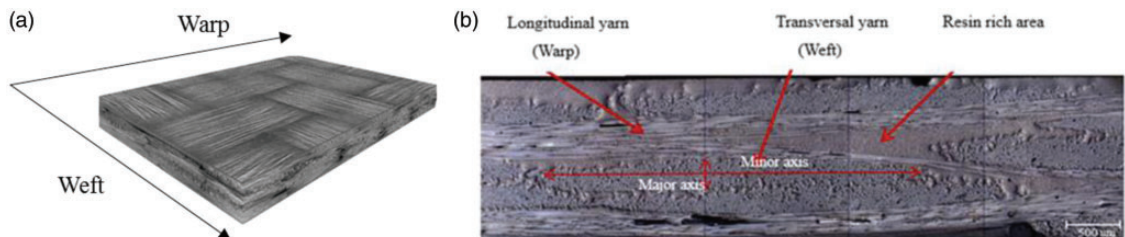
Figure 1. Mesostructure (a) and microstructure microscopic observation (b) of the woven glass fabric-PA66-6 composite showing warp and weft orientation (Pomarède et al., 2018).

The Table 1 provided by DuPont de Nemours presents the density, the Young modulus (E) and the ultimate strength (σ_{UTS}) and strain (ε_{UTS}) of the studied composite material. The microstructure and the architecture of the material reinforcement are presented in Figure 1.

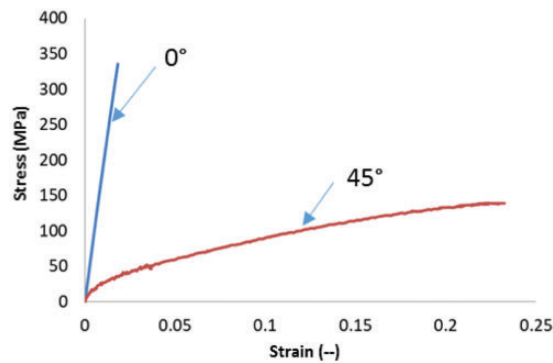
Figure 2. Typical stress-strain responses of the woven glass fabric-PA66-6 composite under tensile loading in 0° and 45° directions (Pomarède, 2018).

Pomarède (2018) studied the tensile response of the PA6.6/6 reinforced composite under two configurations 0° and 45° . It is shown that the mechanical behaviour is highly influenced by the fibres' orientation. Indeed, under tension loading, the 0° configuration behaves as a linear and brittle while at 45° configuration shows a nonlinear ductile response due to the matrix rheology. Typical stress-strain curves showing the response of the woven glass reinforced PA6.6/6 at 0° (or 90°) and that at 45° directions are given in Figure 2. The components of stiffness matrix are determined experimentally using ultrasonic bulk waves (Pomarède, 2018) and are compared with those obtained numerically using periodic homogenization (Praud, 2018) as represented in Table 2.

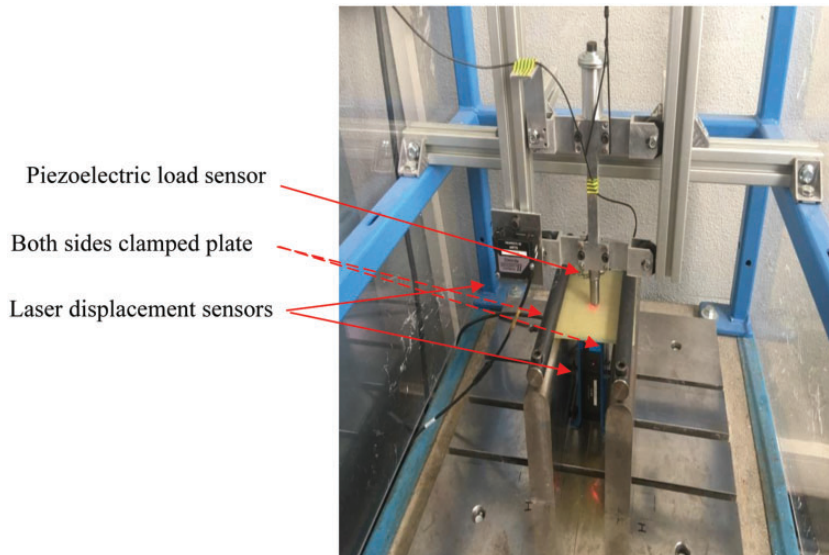
Figure 3. The experimental device used to perform drop weight impact tests showing: a piezoelectric load sensor, a first laser displacement sensor that monitors the displacement of the striker and a second one placed under the clamped sample to record the deflection.

Impact tests are performed using a drop tower equipped with a 1.02 Kg striker having a 16 mm diameter hemispherical end. The experimental device, shown in Figure 3, consists of a piezoelectric load sensor and two laser displacement sensors, as well as a data acquisition system. The plates are clamped at both ends as illustrated in Figure 3, and the impactor strikes the plates in their centre. The displacement of the sample is subsequently measured under the impacted plate using a laser displacement sensor. The acquisition of the striker's (impactor) displacement, the displacement of the centre of plate, and the contact force are measured for data analysis. The main objective of this project is to study the BVID and its detectability in rectangular cross-sections samples made of thermoplastic polymer (PA6.6/6) reinforced glass woven fabric composite. For that matter, four impact energy levels are considered by varying the drop height in such a way to remain in the BVID domain. The four impact energy levels resulting from the variation of the drop height are: 7.30 J, 13.45 J, 15.28 J, and 17.60 J.

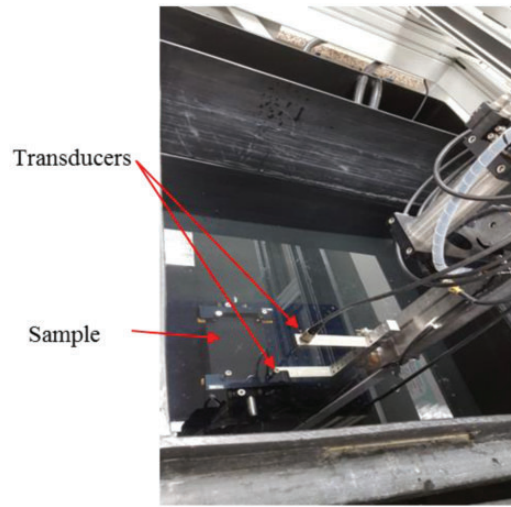
Figure 5. Transmission C-scan setup showing a clamped sample immersed in a tank filled with water and two 10 MHz transducers that scan the sample following a serpentine path.

It should be noted that in both cases, the entire measuring system (transducers and plates) is immersed in a water-filled tank (Figure 5). Unlike air, the water as a coupling fluid has the advantage for providing better ultrasound coupling.

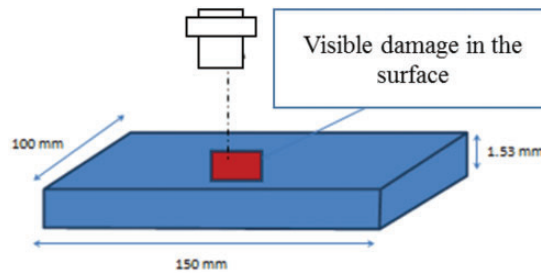
Figure 6. Pulse/echo C-scan configuration using one single 10 MHz transducer that plays the role of both the emitter and the receiver.

Reflection C-scan is performed to obtain further information concerning in-thickness damage propagation. A single focused 10 MHz piezoelectric transducer is used for this purpose. The latter emits an ultrasonic wave that is reflected when encountering defects or inhomogeneities and is later recorded and analysed. The samples are positioned in such a way that the impacted surface is facing the transducer (Figure 6). C-scan images corresponding to the scanned area are later presented.

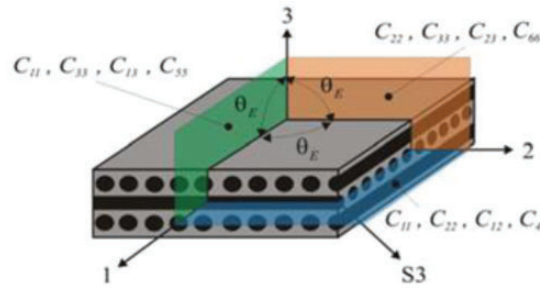
Figure 8. Schematic representation of the considered planes to perform the experimental stiffness measurements in composites (Hufenbach et al., 2006).

Due to the low thickness of the samples (1.53 mm), the ultrasonic measurements are achieved in two principle planes, namely: 1–3 and 2–3 as shown in Figure 8. These measurements lead to the computation of seven out of nine of the stiffness constants.

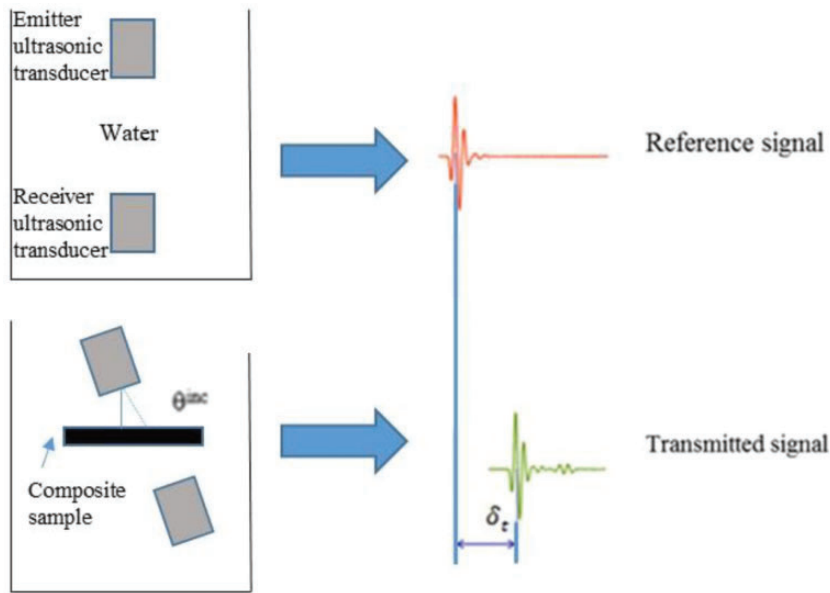
Figure 9. Illustration of the measurement of the time delay [Inspired from perso.univ-lemans.fr].

For each angle in each considered plane, the experimental velocity of the wave propagating in the sample is retrieved by estimating the time delay δ_t using the principle illustrated on Figure 9. The time delay represents the difference between the time of flight (TOF) of the ultrasonic wave in the water i.e without the sample and the TOF of the wave with the sample.

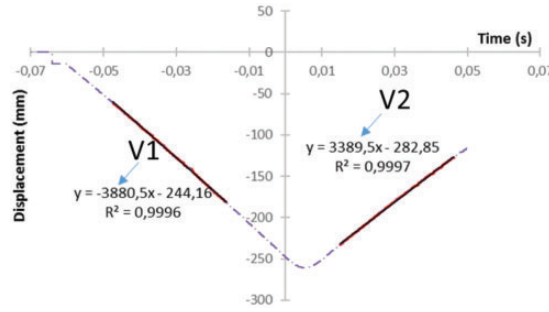
Figure 10. Impactor's displacement- time curve for the sample loaded at 7.30 J detailing the followed method to compute the absorbed energy.

v_1 and v_2 are respectively the impact and the rebound velocities. They are determined as the slopes of respectively the first part and the second part (rebound) of the displacement-time curve, as illustrated in Figure 10.

All estimated velocities correspond to the slope of the best straight line fitted through the real values, where the regression's coefficient is close to 1. Figure 10 presents an example of the sample impacted at 7.30 J where the velocities are estimated using the displacement-time curve of the impactor. The calculated impact parameters are listed in Table 3. As expected, one can notice that the absorbed energy increases with impact energy show in Figure 11(c). Indeed, damage severity and formation can be directly linked to the increase of the absorbed energy. Figure 11 presents deflection-time (a) and contact force-time (b) curves, respectively, for the four impact energy levels. On all curves (force and displacement), a noticeable shift of the amplitude between the response at 7.30 J and the response at the rest of the impact energy levels could be easily observed. Figure 11(a)

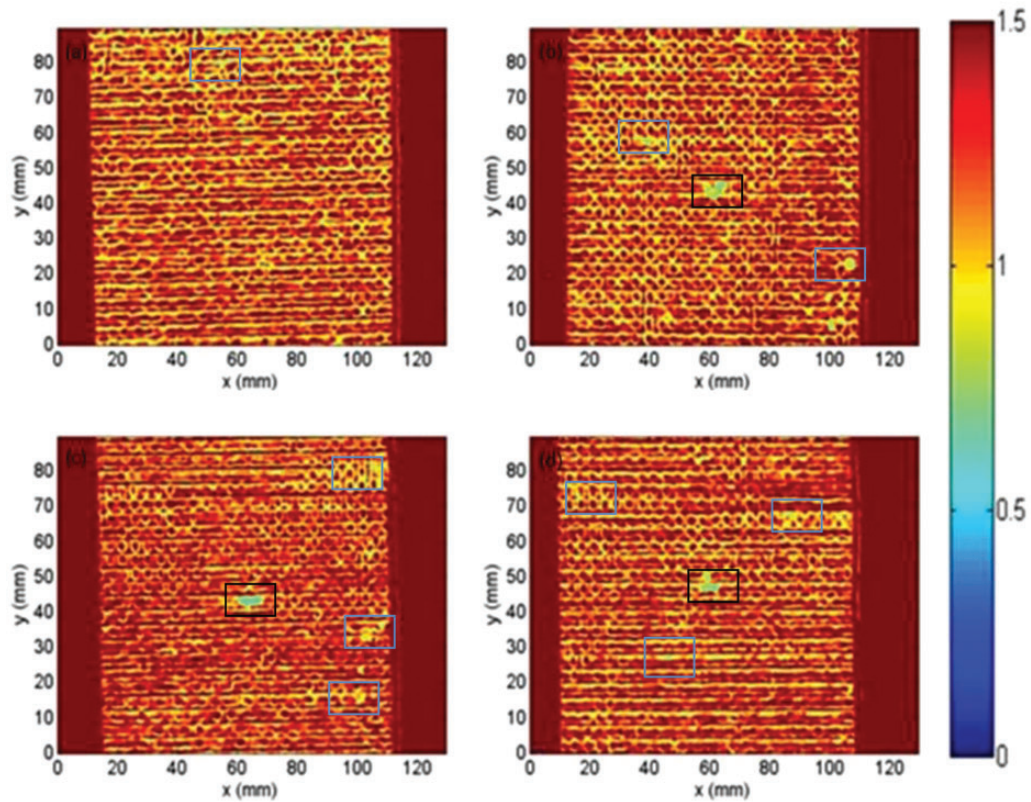
Figure 17. Transmission C-scan results for the four samples damaged respectively at: 7.30 J (a), 13.45 J (b), 15.28 J (c) and 17.60 J (d) using the 10 MHz transducers.

As specified in the Ultrasonic C-scan imaging section, two types of ultrasonic C-scan tests are carried out on the loaded samples, namely transmission and reflection tests. Results of ultrasonic C-scan are represented as cartographies of amplitude (Figures 17 and 18). The isocolor map reflected the variation of the maximal amplitude on the various areas of the scanned surface. The blue color corresponds to an attenuated signal and therefore small amplitude. These blue areas indicate the zones with high probability to contain damage, while the red areas reveal the zones where the signal amplitude reached its maximum value.

Figure 17 demonstrates the results of C-scans in transmission. Relatively small areas at the edges and inside the plates showed an attenuation that indicates a low amount of damage. It can be presumed that the latter was introduced during the cutting process or manufacturing. Thus, it is considered irrelevant and is neglected in the sequel.

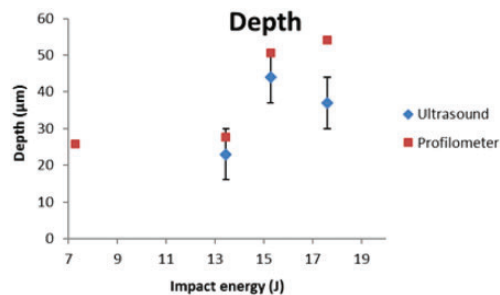
Figure 22. Comparison between the results obtained using both ultrasound-based method and profilometry for the four samples impacted respectively at energies of: 7.30, 13.45, 15.28 and 17.60J.

A comparison between the results provided by the two methods, ultrasound-based method, and optical profilometry, is established and represented in Figure 22. The comparison shows a good correlation between the two methods as well as a satisfying accuracy for the ultrasound-based method.
