# Influence of fibre orientation, moisture absorption and repairing performance on the low-velocity impact response of woven flax/Elium<sup>®</sup> thermoplastic bio-composites

## Abstract

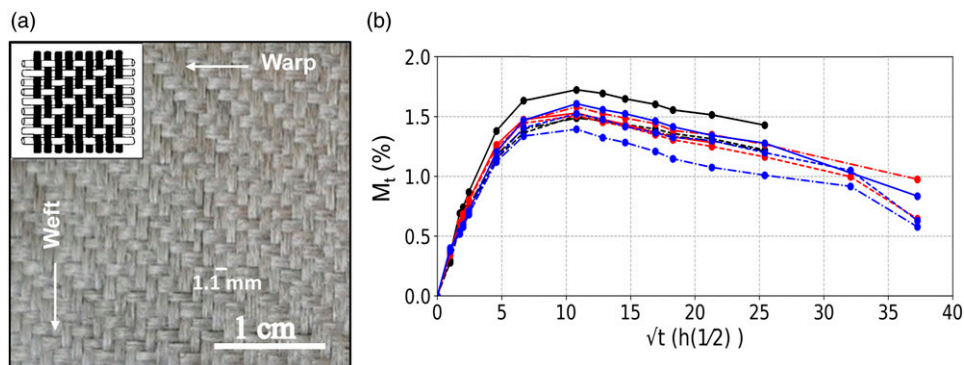
**Figure 1.** (a) Flax twill fabrics from Depestele, (b) Evolution of the mass uptake during hygrothermal ageing: black, red and blue color points represent three batches composed of three samples tested during the hygrothermal ageing.

The bio-composite used in the study composes of the thermoplastic Elium<sup>®</sup>188 resin, recently formulated by Arkema (France), and the flax 2/2 twill weave fabric (Figure 1(a)) produced and provided by Depestele company (France). The fabric weight is 360 g/cm<sup>2</sup>. The physical and mechanical properties of the studied bio-composite, as also its constituents are given in Table 1.

follow a complete evolution of the mass uptake (Figure 1(b)). However, only the samples with maximum moisture uptake were considered for the impact tests and referenced as 75%RH\_090. The choice of that woven fibre stacking orientation is motivated by its supposed better impact resistance (higher contact stiffness) than in the case of (±45)<sub>6</sub> one, and therefore, the influence of material properties (moisture uptake of flax fibres) on its impact performance.

Results of hygrothermal condition show that the maximum moisture uptake (1.57±0.17%) is reached after around 10 h<sup>1/2</sup>, followed by its decreasing, which means the bio-composite is losing mass probably due to a hydrolysis process (Figure 1(b)).

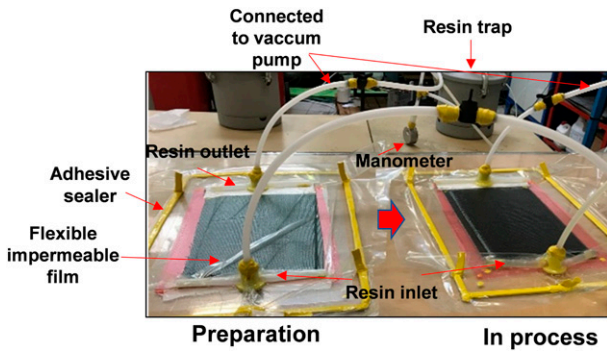
**Figure 2.** Preparation of the components and infusion process.

**Liquid resin infusion.** Composite plates of dimensions 1000 × 750 mm<sup>2</sup> and a thickness in the range of 4.5–4.8 mm were manufactured using the Liquid Resin Infusion (LRI) process by CMP company (France) under a vacuum pressure of −0.95 bar (−95 kPa) at room temperature. The process consists of preparing first the glass mold with a release agent, then depositing of dry fibres with the desired stacking sequence, followed by a peel ply as well as an infusion complex composed of a micro-perforated film and an infusion mesh to facilitate the resin migration. Finally, an impermeable film was attached to the mold with an adhesive sealer. This vacuum bag contains a resin inlet initially closed and an outlet connected to the vacuum pump. The resin has been degassed

before infusion for better specimen quality. The summary view of this process is shown in Figure 2.

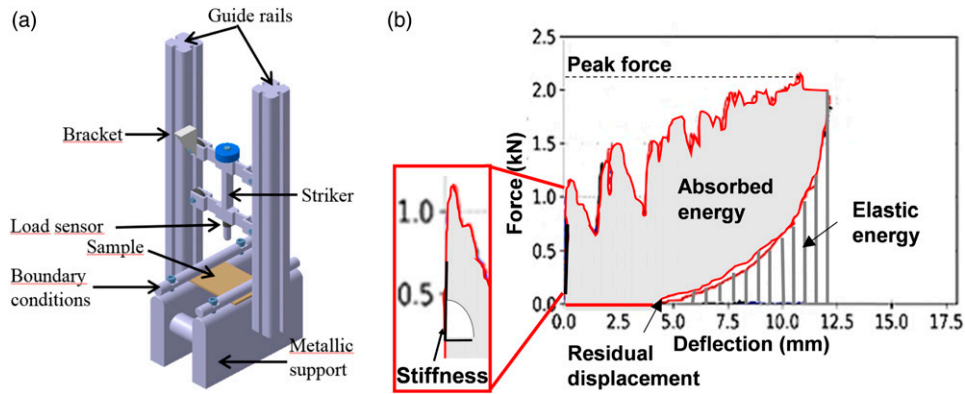
Figure 3. (a) Drop weight tower; (b) Schematic view of the definition of impact energy.

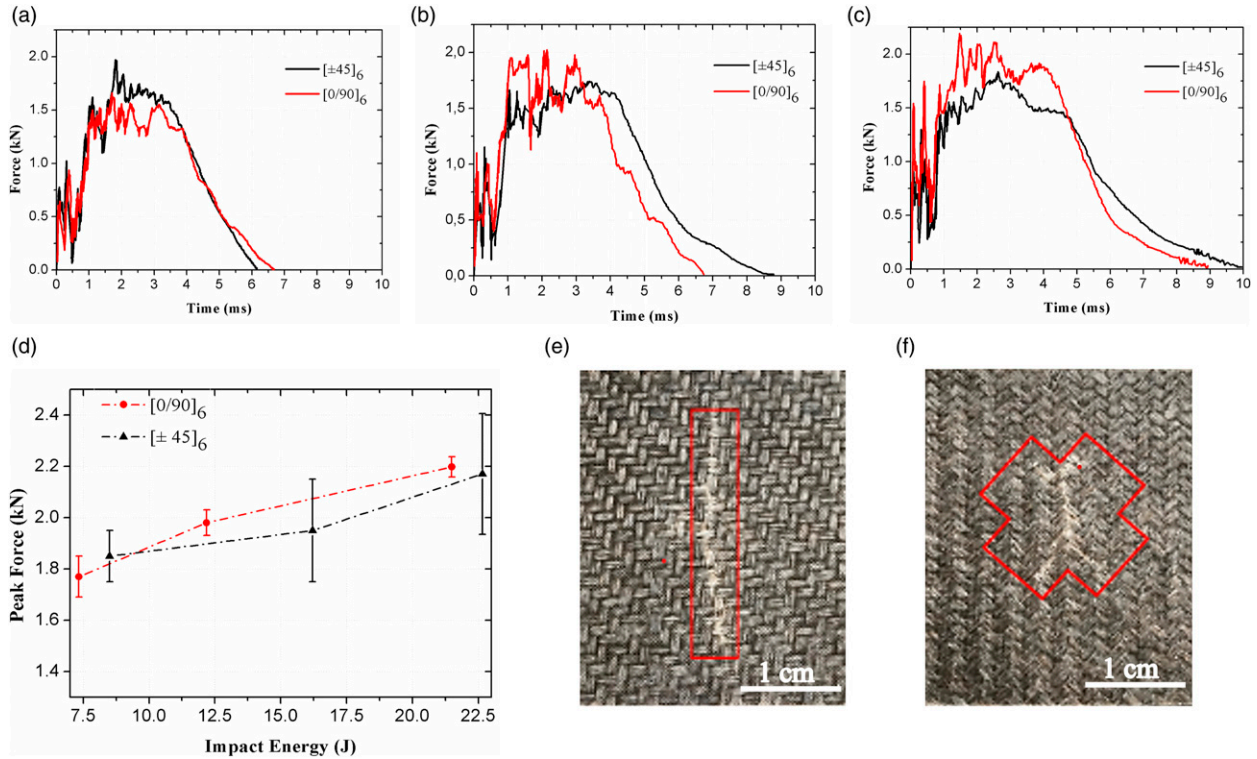
**Figure 4.** Load versus impact time for around: (a) 7 J, (b) 12 J, (c) 22J, (d) Peak force evolution versus impact energy. Back face of damaged flax/Elium<sup>®</sup> bio-composites impacted at 12 (j) (e)  $(0/90)_6$  (f)  $(\pm 45)_6$ .

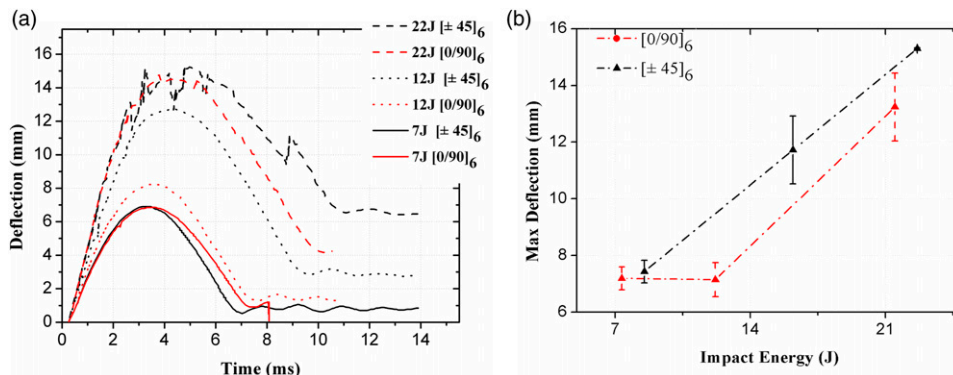
**Figure 5.** (a) Deflection versus impact time for around 7 J, 12 J and 22J, (b) max deflection evolution versus impact energy for  $(0/90)_6$  and  $(\pm 45)_6$  orientations.

sample, are given in Figure 5. Note that the fluctuations on the curves at 22 J corresponding to  $(\pm 45)_6$  orientation are due to noticeable local damage induced on the back surface (see Figure 8(h)). Figure 5 shows the temporal evolution of deflection that is not symmetrical. The curve does not return to zero when the impactor leaves the sample and subsequently when the contact force is canceled.

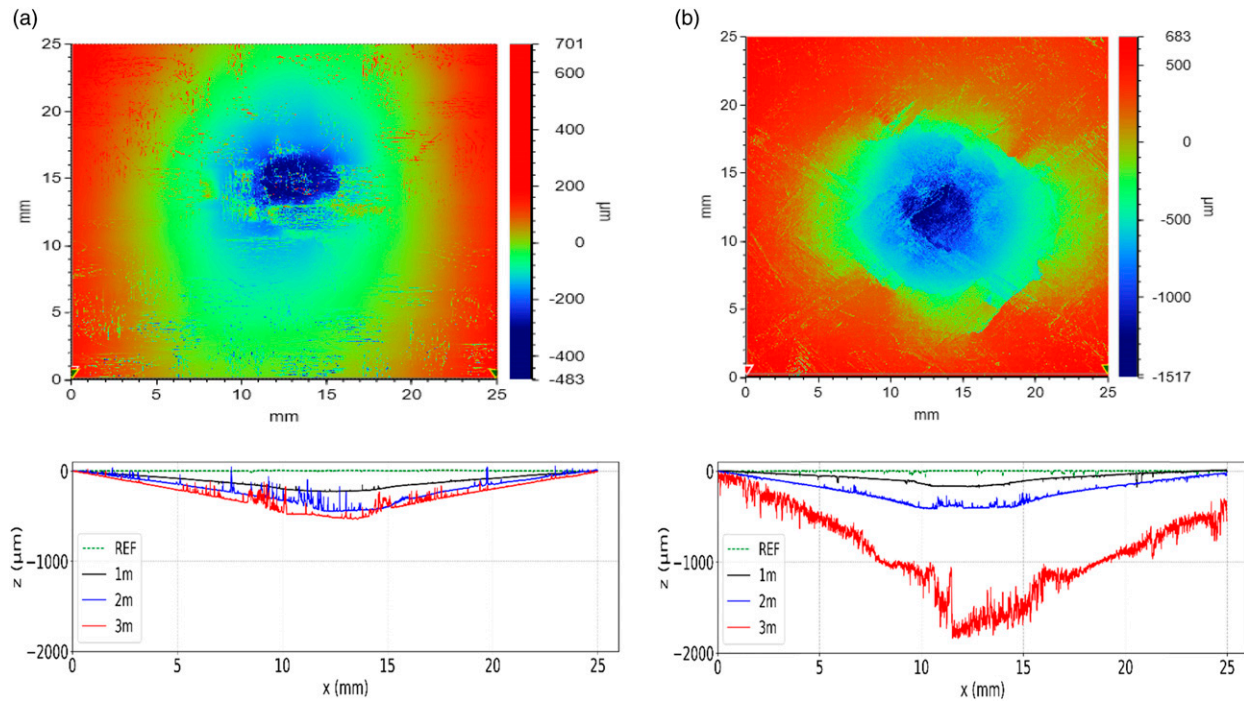
**Figure 6.** Profilometry scans of surface and indentation depth in the area of  $25 \times 25 \text{ mm}^2$ : (a)  $(0/90)_6$ , (b)  $(\pm 45)_6$ . The scans represent samples impacted at 22J.

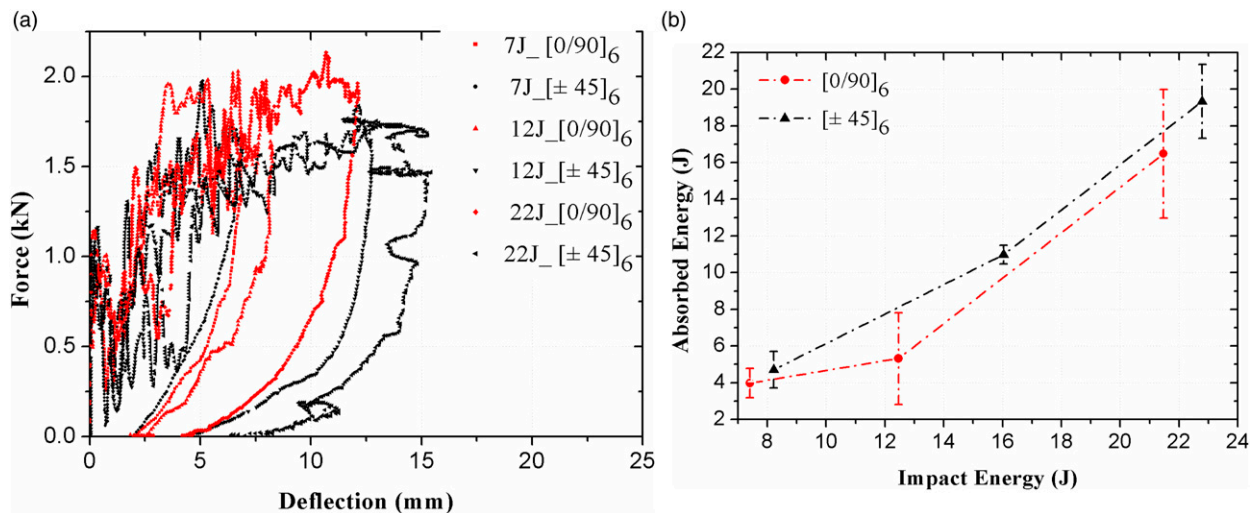
**Figure 7.** (a) Force vs deflection during impact at 7 J, 12 J and 22 J, (b) absorbed energy comparison.

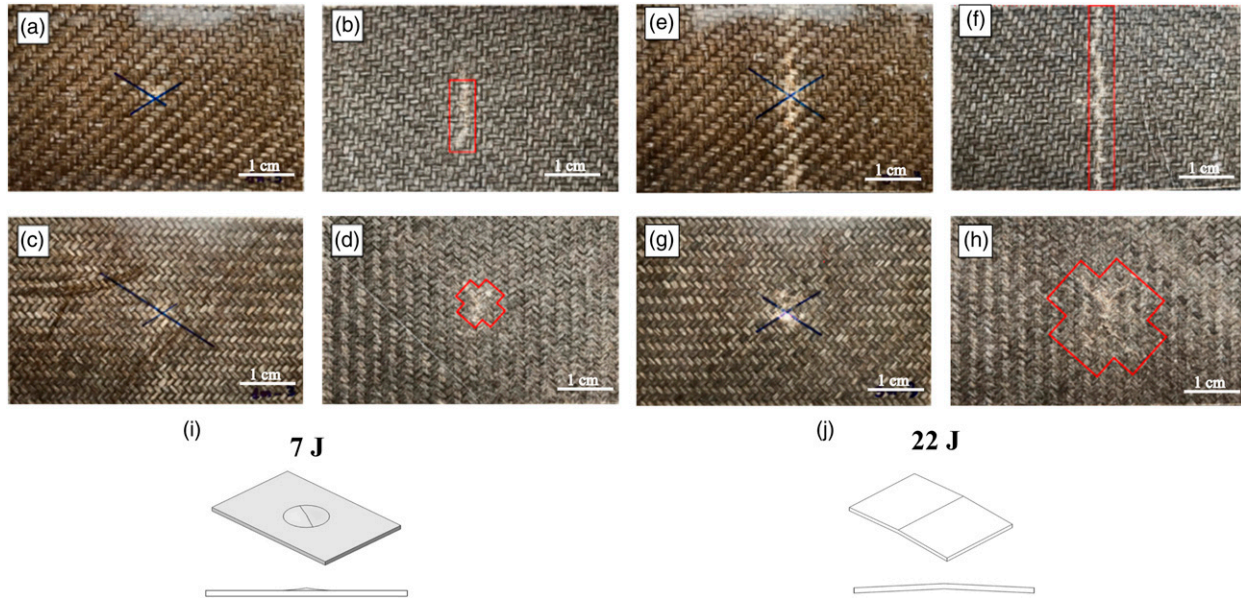
**Figure 8.** Visual damage evolution after impact from 7 to 22J: (a), (b), (e), (f) -  $(0/90)_6$ , (c), (d), (g), (h) -  $(\pm 45)_6$ . Left view – top surface and Right view – back surface. Schema of damage observed for (i)  $(\pm 45)_6$  and (j)  $(0/90)_6$ .

**Visual observations.** The post-impact visual observations reveal an indentation mode on the front face due to the compression under impact, and its depth increases with applied impact energy (Figure 8). The orientation of the fibre stacking also affects the shape of damage. For the (±45)<sub>6</sub> samples, the impacted front face shows deeper indentation than for the (0/90)<sub>6</sub> one at an impact energy of 22 J (Figure 8(g) and (h)). The back face of that (±45)<sub>6</sub> sample exhibits an ‘X’ pattern damage represented by the shear failure mode where either matrix crack, fibre/matrix debonding, or fibre breakage propagates along the fibre direction orientated at 45° to the bending axis. It is clear that damage (transition from matrix cracking to fibre breakage) extends with increasing impact energy (Figure 8(d)–(h)). The latter is observed locally and affects only the area near the impact, which is also increased with applied impact energy. As for the (0/90)<sub>6</sub>

samples, a macro-crack is propagated widthwise and is consequently parallel to the direction of the clamping system. The size of the cracking increases with the applied energy level, going from 25 to 45 mm and finally to 95 mm, approaching the width of the plate. At least, Figure 8(i) and (j) summarizes the damage evolution for both considered bio-composites.

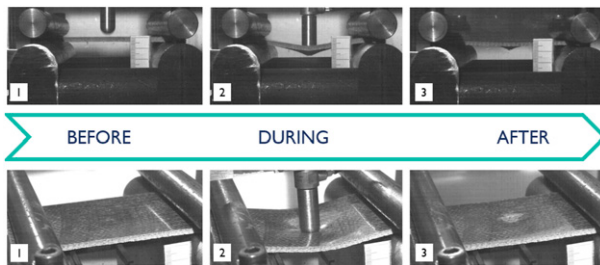
**Figure 9.** Impact test with high-speed camera: images of deflection evolution captured under two visual angles for the  $(\pm 45)_6$  flax/Elium<sup>®</sup> composite.

**High-speed image observations.** To complete the previous visual observations and better understand the evolution of plate deflection and damage as a function of impact duration, the high-speed camera was used. The overall mechanism is the following: when the impactor touches the surface of the plate, it first compresses locally the bio-composite that corresponds to moreover, the first peak on the force-time curves (Figure 4(a)–(c)). Therefore, the indentation occurs right at the impact point and forms the crater more or less deeper, depending on the local stiffness of the material, the impact energy, etc. Then, once the maximum local compression has been reached, the plate deforms globally, at which the macroscopic cracks appear (Figure 9).

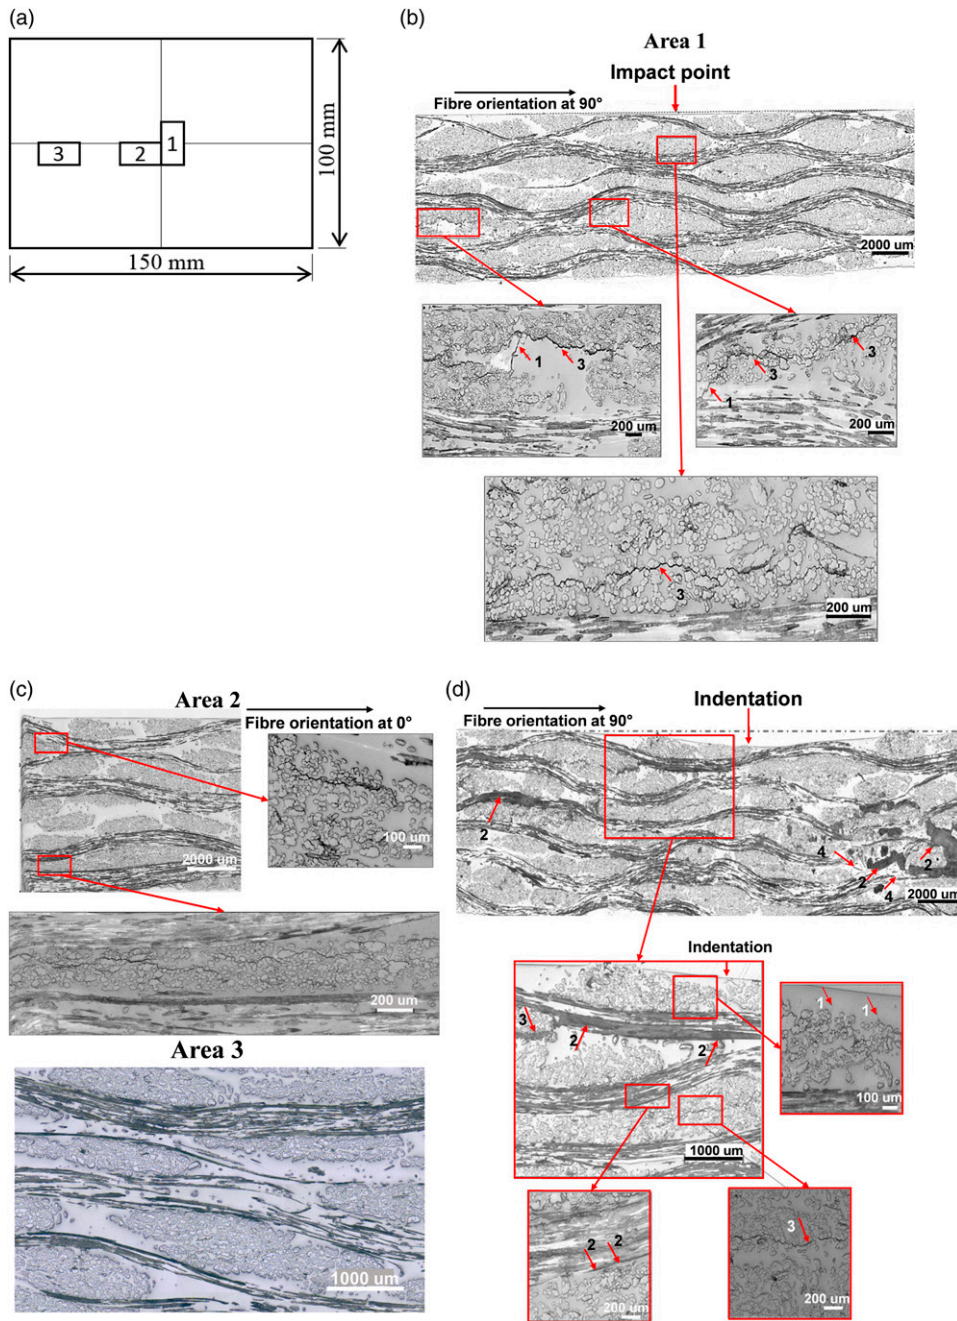
**Figure 10.** (a) Areas of the plate cut for observation by optical microscope. Microscopic observations of the damages induced by impact at (b) 7J and (d) 22J in the area 1; (c) 22J in the area two and 3. (1) matrix crack propagation, (2) delamination, (3) fibre/matrix debonding; (4) fibre breakage.

**Optical microscopic observations.** Three different sections of several samples were cut to investigate the damage. The cutting plan is available in Figure 10(a). Area one is the section close to the impact point and parallel to the rod used to clamp the sample (also corresponding to the axis of sample width). Area two is the section perpendicular to the latter and runs along the axis of sample length. Area three is the region far from the impact zone to assume some or no damage due to the impact. As mentioned above, the dry  $(0/90)_6$  woven flax/Elium<sup>®</sup> composite demonstrated better impact performance. It is

interesting now to examine in detail its damage progression after impact and determine if it follows the typical conical damage pattern with delamination that is usually observed in unidirectional  $0/90^\circ$  composite laminates.<sup>53</sup> An overview of a cross-section of the observed samples highlights the presence of indentation left by the impactor. The impact indentation is naturally deeper as the impact energy increases by confirming the previous visual observations. The observed damage mechanisms appear mainly in the impacted region of the sample, as area one at 7J and 22J (Figure 10(b) and (d)). The principal damage mechanisms identified for this area are mainly fibre/matrix debonding. Matrix cracking in the form of shear/bending failure was also observed, as well as some delamination due to the stiffness difference of adjacent yarns/layers (mainly developed at  $0/90^\circ$  interfaces), and fibre breakage (due to locally high stresses and indentation effects) with increasing of impact energy. For the energies below 22J, the delamination was few presented (Figure 10(b)). This is due to the resistance to delamination of woven-reinforced composites.<sup>16,41,42</sup> As for the microscopic observations of area two of the  $(0/90)_6$  samples, the indentation point was not visible. The principal damage mechanism for this area is also some fibre/matrix debonding (Figure 10(c)). This could be explained by the fact that  $[0/90]_6$  samples are damaged in a V-shape and the linear crack propagation is only visible on its widthwise corresponded to the area 1.

In addition, no damage was observed in area 3, which was far from the impacted region (Figure 10(c)). This

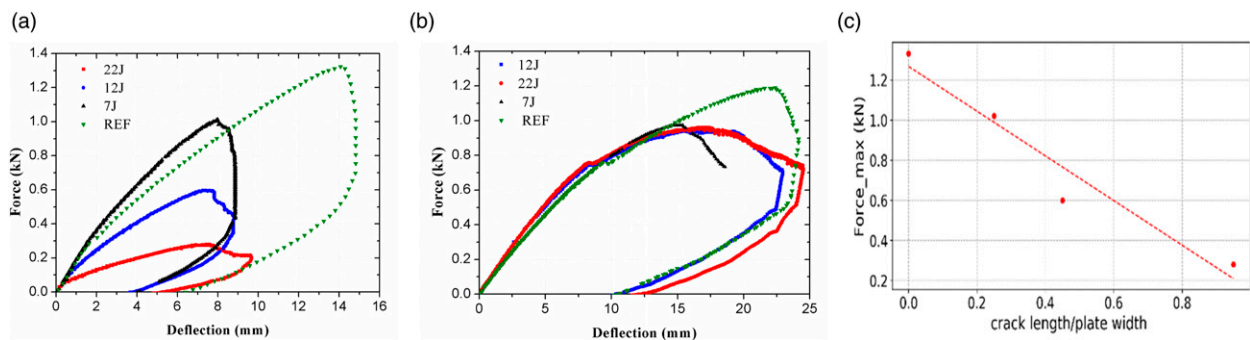
**Figure 11.** Residual performances after impact for dry (a)  $(0/90)_6$  and (b)  $(\pm 45)_6$  flax/Elium<sup>®</sup> composites; (c) Relation between the residual maximum bending force vs crack length/plate.

the maximum force (for the same considered volume) evolution of the impacted dry  $(0/90)_6$  and  $(\pm 45)_6$  flax/Elium<sup>®</sup> composites was compared to non-impacted ones considered as the reference. Figure 11 shows the results obtained for both bio-composites. It can be noted that the  $(0/90)_6$  orientation has a greater sensitivity to the bending loading than the  $(\pm 45)_6$  one compared to the reference and between them. Figure 11(a) shows the strong decrease of

residual stiffness and maximum force versus impact damage at 7J–22J for that orientation. Its residual stiffness was 67% and 47% lower regarding the reference and  $(\pm 45)_6$  orientation respectively subjected to impact energy of 22J. This is expected because the macro-crack observed after impact growths in the widthwise direction of the plate. A linear relation seems to exist between the residual maximum bending force and crack length vs plate width (Figure 11(c)). By contrast, the  $(\pm 45)_6$  orientation has a similar residual bending behaviour for whatever the impact energy applied. Their residual maximum bending force is about 20% lower than that of the reference (Figure 11(b)). This is probably due to the pattern of the damage because the cracks are diagonally oriented to the bending loading which impact is less evident on the residual bending properties. Better residual tougher behaviour of  $(\pm 45)_6$  orientation than the  $(0/90)_6$  one was also highlighted in the literature.<sup>41,42</sup>

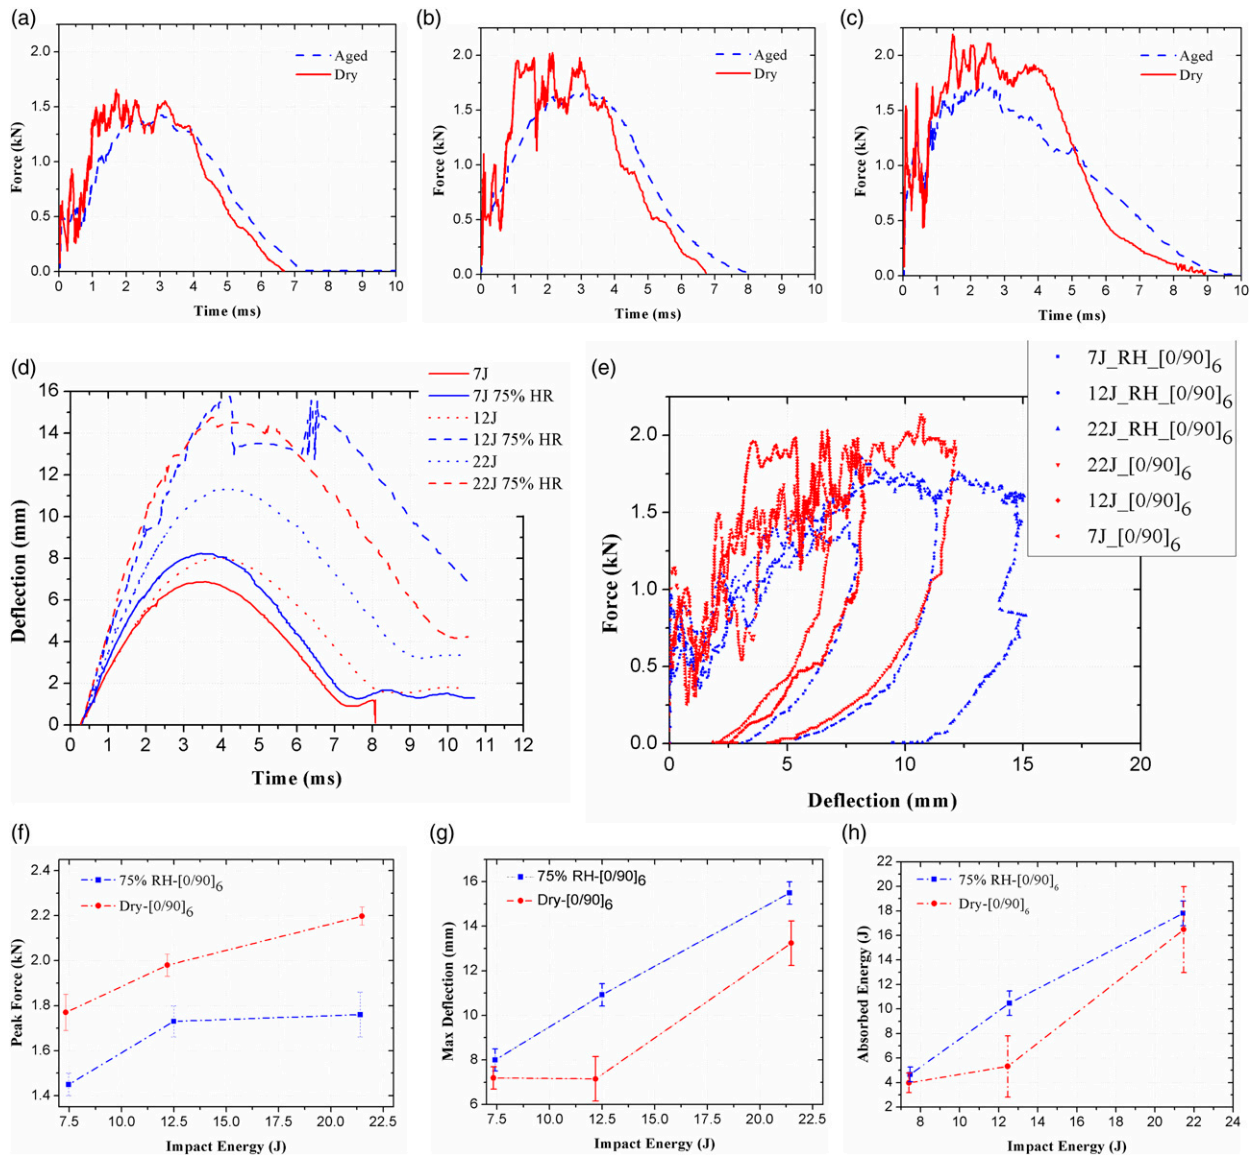
**Figure 12.** Load versus impact time for around: (a) 7J, (b) 12J, (c) 22J; (d) Deflection versus impact time for around 7J, 12J and 22J; (e) Force vs deflection during impact at 7J, 12J and 22J; (f) Peak force evolution versus impact energy; (g) max deflection evolution versus impact energy; (h) absorbed energy comparison of dry and 75%RH (0/90)<sub>6</sub> orientation.

Figure 12 presents the results of the hygrothermal ageing on the impact properties of the  $(0/90)_6$  woven flax/Elium<sup>®</sup> composite. The force curves of aged samples show a similar overall response, but are smoother than the unaged ones (Figure 12(a)–(c)). It may indicate a softening (reduction in the stiffness) of the sample due to ageing. Decrease of 10, 15, and 20% in the maximum impact load have been observed at 7J, 12J, and 22J impact energies for the aged samples.

The influence of hygrothermal ageing on the permanent and maximum deflection behaviour of the current bio-composite has also been studied with respect to the evolution of impact energies applied (Figure 12(d)). The maximum deflection of aged samples increases by 7%, 34.5%, and 14% at 7J, 12J, and 22J impact energies respectively while the difference in permanent deflection between aged and dry samples is higher 28%, 54%, and 43% respectively (see Table 3). It could be explained by

The force vs deflection curve analysis shows better impact resistance of the unaged bio-composite, as already noted for contact force and deflection (Figure 12(e)). A reduction of 40% of the threshold is observed for the aged samples in the same stacking direction (Figure 12(f)). The absorbed energy of the aged samples increases due to the damage accumulation and the plasticization effect of the composite material.

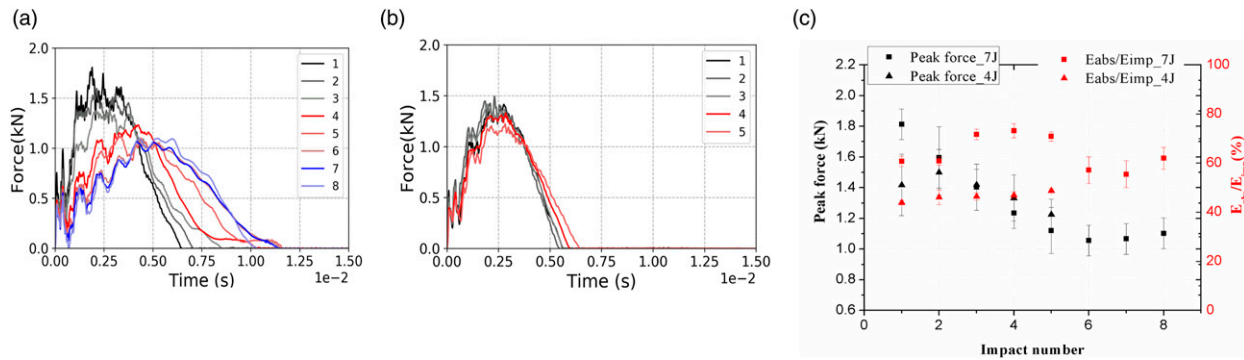
**Figure 13.** Impact force vs time duration for the multiple impact/repair cycles on  $(0/90)_6$  flax/Elium<sup>®</sup> samples conducted at (a) 7J and (b) 4J; (c) Ratio  $E_{abs}/E_{imp}$  and peak force vs the number of impact/repair cycles.

points 1 and 2 to verify residual impact performance. Figure 13(a) shows the load-time curves carried out at 7J of impact energy and correspond to eight impact/repair cycles. The repeated impact events are frequent in the marine and aerospace structures.<sup>41</sup> So, the understanding of their behaviour after repair is primordial. As it could be observed, the maximum impact force (peak force) decreases by about 60%, wherever the contact duration increases by 73% from the 1<sup>st</sup> to the 8<sup>th</sup> cycle respectively. It confirms the fact that the impact properties of the plate evolve with each impact/repair cycle applied because of the fibres broken from the first cycle, which strongly

affects the resistance to bending. However, it is possible to see that even with fibre breakage the properties do not change much between two successive curves (Figure 13(a)). Figure 13(b) presents the results of the second (4J) impact energy configuration. Contrary what was observed, the maximum impact force begins to decrease at the 4<sup>th</sup> impact/repair cycle to reach about 14% of its loss at the 5<sup>th</sup> cycle. A similar trend was observed for the contact time duration: it increases only by 17% against 73% shown previously. This difference is probably due to the breakage of fibres at an impact energy of 7J, which is irreversible. The results show the great potential of flax/Elium<sup>®</sup> composite to its repair aptitude. Figure 13(c) compare the peak force and the ratio  $E_{abs}/E_{imp}$  evolution versus the impact number for both considered impact energies. It confirms the trend of impact peak force evolution observed in Figures 13a and 13(b). In addition, the absorbed energy evolution increases linearly at 4J impact energy and up to 4<sup>th</sup> cycle at 7J. Note that slope of 4J impact energy is 78% lower than at 7J one due to few damage accumulation at that energy. In contrast, the ratio of  $E_{abs}/E_{imp}$  at 7J tends to decrease from 4<sup>th</sup> to 6<sup>th</sup> cycle followed by slight increasing for the second time. As the fibre was broken after the first impact, the extend damage continues to progress even after repair cycle up to intensify the maximum of fibre breakage density (associated to decrease of  $E_{abs}/E_{imp}$  at 4<sup>th</sup> – 6<sup>th</sup> cycles) and tend to reach the perforation damage (the trend of second increase of  $E_{abs}/E_{imp}$ ) (Figure 13(b)). Additional studies through X-CT tomography analysis are necessary to understand further the effect of multi-impact/repair cycles on the material behaviour of composites.
