Bastien EHRHART, Romain ECAULT, Fabienne TOUCHARD, Michel BOUSTIE, Laurent BERTHE, Clemens BOCKENHEIMER, Bernd VALESKE - Development of a laser shock adhesion test for the assessment of weak adhesive bonded CFRP structures - International Journal of Adhesion and Adhesives - Vol. 52, p.57-65 - 2014

Development of a laser shock adhesion test for the assessment of weak adhesive bonded CFRP structures

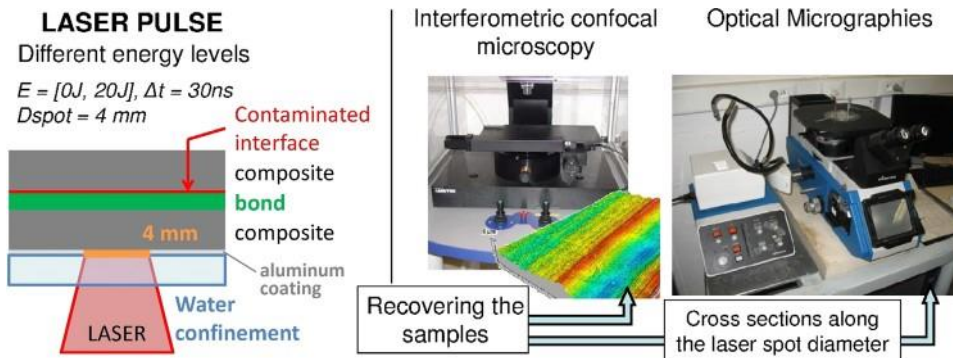
Fig. 3. Sketches of the laser shock experimental configuration and of the followed experimental procedure to test and analyze the bonded composites.

confinement configuration in order to increase the pressure level. A sketch of the experimental configuration is given in Fig. 3. A Nd:YAG laser (1053 nm wavelength) whose energy is tunable in the range [0–20 J] was used. Optical densities were used to change the laser energy sent on target and so, the laser intensity. The source pulse duration is about 30 ns, which leads to an induced pressure pulse about 60 ns because of the water confinement as shown by the work of R. Fabbro [34]. The laser parameters measured for each tested sample are presented in Table 3 with the associated uncertainties. After the shock, the samples are analyzed with two different setups as shown in Fig. 3. Interferometric Confocal Microscopy (ICM) on the sample back face was used to quantify the out-of-plane back face residual deformation such as height variations (topography). Optical micrographs of sample cross sections were also performed to observe the inside damage resulting from the laser shock wave propagation.

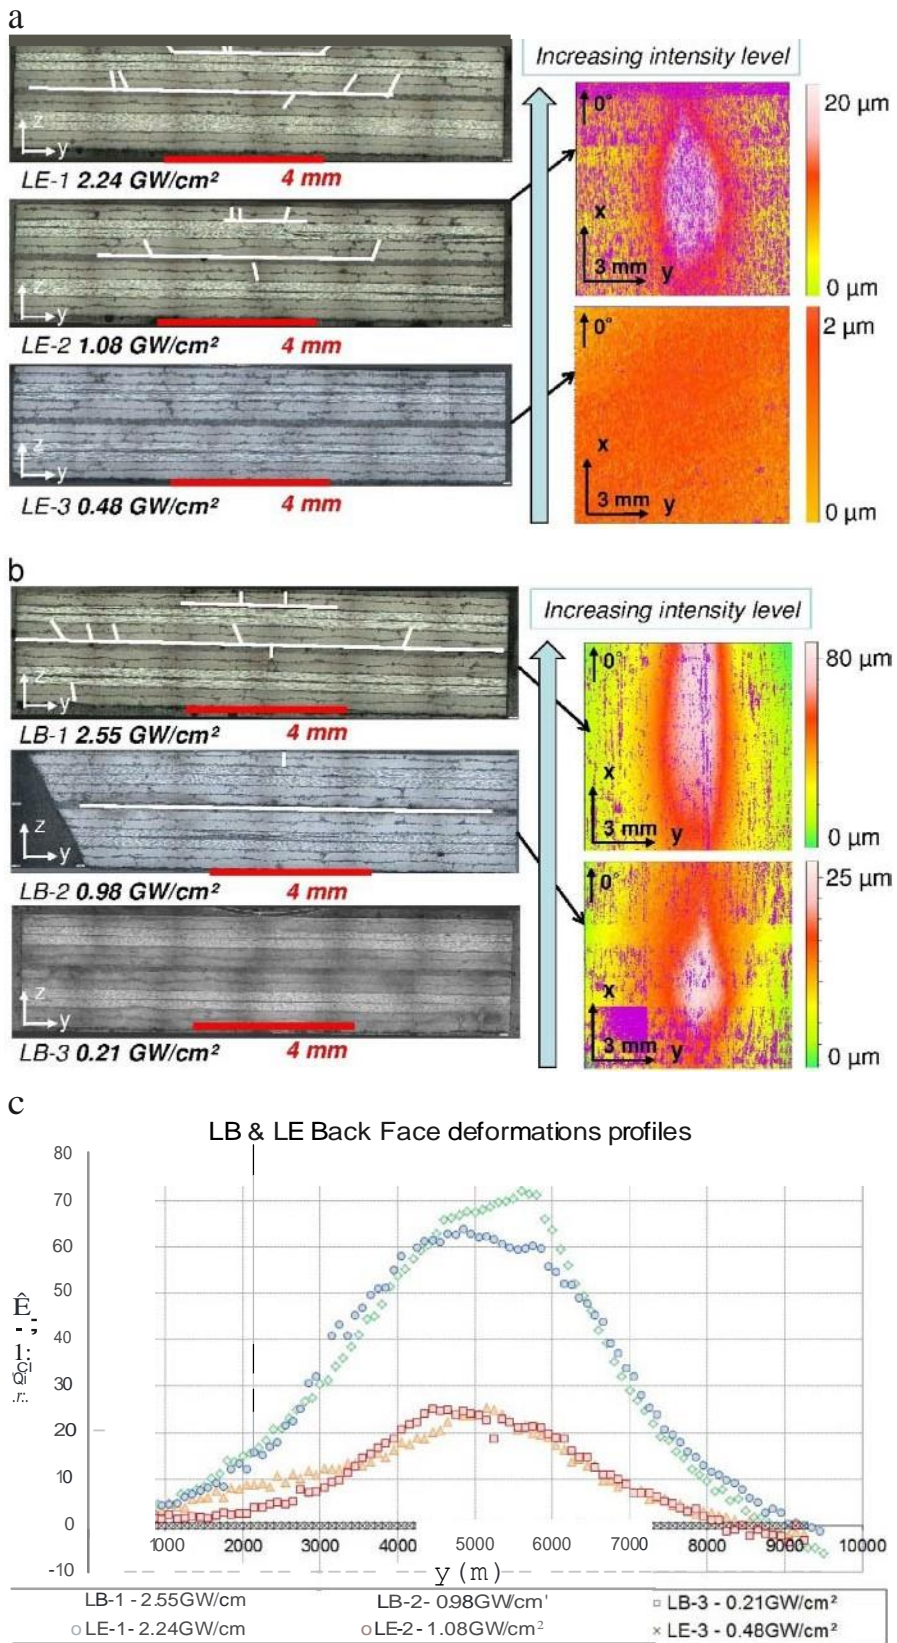
Fig. 5. Characterization of the damage extent into the bonded composite by microographies and JCM 111 case of (a) LE series, (b) LB series, (c) comparison between the back face residual deformations measured by JCM 111 case of LE and LB series for three different Laser Intensities.

Results obtained in case of LE contamination series are presented in Fig. 5a, in which three micrographies and two of the corresponding ICM measurements are presented. A correlation between the laser intensity and the inside damage extent is observed (see in Fig. 5a). In the cross section observations, a gradation in the level of damage can be seen from the lowest intensity level to the highest. Indeed, the lowest laser shock (LE-3) did not lead to any observable damage inside the bonded composite. Samples LE-2 and LE-1 analyses show respectively more and more cracks, as well as more sizeable delamination in the back face composite, and more sizeable debonding. The residual back face deformation measurements obtained by ICM also agree with this trend. As it is shown in Fig. 5a, the lowest shock did not modify the LE-3 sample back face, which is consistent with the absence of delamination. In case of LE-2 sample, a small blister can be observed, corresponding to the inside delamination revealed by the micrography observation. Case of sample LE-2 is interesting. Indeed, the composite part of the assembly remained almost unharmed after the laser shock wave propagation (small residual deformation and delamination). This is probably due to the fact

that the used laser intensity ($\sim 1 \text{ GW/cm}^2$) was low enough for the induced tensile stresses to be close to the damage threshold of the CFRP composite, meanwhile being high enough to open the bond line of the sample, whose damage threshold was even lower according to these observations. From results presented in Fig. 5a, it can be concluded that in these experimental conditions the debonding threshold of the LE series is between 0.48 GW/cm^2 and 1.08 GW/cm^2 and that its composite damage threshold is in the same range, but probably closer to 1.08 GW/cm^2 .

The results obtained in case of LB contamination series are presented in Fig. 5b, and agree with the observations made in case of samples LE. The correlation between the laser intensity and the damage extent has also been evidenced in the case of the LB contamination series. ICM measurement and micrographies are still consistent (see samples LB-1 and LB-2 in Fig. 5b). The results obtained in case of LB samples are really similar from the ones coming from LE samples. According to the results presented in Fig. 5b, the LB series debonding threshold is in the range $[0.21\text{--}0.98 \text{ GW/cm}^2]$ which is really close to what has been observed on LE samples. This could be explained by the small difference on the adherence level induced by the contamination. Indeed, even if the contamination process is very different from LB to LE samples, their consequences on the adhesion level have been identified by the GIC testing to be close to each other (see GIC test in Fig. 1b). Considering the uncertainties on the contamination process as well as the uncertainties on the produced laser shock, it would be difficult so far to distinguish these two contamination levels. With regards to the composite damage, the out-of-plane deformation (about $25 \mu\text{m}$ high) observed by ICM on the LB-2 sample back face shows that the composite damage threshold is again closer to 1 GW/cm^2 . The contaminations in case of both LE and LB series have no reason to affect the composite part of the assembly, which can explain the similarity between the two composite delamination thresholds. The composite being the same, it is logical that the induced laser shock damage is also the same for a given intensity in the different samples.

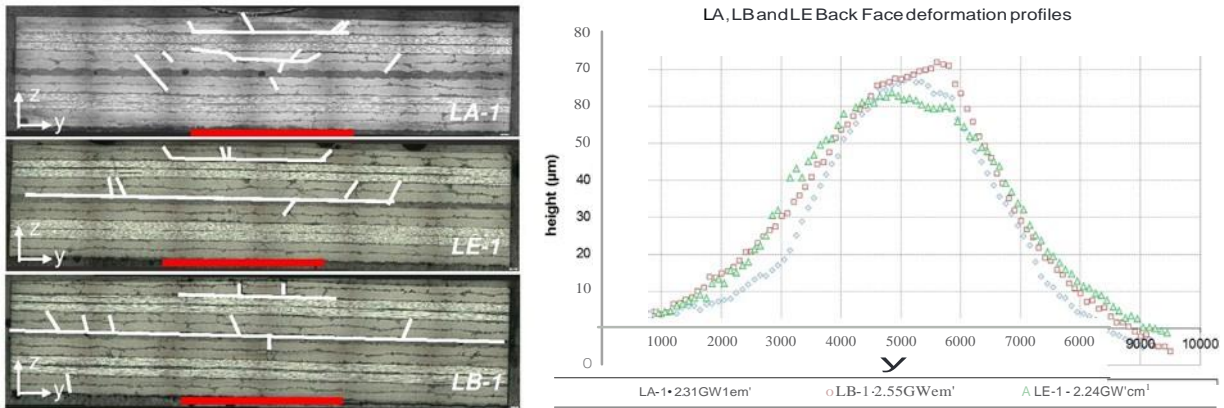
Fig. 7. Comparison between a correctly bonded assembly (LA) and two weak bond samples (LB and LE) by use of cross section observations and ICM measurements.
