Sana CHAABANI, Pedro José ARRAZOLA, Aitor MADARIAGA, Albert TIDU, Guénaël GERMAIN, Yessine AYED - Comparison between cryogenic coolants effect on tool wear and surface integrity in finishing turning of Inconel 718 - Journal of Materials Processing Technology - Vol. 285, p.116780 - 2020

# Comparison between cryogenic coolants effect on tool wear and surface integrity in finishing turning of Inconel 718

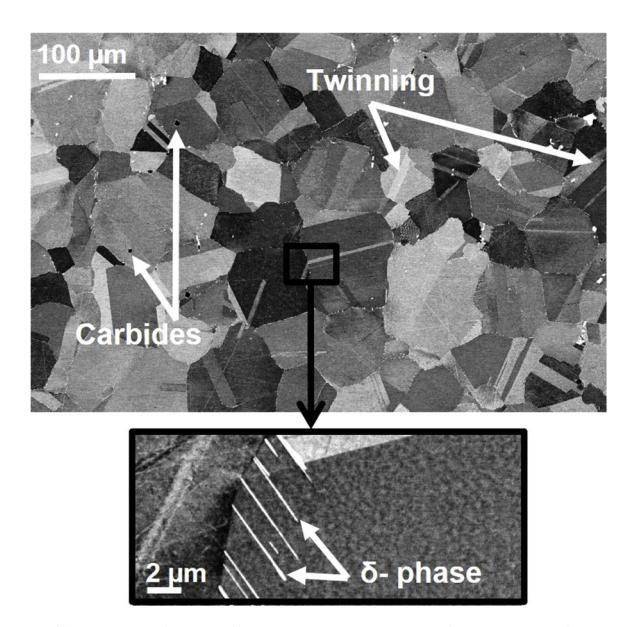
Fig. 1. Illustration of Inconel 718 microstructure in the as-received state observed by SEM technique.

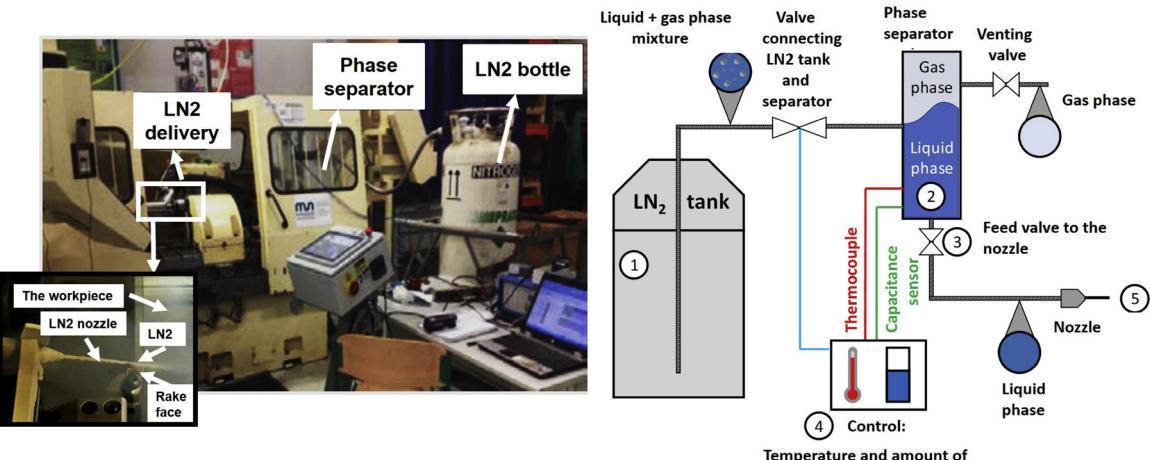
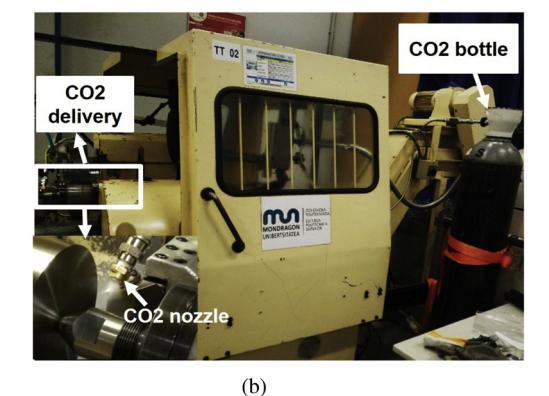
Fig. 2. Experimental set-up for the cryogenic tests: (a) LN<sub>2</sub> set-up; (b) LCO<sub>2</sub> set-up.

nitrogen bottle mounted on the CNC lathe (Fig. 2).

$LN_2$  spray was activated before starting the cutting process in order to reach stable outlet condition. The parameters of the  $LN_2$  flow are depicted in Table 3.

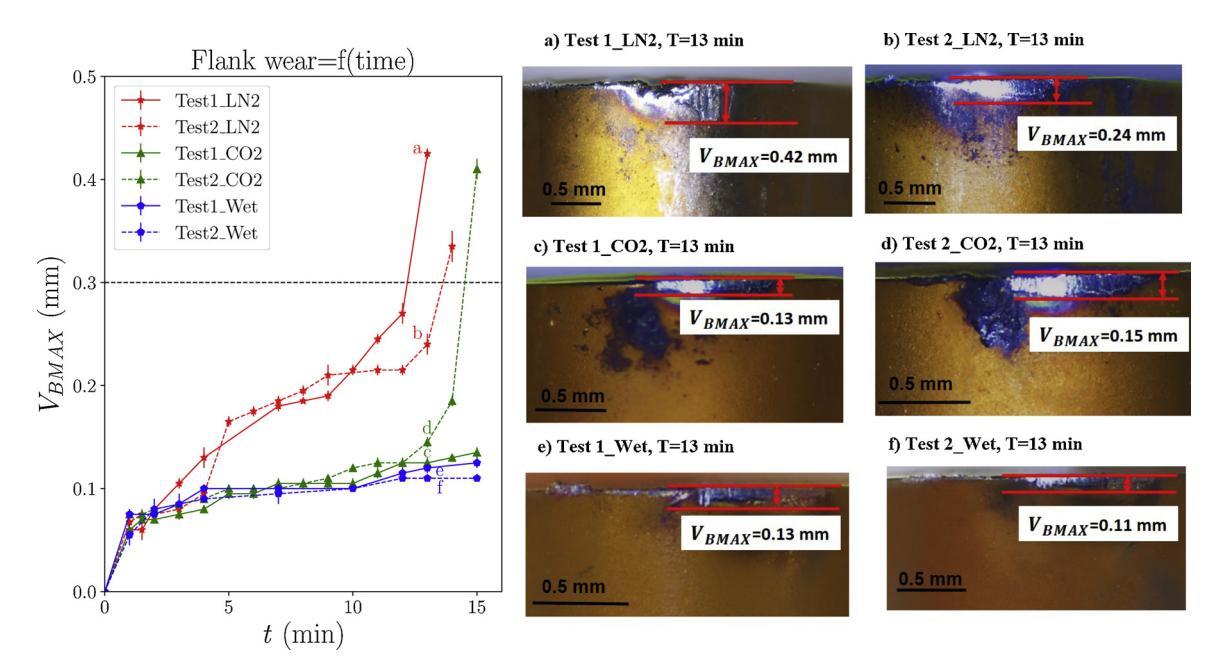
Fig. 3. Tool flank wear evolution under wet, LN<sub>2</sub> and LCO<sub>2</sub> cooling conditions during the tests.

Tool flank wear evolution was measured throughout the turning operations for all cooling methods (conventional and cryogenic conditions). The trials were stopped when reaching 15 min of cutting in conventional lubrication even if the criterion of maximum flank wear namely  $V_{BMAX} = 0.3$  mm was not achieved. Regard the LCO<sub>2</sub> condition, both tests were stopped at 15 min while the tool flank wear levels were notably different. However, under LN<sub>2</sub> cryogenic condition, the trials were stopped when the criterion of  $V_{BMAX}$  was reached. Focusing on Fig. 3, results indicated that the conventional condition revealed the longest tool life. In fact, the tool flank wear did not surpass 0.12 mm over 15 min of cutting in conventional lubrication. Both repetitions induced the same trend during the cutting process showing a good repeatability.

As for the LCO<sub>2</sub> cooling strategy, a similar evolution has been perceived up to 13 min of cutting. Nevertheless, beyond this duration, the tool flank wear progressed drastically to surpass the criterion at 15 min during the second repetition of LCO<sub>2</sub> experiment. With respect to LN<sub>2</sub> cryogenic condition, tool flank wear increased rapidly from the first 2 and 6 min of cutting during test 1 and test 2 respectively causing reduced tool life. In addition, tool flank wear progress in both cryogenic conditions is quite repeatable at the beginning of the machining process. Nevertheless, a significant variability was observed at 11 min and 13 min respectively in LN<sub>2</sub> and LCO<sub>2</sub> cooling strategies when the tool flank wear increased notably. In conventional cooling approach, a homogeneous tool flank wear evolution was observed even after longer machining times. In contrast, during LN<sub>2</sub> cryogenic machining, wear peaks occurred from the beginning of the turning process, indicating that the cutting process is not performed homogeneously while this parameter showed a steady and slow evolution in LCO<sub>2</sub> cryogenic condition except the last minutes of machining.

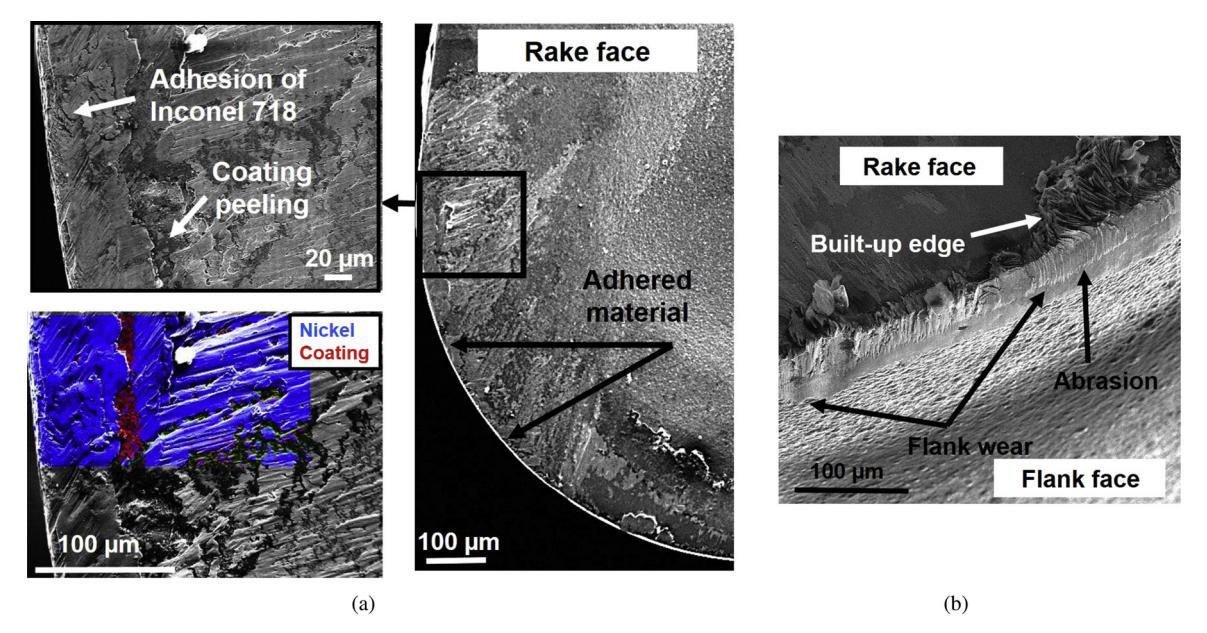
Fig. 4. SEM observations of the tool wear after 15 min of machining in wet condition: (a) rake face/EDS analysis; (b) flank face.

properties are significantly different compared to the one used in the current study. In addition, other factors could be identified consisting in the cutting conditions (cutting parameters as well as the cutting tool geometry). For these reasons, a scientifically rigorous comparison between previous studies and the current job seems to be difficult. Additional analysis have been carried out in order to study the tool wear mechanisms when machining Inconel 718 under conventional lubrication and cryogenic conditions using SEM. Fig. 4 shows the SEM observations of the tool wear state on the rake face as well as the flank face obtained in wet condition after 15 min of cutting.

The main mechanism observed consists in adhesion wear. Effectively, deposits of workpiece material were stuck on the rake face near the cutting edge revealing the chip rubbing. This observation is proved by EDS analysis showing the adhered material consisted in nickel. In fact, as long as machining time increased, adhered layers were formed progressively to establish built-up edges that protect the rake face (Xue and Chen, 2011). However, when achieving stagnation state, the build-up edges are not stable inducing the peeling of tool coating material.

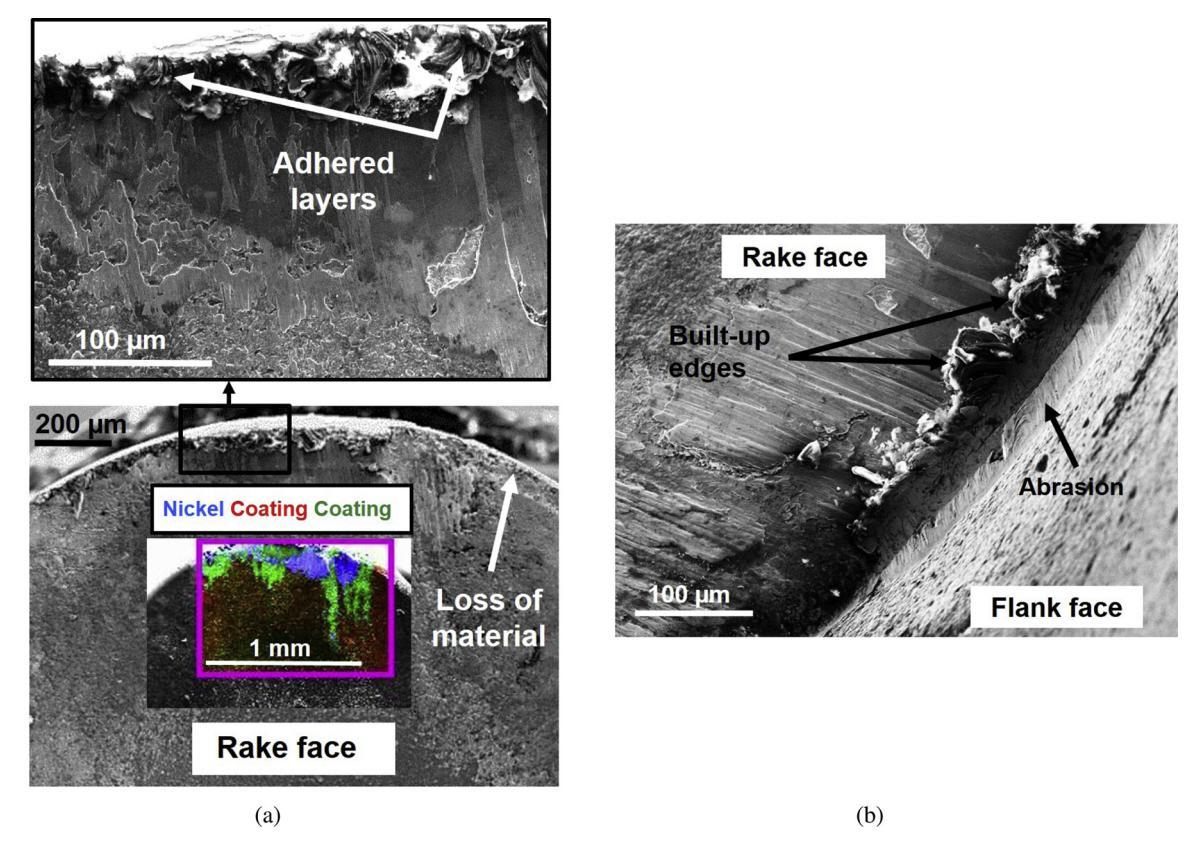
Fig. 5. SEM observations of the tool wear after 15 min of machining in LCO2 condition during Test 1: (a) rake face/EDS analysis; (b) flank face.

With respect to tool wear mechanisms under  $LCO_2$  condition, the two tests revealed different mechanisms. The first test exhibits the same trend as the conventional lubrication. Indeed, adhered layers are formed during machining as well as abrasion wear that is mainly caused by the hard carbide particles present in the workpiece material. It is worth mentioning that these two wear mechanisms are closely related (Cantero et al., 2013). Effectively, the adherence of the workpiece material inducing the formation of the built-up edge (BUE) leads to tool chipping, because of the instability of BUE that breaks off alternatively tearing out a small lump of the cutting edge (Fig. 5).

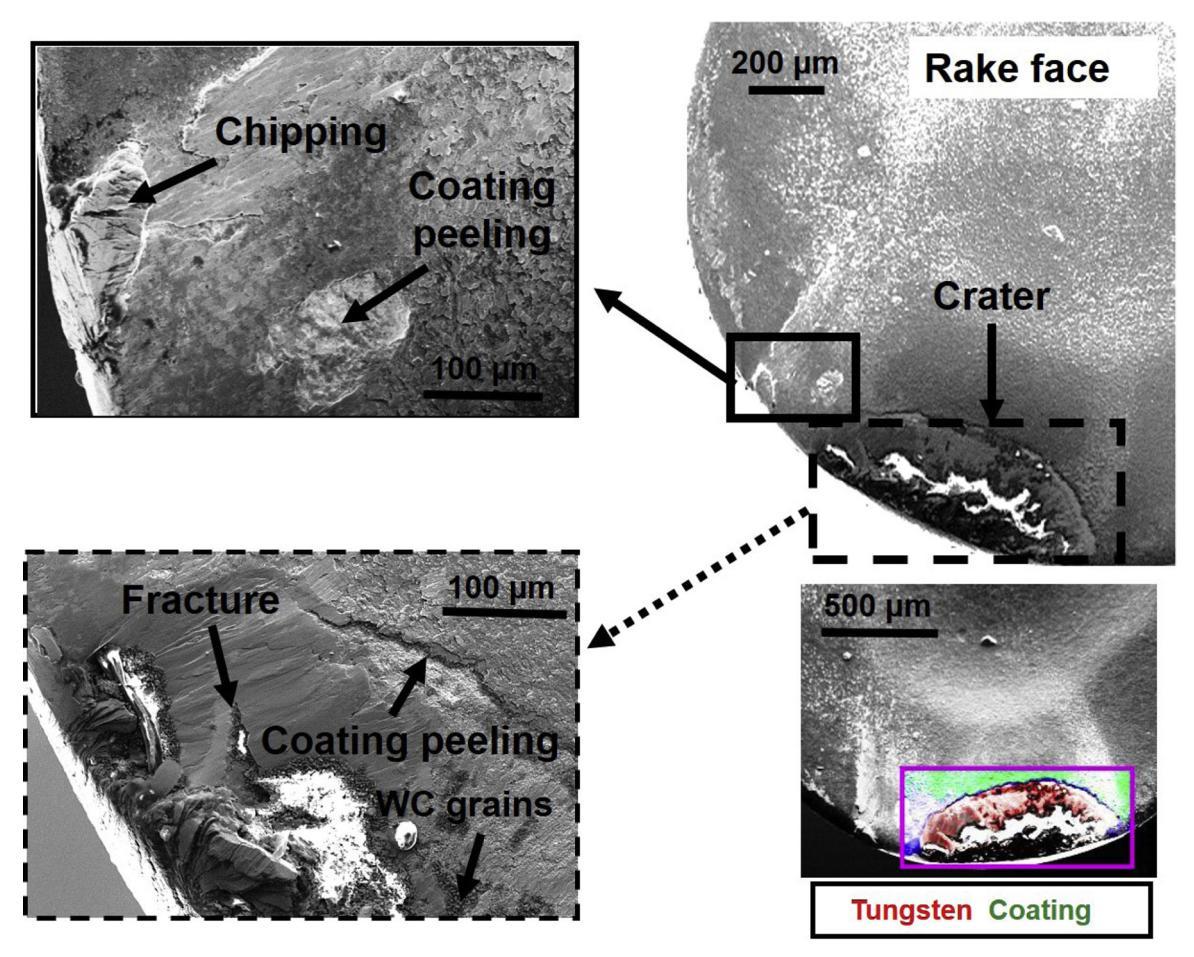
Fig. 6. SEM observations of the tool wear after 15 min of machining in LCO<sub>2</sub> condition during Test 2.

Nevertheless, the tool wear modes and mechanisms occurred during the second test when using  $LCO_2$  are rather different. Besides the flank wear, drastic crater wear took place caused by the plucking out of the tool coating particles as illustrated in Fig. 6.

Micro-cracks and chipping of the cutting edge have also been observed. Overall, these mechanisms are induced by mechanical loads which developed chipping, fracture and coating peeling as well as the chemical interactions at the tool-workpiece and tool-chip interfaces that caused adhesion (Halim et al., 2019).

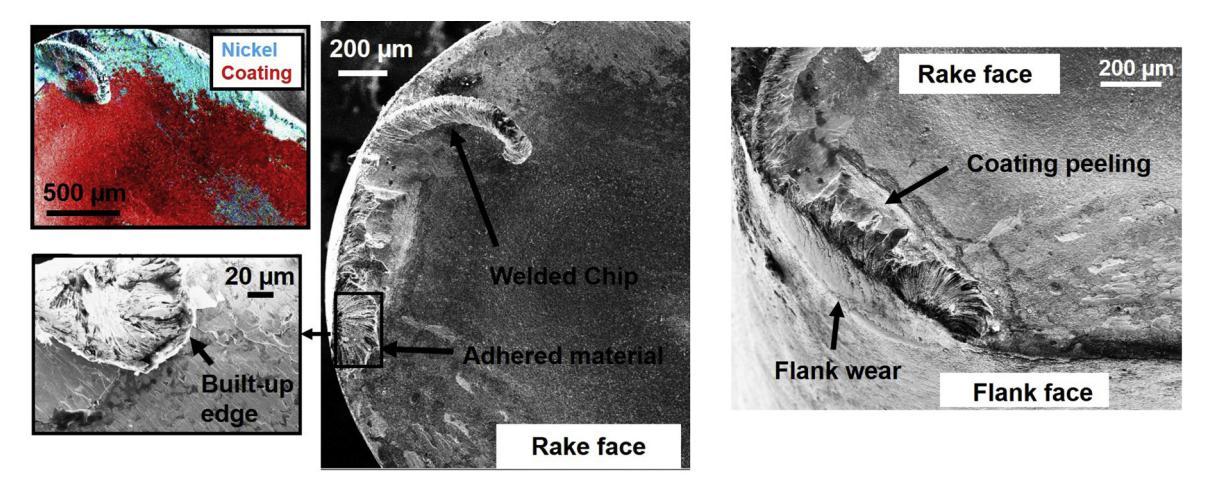
Fig. 7. SEM observations of the tool wear after 13 min of machining in LN<sub>2</sub> condition during Test 1: (a) rake face/EDS analysis; (b) flank face.

Concerning the  $LN_2$  cooling conditions, tool wear mechanisms that have been detected through the SEM observations and the EDS analysis are not far from those obtained during the second test of  $LCO_2$  lubrication. Indeed, during both  $LN_2$  tests, the degradation of cutting tool is primarily caused by adhesion and micro-chipping as depicted in Figs. 7 and 8.

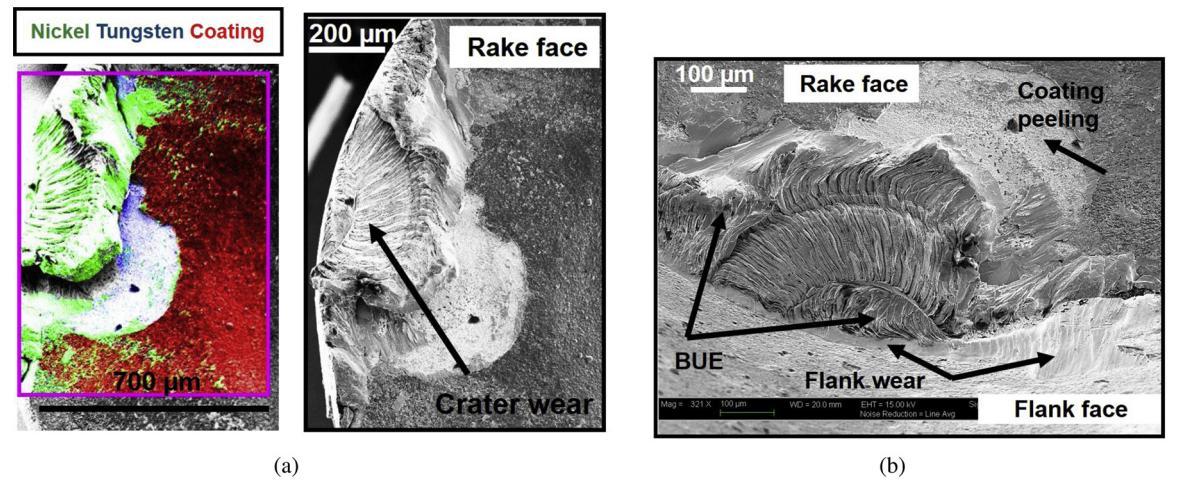
Fig. 8. SEM observations of the tool wear after 14 min of machining in LN<sub>2</sub> condition during Test 2: (a) rake face/EDS analysis; (b) flank face.

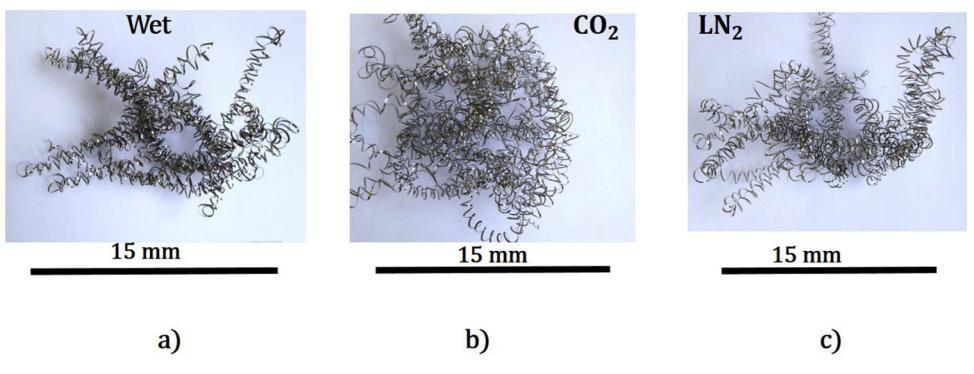
Fig. 9. Chip morphology obtained in the three cooling strategies: (a) wet, (b) CO<sub>2</sub> and (c) LN<sub>2</sub>.

Another aspect should be stated consisting in that when delivering  $LN_2$  cutting fluid on the tool rake face, it seems complicated to avoid cooling the unmachined workpiece. Consequently, the work material deformation behavior as well as the thermal properties could change by the cryogenic temperature (-196 °C). Thereby, the cutting process in this case turns out to be nonhomogeneous affecting the tool wear resistance. Moreover, when examining the chip morphology obtained under all cooling conditions, there is no significant difference; the chips exhibit almost the same morphology as depicted in Fig. 9.

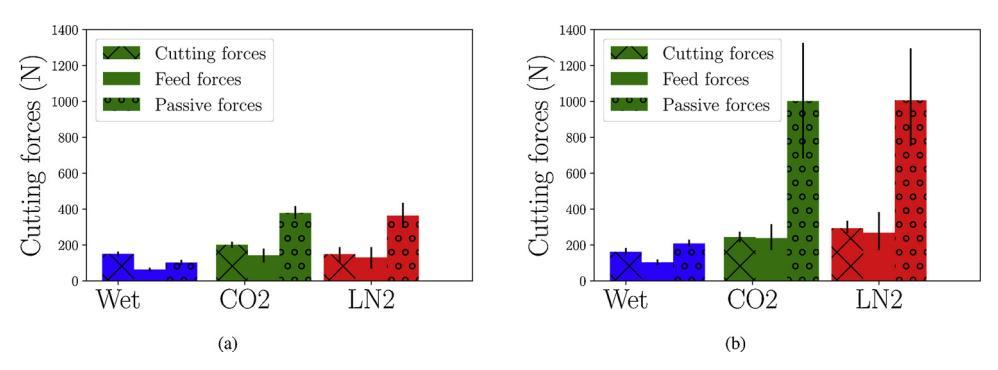
Fig. 10. Comparison between cutting forces components: at the beginning (a); at the end (b) of test.

Results showed that all cutting forces components exhibit lower values in conventional cooling condition than in the case of cryogenic conditions (Fig. 10). Indeed, the cryogenic cutting fluids (LN $_{\rm 2}$  and LCO<sub>2</sub>) display very low temperature throughout machining time leading to increase the flow stress of the workpiece material. As a result, the machining forces components heighten significantly. For instance, when examining the values of the cutting forces components found in conventional and cryogenic conditions, a strong difference is obtained where the maximum value of cutting forces that has been measured in conventional condition is 180 N. In contrast, in LN2 and LCO2 cooling approaches, this variable has exceeded 300 N and 250 N respectively at the end of cutting. Furthermore, the feed forces show the same tendency where the highest values are achieved in LN<sub>2</sub> cryogenic conditions. However, the passive forces revealed the highest values recorded in all cooling environment compared to the cutting and feed forces reaching over 1200 N after 14 min of machining in LN2 condition.

Cutting forces values are key factors to indicate the tool wear state. Fig. 10 illustrates the cutting forces measurements at the beginning and the end of the cutting process revealing the effect of tool wear evolution. Obviously, over machining time, the tool wear increases relatively to the cooling environment and therefore cutting forces rise as well. In addition, when comparing between the three components of the cutting forces regardless the lubrication strategy, one could recognize that the passive force measurements showed the highest values, mostly by the end of the machining process where the tool flank wear increased notably (Grzesik et al., 2018). In addition, when comparing between the different cooling methods, one could notice that passive force progress is slow and steady in conventional condition. Nevertheless, under cryogenic conditions, this parameter evolves drastically at the end of machining. This tendency is more pronounced under LN<sub>2</sub> cryogenic condition than under LCO<sub>2</sub> condition. This result may be attributed to the rapid tool flank wear progress in LN<sub>2</sub> cryogenic strategy mentioning that the passive forces are the most sensitive to tool flank wear as depicted in Fig. 11.

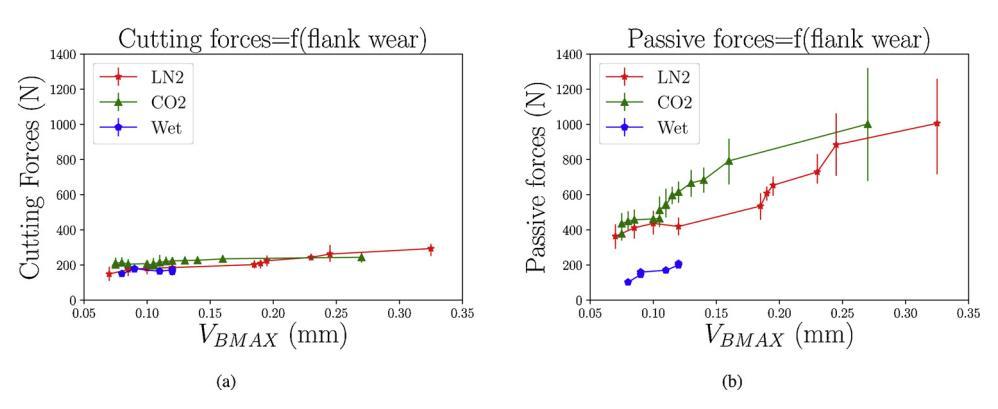
Fig. 11. Correlation between cutting forces components evolution and tool flank wear under Wet, LN2 and LCO2 conditions: (a) cutting forces, (b) passive forces.

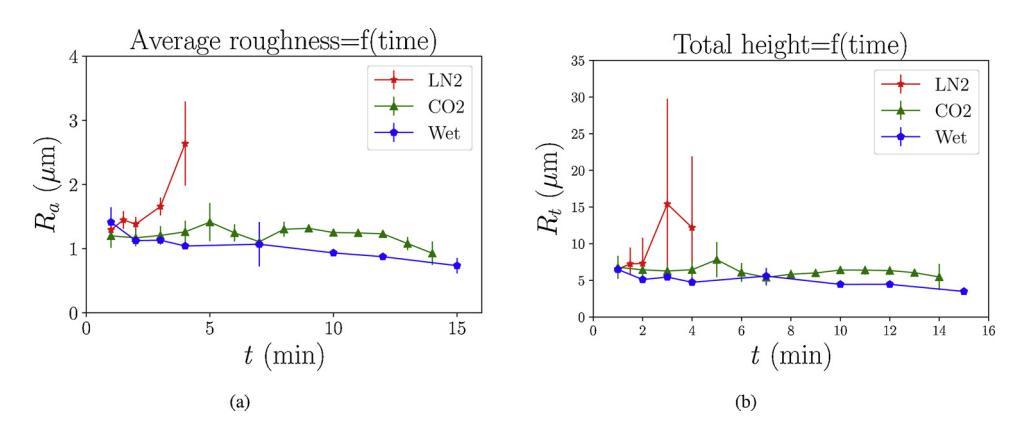
Fig. 12. Surface roughness evolution under wet, LN<sub>2</sub> and LCO<sub>2</sub> cooling conditions: (a) average roughness, (b) total height of the profile.

Surface finish is a crucial parameter that provides good machining performance of machined parts. Fig. 12 illustrates the evolution of surface roughness obtained in conventional and cryogenic conditions. Results showed that conventional coolant tended to enhance significantly the surface finish as it provides the lowest values in terms of the average roughness  $R_a$  as well as the total height of the profile  $R_t$ . Concerning the LCO<sub>2</sub> condition, it induced approximately the same tendency as the conventional strategy. Nevertheless, in LN<sub>2</sub> cryogenic condition, the surface quality exhibited a mediocre state in comparison with wet and LCO<sub>2</sub> conditions. Actually, under LN<sub>2</sub> cryogenic condition, surface roughness has achieved very high values reaching more than 3 µm of  $R_a$  and 20 µm of  $R_t$ . In comparison with LN<sub>2</sub> cryogenic

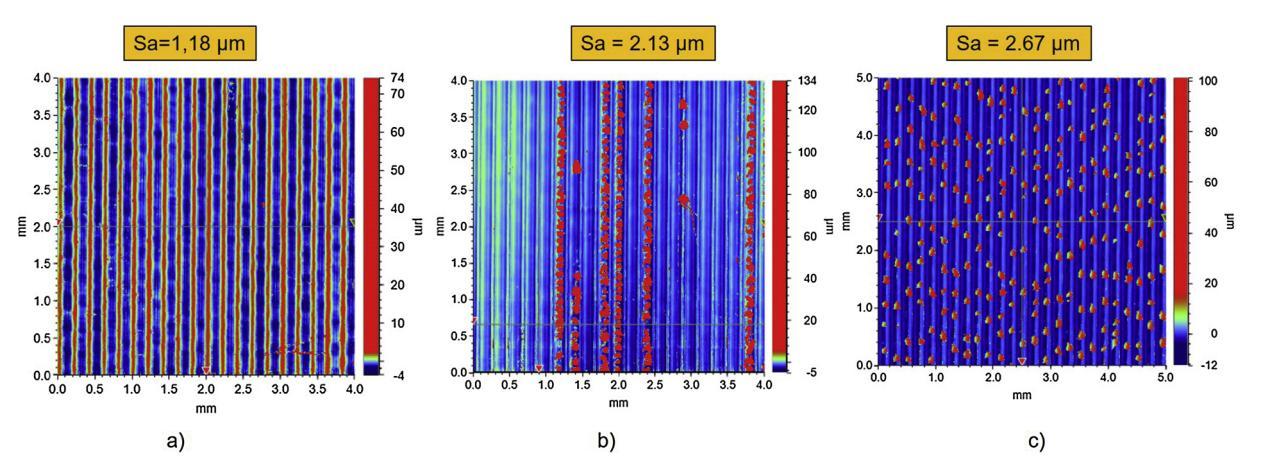
Fig. 13. Surface topography scanned using the Bruker profilometer after machining under  $LN_2$  condition: (a) t = 0.5 min, (b) t = 5.5 min, (c) t = 11 min.

the profilometer in order to characterize the  $LN_2$  surface finish measuring the average areal roughness  $S_a$ . Fig. 13 highlights the increase of  $S_a$  measured at different machining times. Indeed, the scanned surfaces reveal the presence of adhered particles on the machined workpiece surfaces that become more important as the machining time increases. This could be the main reason of the worst surface quality obtained in  $LN_2$  cryogenic condition.

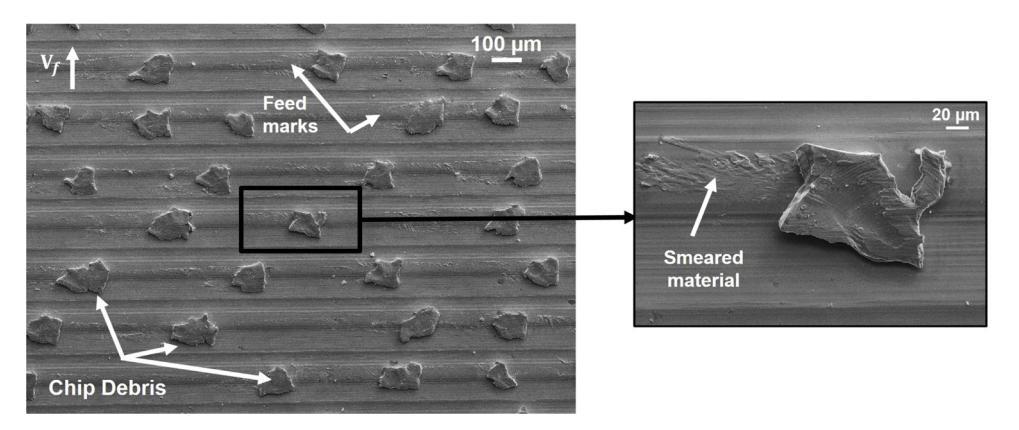
Fig. 14. SEM observations of the surface topography after 11 min of machining under  $LN_2$  condition.

These observations of the machined surface could be explained by the fact that during the chip formation process, the  $LN_2$  cutting fluid did not efficiently evacuate the chip from the cutting zone. Consequently, the chips were stuffed between the cutting edge and the freshly machined surface. Furthermore, the degree of tool wear affects strongly the machined surface quality knowing that thereby the cutting forces and the cutting temperature increase as well when the tool wear evolves. Indeed, these features have been observed in previous work (Zhou et al., 2012). The study pointed out that the chip debris (the adhered chip) is attributed to the increase of the plastic deformation localized at the cutting tool-work material interface. It is worth mentioning that the carbides particles could deteriorate the machined surface quality by generating the smearing of the fresh machined surface as displayed in Fig. 14.

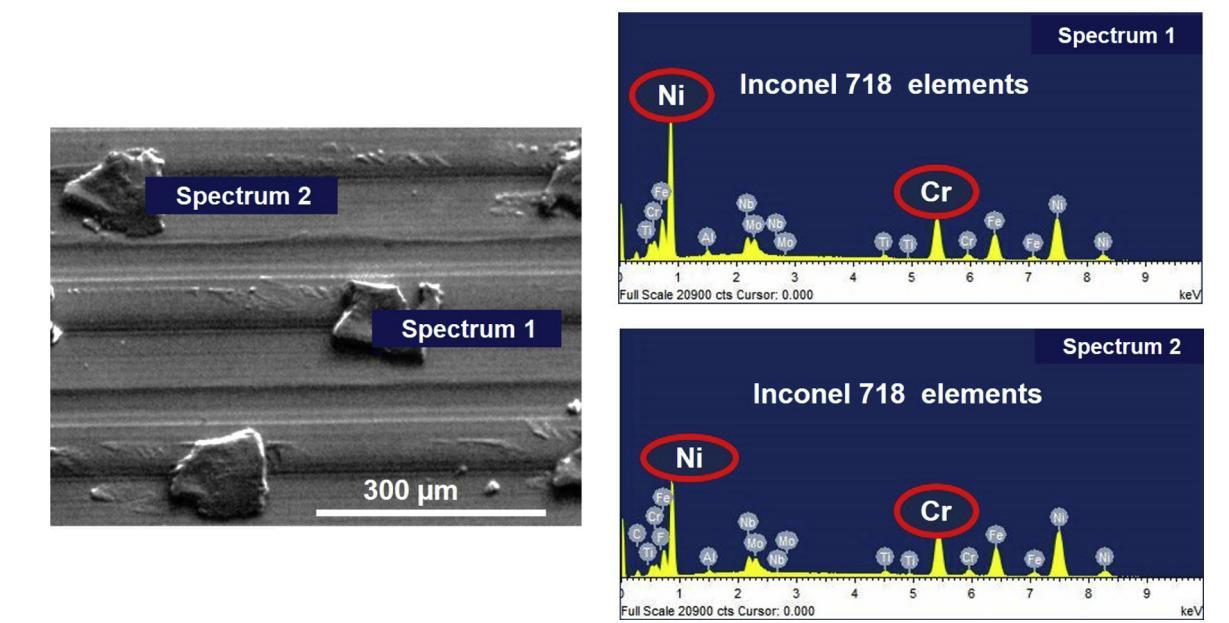
Fig. 15. EDS analysis carried out on the machined surface after 11 min of machining under LN<sub>2</sub> condition.

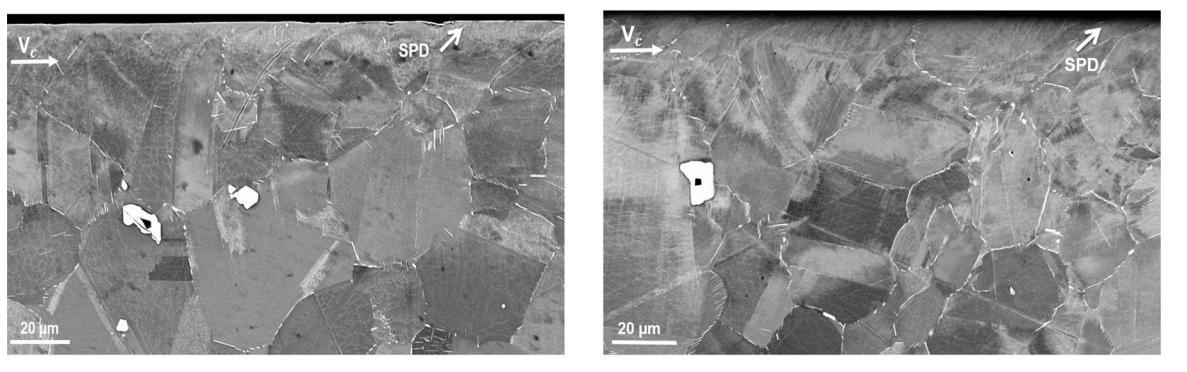
Fig. 16. SEM observations of the machined surfaces in wet condition using new and semi-worn tools: (a) new tool, (b) semi-worn tool ( $V_{BMAX} = 0.12 \text{ mm}$ , t = 15 min).

Figs. 16–18 disclose the machined surfaces and subsurfaces alterations induced by machining under the conventional and cryogenic conditions when using new and worn tools along the cutting direction.

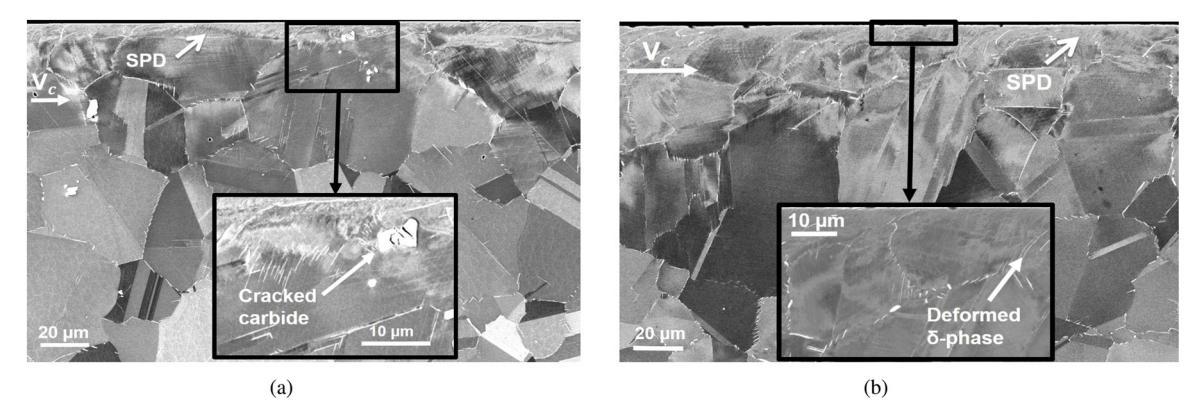
Fig. 17. SEM observations of the machined surfaces in LCO<sub>2</sub> condition using new and semi-worn tools: (a) new tool, (b) semi-worn tool ( $V_{BMAX} = 0.14$  mm, t = 15 min).

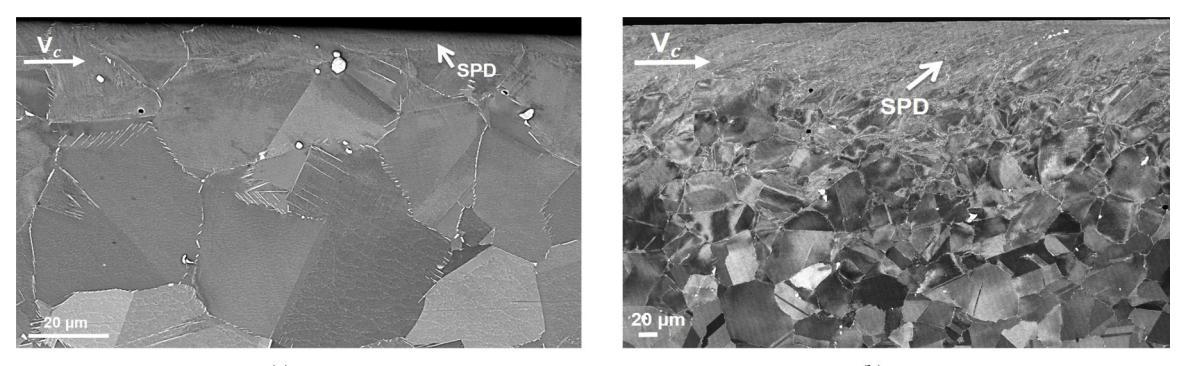
Fig. 18. SEM observations of the machined surfaces in  $LN_2$  condition using new and worn tools: (a) new tool, (b) worn tool ( $V_{BMAX} = 0.35$  mm, t = 14 min).

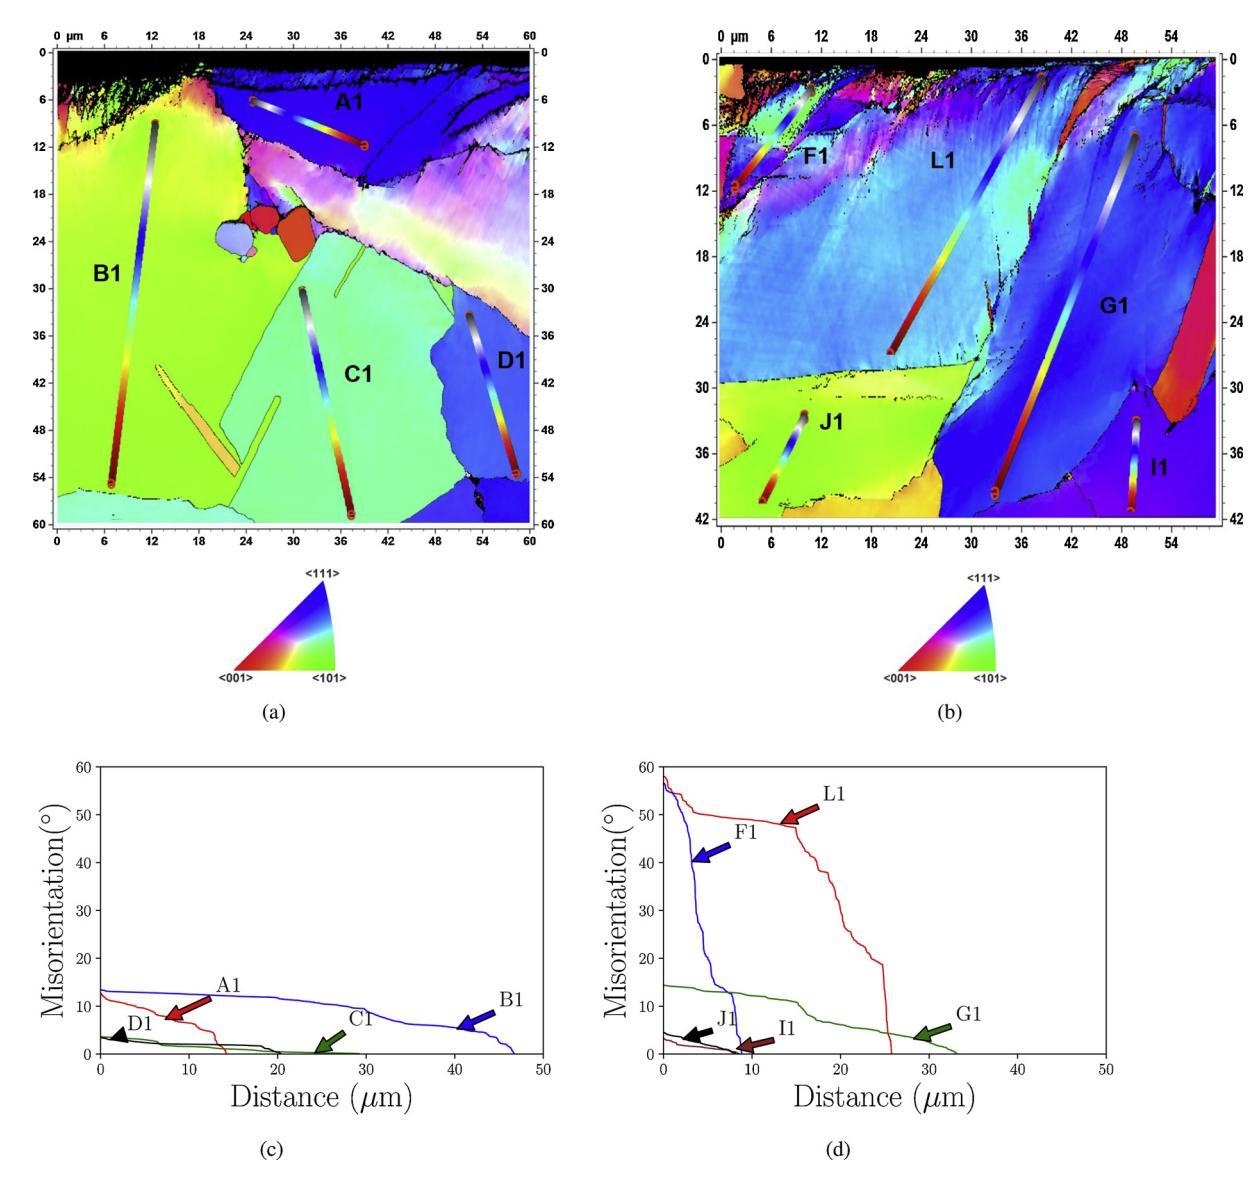
Fig. 19. EBSD maps of the machined surfaces (projection axis [001]) obtained in LCO<sub>2</sub> condition using new tool (a) and semi-worn tool (b); misorientation gradients measured inside deformed grains (in the direction as indicated by lines) in the case of: (c) new tool, (d) semi-worn tool.

Fig. 19 gives information about the misorientation gradients measured inside the deformed grains chosen in the region close to the machined surface in the case of  $LCO_2$  cooling strategy when using new and semi-worn tools.

In addition, when examining the resulting profiles as displayed in Figs. 19 and 20, the latter's show clearly the higher values of the cumulative misorientation inside the deformed grains localized at the vicinity of the machined free surfaces when using semi-worn tools as well as worn tool respectively revealed under wet,  $LCO_2$  and  $LN_2$  cooling approaches.

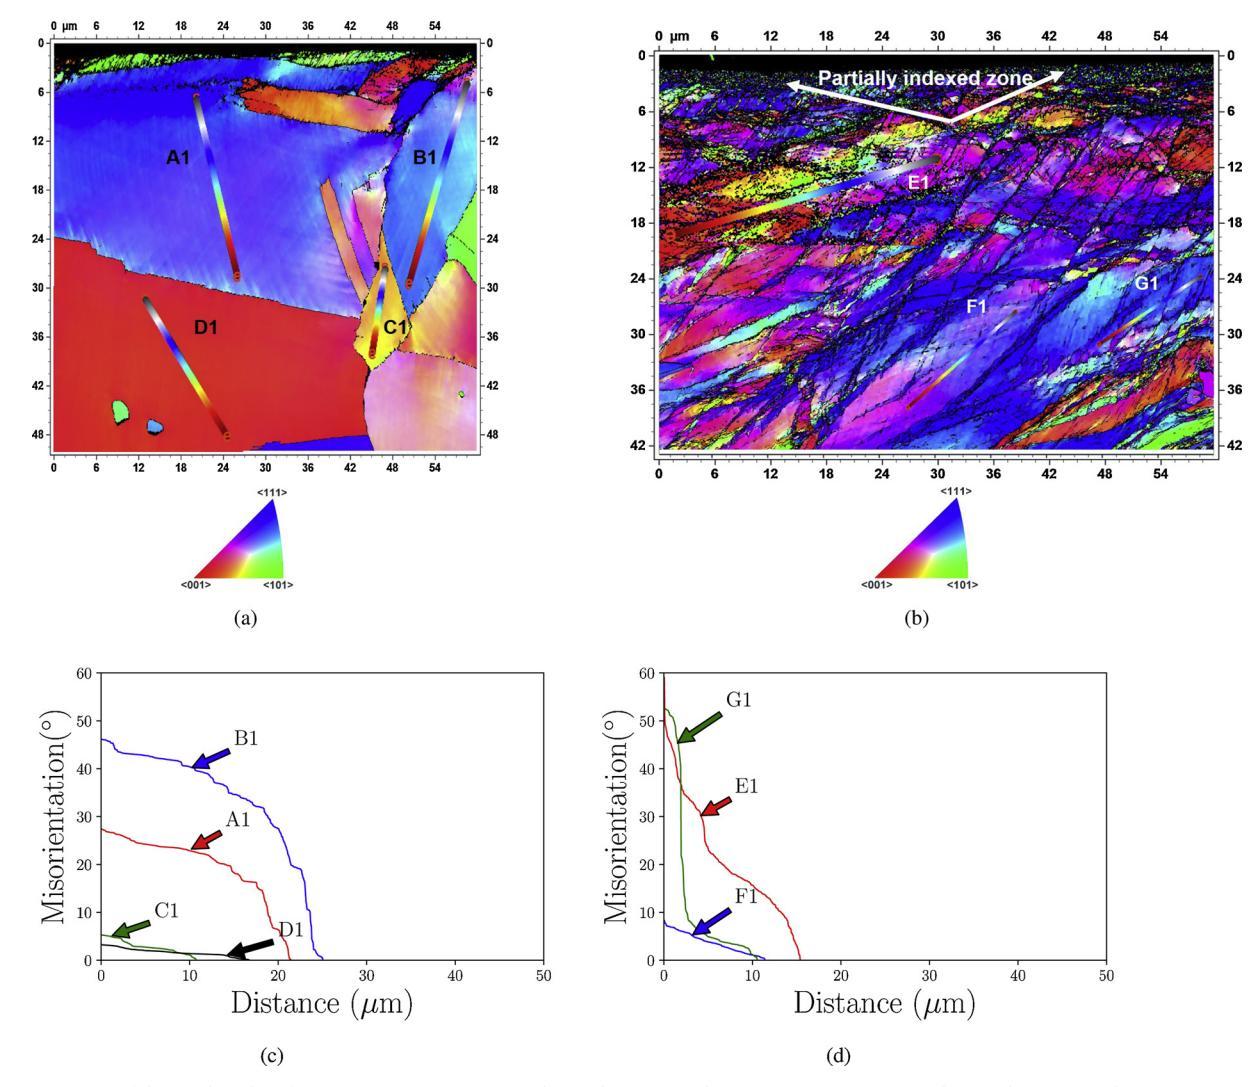
Fig. 20. EBSD maps of the machined surfaces (projection axis [001]) obtained in wet condition using a semi-worn tool (a) and in LN<sub>2</sub> condition using worn tool (b); misorientation gradients measured inside deformed grains in the case of: (c) wet, semi-worn tool, (d) LN<sub>2</sub>, worn tool.

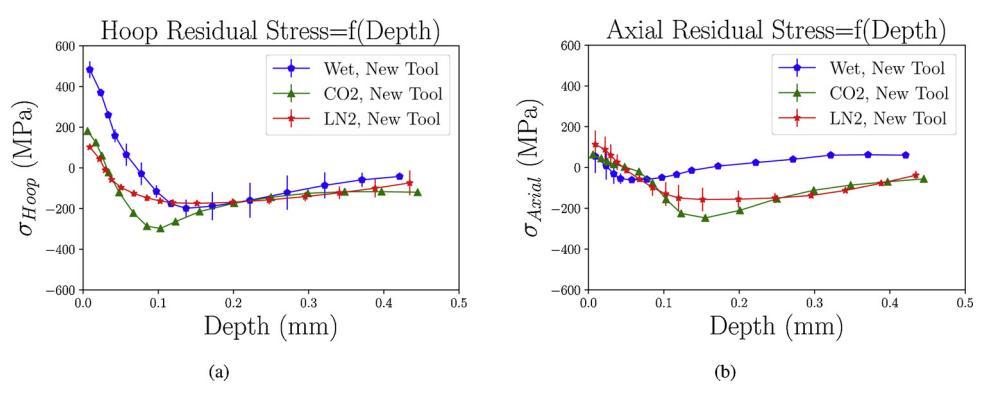
**Fig. 21.** Residual stress profiles near and beneath the machined surface using a new tool wet, LCO<sub>2</sub> and LN<sub>2</sub> cooling conditions measured along: (a) hoop direction (cutting direction); (b) axial direction (feed direction).

Additionally, conventional condition generated the largest tensile hoop stress layer reaching 100  $\mu$ m below the machined surface and induced a compressive peak holding around -200 MPa. In contrast, LCO<sub>2</sub> cooling condition revealed the largest compressive depth initiating from 35  $\mu$ m to more than 400  $\mu$ m and provided the highest compressive peak reaching almost – 300 MPa. Concerning the LN<sub>2</sub> condition, beneath the machined surface within 30  $\mu$ m, hoop stress shifted to compressive values showing larger compressive depth compared to conventional condition. Overall, under cryogenic conditions, as the depth beneath the workpiece surface rose, the tensile hoop stresses rapidly dropped and quickly reached compressive levels before slowly returning to bulk values in the case of machining using new tools.

As for the axial stress profiles, results indicated very low tensile values near the surface that shifted gradually to compressive trend under wet and  $LN_2$  cryogenic conditions. However, under  $LCO_2$  cryogenic condition, residual stress in the feed direction induced more

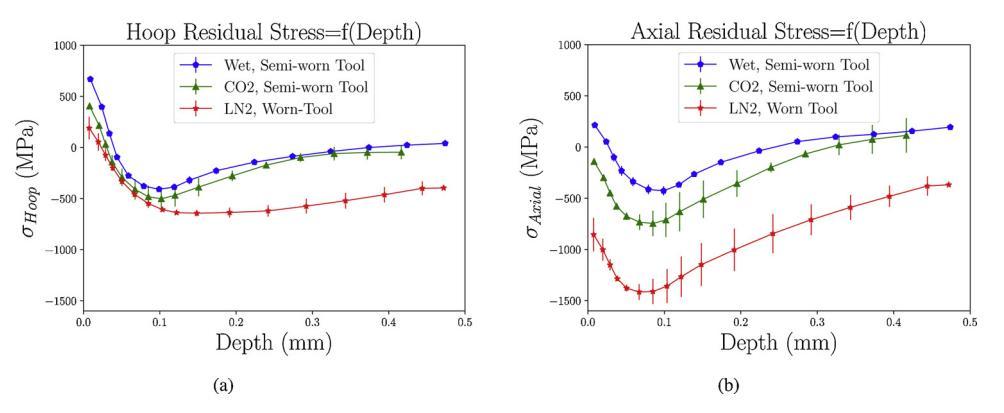
Fig. 22. Residual stresses profiles near and beneath the surface machined using semi-worn tools under conventional and  $LCO_2$  cooling conditions and worn tool under  $LN_2$  condition measured along; (a) hoop direction; (b) axial direction.

With regard to the LCO<sub>2</sub> cooling condition, as expected, near the surface, hoop residual stresses rose significantly reaching 405 MPa and then decreased gradually to compressive values at the depth of 50  $\mu$ m showing higher compressive peak around -468 MPa in comparison with the values obtained in the case of using new tool. Alternatively, along the axial direction, residual stresses tended to be much more compressive from the first increment (10  $\mu$ m) and penetrated to a deeper depth inducing greater compressive peak holding -746 MPa compared to the result obtained when cutting with a new tool. Another aspect that should be noticed is that when comparing conventional and LCO<sub>2</sub> cooling conditions that exhibited the same tool wear state, results showed better residual stress distribution revealed in the case of LCO<sub>2</sub> strategy indicating the advantage of cryogenic approaches with respect to fatigue resistance.

Concerning the  $LN_2$  cooling method, when examining the residual stress distribution near the surface, in the cutting direction, it is obvious that residual stresses were tensile. Nevertheless, they are surprisingly maintained almost at the same range when using a new tool holding 189 MPa versus 102 MPa respectively. Consequently, one is interested to mention that when machining with severe tool wear, it is well known that temperatures rise drastically near the surface due to the increase of friction contact area between tool flank face and the workpiece. However,  $LN_2$  cryogenic condition that reveals the highest tool wear level induces lower tensile residual stresses along the cutting direction compared to conventional and  $LCO_2$  cooling conditions. In the other hand, along the feed direction, very close to the surface, stresses are much more compressive shifting from 113 MPa to -855 MPa when the
