# Crystallography of Stress corrosion cracking of austenitic stainless steel by scanning electron microscope and electron backscatter diffraction.

Hazem Mubarak\*, Sébastien Jégou\*, Laurent Barrallier \* Polina Volovitch\*\*, Kevin Ogle\*\* \*MSMP Lab., Arts et Métiers ParisTech, Aix-en-Provence/France \*\*Chimie ParisTech, Paris/France

# Summary

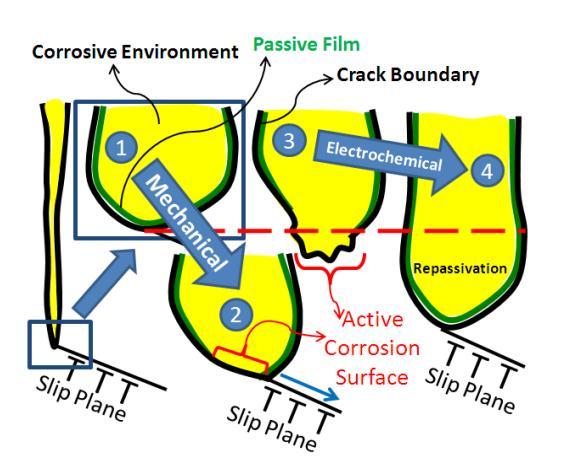
**Figure 1:** Representation of FRM showing a crack propagation cycle of mechanical slip (1-2), chemical dissolution (2-3), and passivation (3-4).

Film Rupture dissolution Model (FRM) describes intergranular SCC of stainless steel as a cyclic process of local surface activation by mechanical slipping and chemical dissolution of the freshly exposed surface at that location until it passivate again. The process is represented in Fig.1 and 2 [1,2,3].

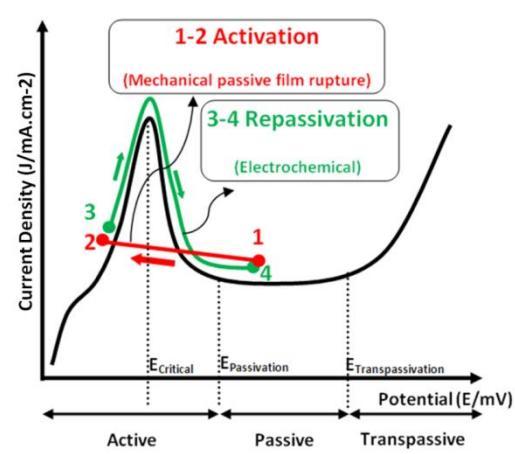
**Figure 2:** Stainless steel polarization curve representing an activation/passivation cycle of SCC of stainless steel.

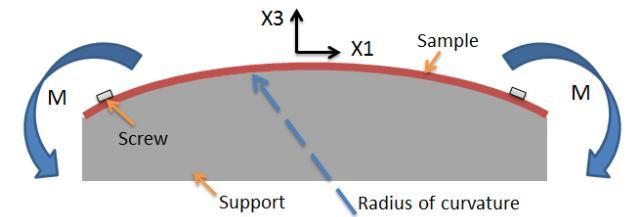
**Figure 3**: Side view of the support-sample assembly. Bending moment is applied to the sample resulting in a constant uniaxial stress.

To apply certain value of tensile stress, the samples were elasto-plastically deformed using curved supports having different radii of curvature, as shown in Fig.3.

By this assembly, the sample is subjected to constant bending moment by the two screws fixing it to the curved support. This creates an applied uniaxial stress on the central part of the sample. Assuming that the volume doesn't change, the sections of the sample remain flat after deformation, and the stress is uniaxial, the stress tensor is reduced to  $\sigma_1$ ; where  $\sigma_2$  and  $\sigma_3$  are negligible, and  $\sigma_{12}$  and  $\sigma_{23}$  are zero.

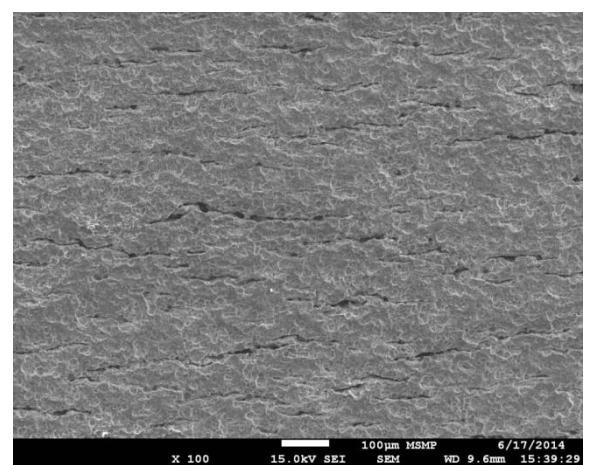
**Figure 4**: Upper surface,  $\varepsilon = 0.16\%$ .

The topography of the upper surface and the cracks profiles has been observed by SEM. Fig.4-5 show the resulting images.

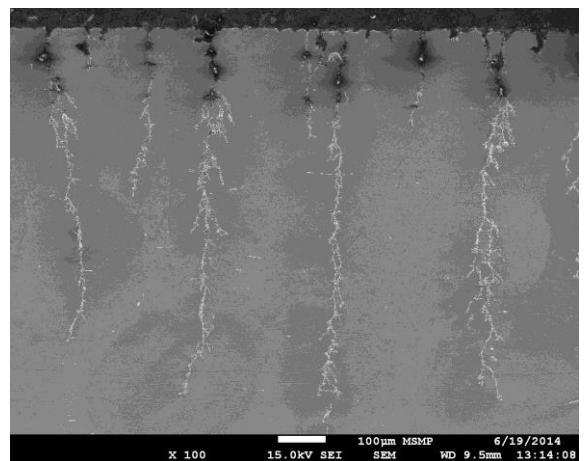
**Figure 5**: Cross section,  $\varepsilon = 0.16\%$ .

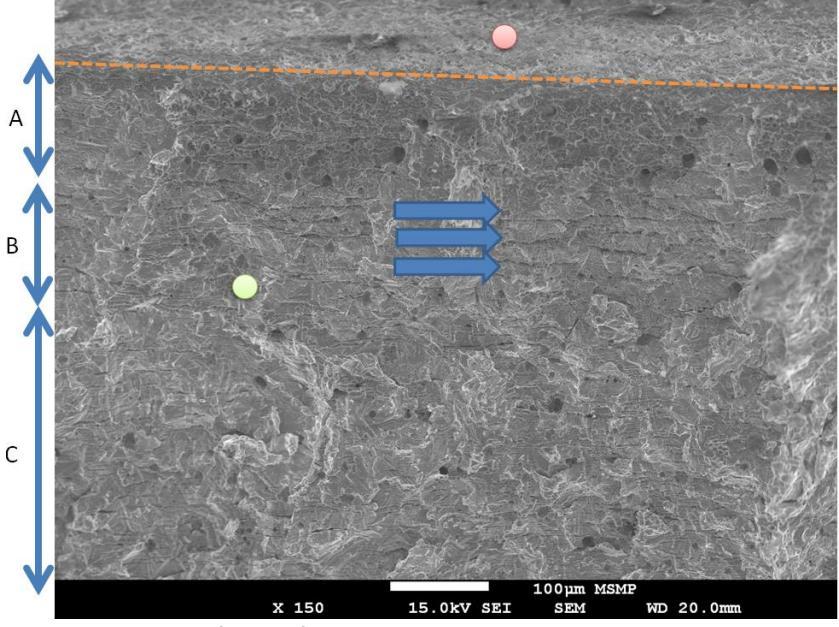
**Figure 6**: The crack facet of ,  $\varepsilon = 0.16\%$ , 21-day immersion SCC test.

Since the produced cracks were very well developed in the depth of the sample, characterising the crack fractography of the produced cracks was of interest. For this, the sample of R500 was chosen. One of the cracks was open such that SEM analysis can be made for its facet. Fig.6 below shows the crack facet as marked by the green circle, below the dashed line. The surface with the pink circle is the sample's upper surface.

Fig. 6 shows different corrosion regimes. Regime "A " corresponds to an aggressive corrosion after the crack propagation over the entire experiment. Following this is regime "B" where the three parallel lines indicated by the arrows in Fig.6 are traces of the step wise mode of crack propagation. This might correspond to locations of slip system activation, followed by dissolution of freshly exposed surface. This stands as evidence in favor of the FRM, as described in Fig. 1 and 2. Such results were found by [12]. The last regime is "C", which represents the rapid propagation of SCC, where the cracks have grown to make large decohesive crack coalesce with cleavage and fluting features. Such results were found by [13,14]. Fig.6 helps identify these regimes on the cross-section. This cracking behavior is in agreement with cracking kinetics described by [15].

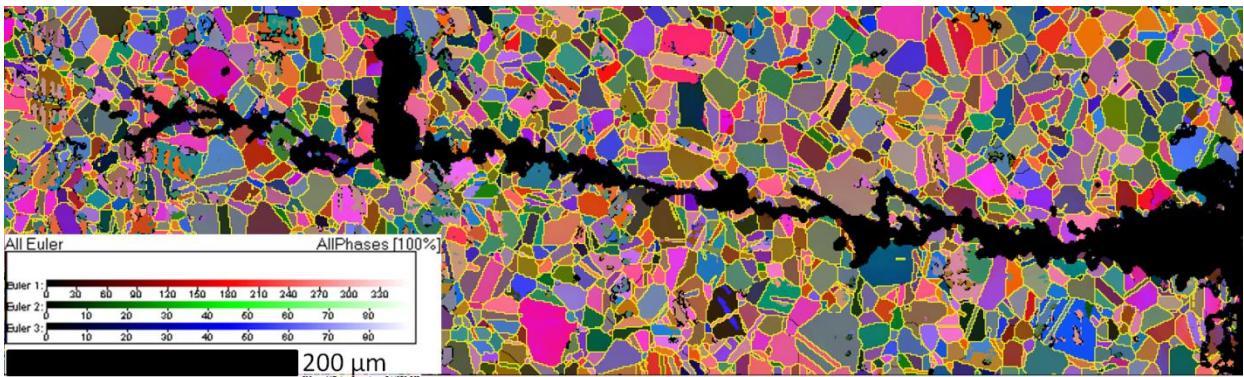
**Figure 7**: EBSD map of crystallographic orientation around a SCC,  $\sigma$  = 245 MPa sample.

Three cracks were selected to be analysed in this section. The orientation map shown in Fig.7 is one of them. This is related to  $\sigma$  = 245 MPa applied stress sample.

Having the EBSD map for the crystallographic orientation of the grains made it possible to analyse the cracking planes. The interest was to check if the cracking plane has any crystallographic features. Thus, the ruptured grains were isolated. From the crack path, a line is chosen representing the top view of the cracking plane. An assumption is made here is that this plane is perpendicular to the sample cross-sectional plane. To verify if this assumption is valid, step-wise polishing was

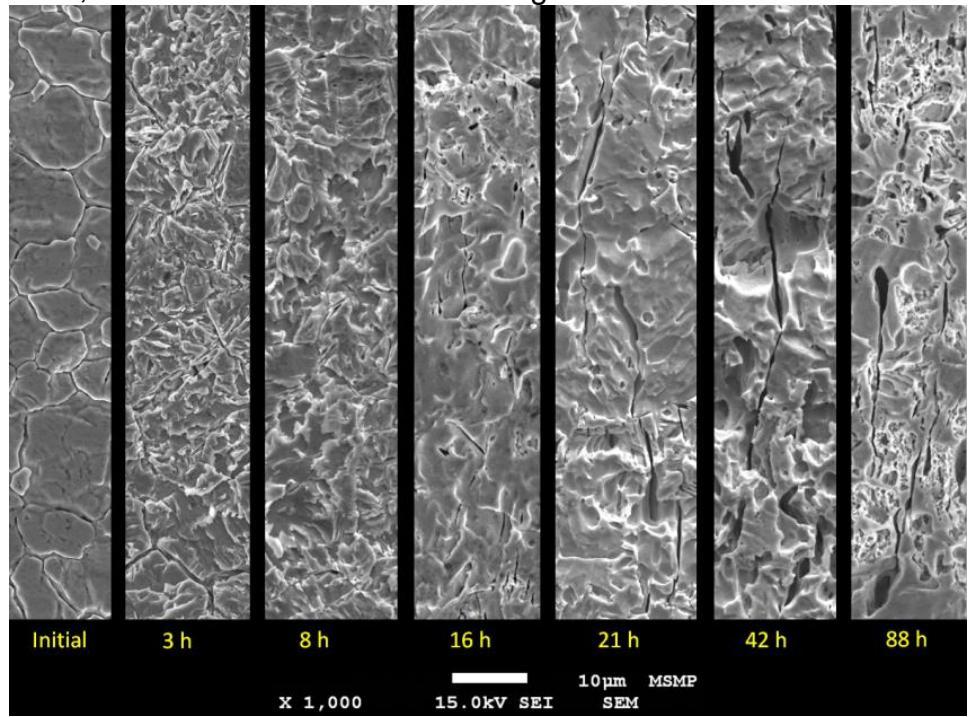
**Figure 8**: SCC evolution with time on the upper surface,  $\sigma = 210$  MPa.

For the different tests performed here, the upper surface and cross section were observed using SEM imaging. Fig.8 shows the evolution of corrosion with time on the upper surface, and on the crack initiation and growth.

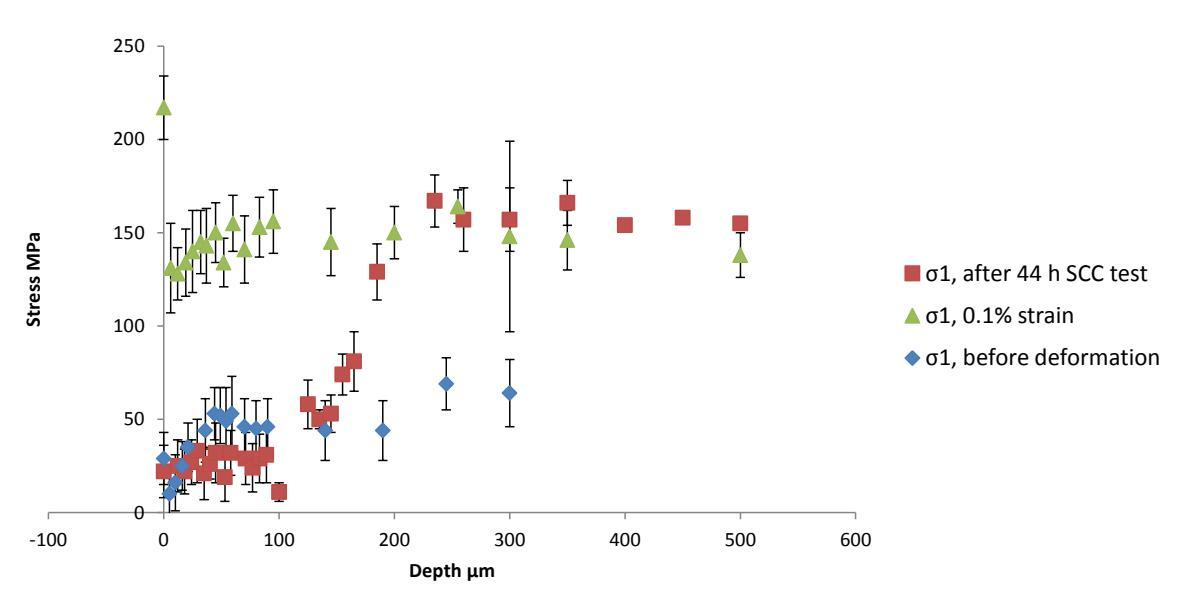
Figure 9: XRD residual – applied profile stress analysis over the sample's depth.

The XRD analysis over the sample depth profile gave the curves indicated in Fig.9. The crude metal sheet shows to have residual stresses due to manufacturing processes. The effect of the applied stress is very pronounced on the curve representing the sample after deformation.

From the obtained stress profiles, we see that the metallic sheet used in these experiments has an initial residual tensile stress. This stress is propably due to manufacturing processing, such as rolling. The average of the measured stress on the surface was 33 MPa. The sample was deformed using the support of 800 mm radius. For the deformed sample, the same measurements were made on the upper surface giving a stress value equals to 213 MPa. This value of stress represents the elastic limit of the material in hand, and it confirms the theoretical calculation made by eq.4 corresponding to this amount of deformation.

The interest was to measure the stress value after the SCC test. The average crack length for this period of SCC test is about 95  $\mu$ m, and the maximum possible crack length is about 175  $\mu$ m. This is directly reflected on the measured stress profile over the sample's depth. From the upper surface (depth = 0) to the point at 100  $\mu$ m, the stress falls to a close value to the initial residual stress in the bulk of the material. And starting from this point, the measured stress starts to increase gradually with depth. This gradual increase stops at depth equals to 175  $\mu$ m, after which the stress profile shows a platform until 500  $\mu$ m depth representing the applied stress value. This is clarified in table 3.
