Nano- and micro-scale morphological defects in oxidized a-SiC:H thin films

A. V. Vasin^{*1}, Y. Y. Gomeniuk¹, A. V. Rusavsky¹, A. N. Nazarov¹, V. S. Lysenko¹, P. M. Lytvyn¹, O. G. Gontar, S. P. Starik², C. Nouveau³, and S. Ashok⁴

Keywords amorphous SiC films, oxidation, morphological defects

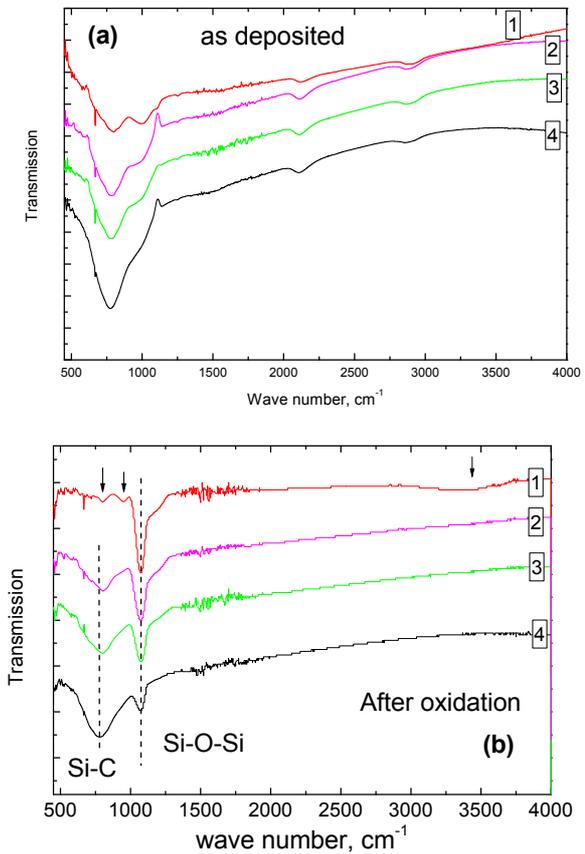
Figure 1 FTIR transmission spectra of as-deposited (a) and oxidized (550 °C) a-SiC:H samples deposited at RF-discharge power of 180 W (1), 200 W (2), 250 W (3), and 330 W (4).

FTIR transmission spectra of as-deposited and thermally treated samples are presented in Fig. 1. Spectra of as-deposited samples (Fig. 1(a)) are composed of four main absorption bands typical for a-SiC:H layers: 800 cm⁻¹ (Si-C stretching), 1000 cm⁻¹ (Si-C-H₂ bending), 2100 cm⁻¹ (Si-H_n stretching), and 2800–3000 cm⁻¹ (C-H_n stretching) [7, 8]. In the 1000–1100 cm⁻¹ region some contribution to the absorption due to oxygen contamination is expected.

It is evident from the figures that the principal effect of increase in discharge power is increase of the relative intensity of the Si-C related absorption band at 800 cm⁻¹, in comparison with the hydrogen related band at 1000 cm⁻¹. It can be interpreted as increase of the concentration of Si-C bonds and decrease of SiC-H_n associated mainly with hydrocarbon radicals in the nano-voids. Such interpretation is in good agreement with increase of the density of the films observed with increasing of discharge power.

The FTIR spectrum of the sample after oxidation in O₂ atmosphere at 550 °C is presented in Fig. 1(b). No Si-H_n (2100 cm⁻¹) and C-H_n (2900–3000 cm⁻¹) stretching vibration bands were detected after dry oxidation. In the spectrum of the sample deposited at lowest discharge power (i.e. lower density of the material) there are four pronounced absorption bands at 446 cm⁻¹, 805 cm⁻¹, 945 cm⁻¹, 1070 cm⁻¹ (with shoulder at 1200 cm⁻¹) all of which known to be related to oxygen bonds: Si-O-Si (symmetrical stretching), Si-OH (stretching), Si-O-Si (asymmetrical

stretching), and O-H (stretching) respectively. One can see that relative intensity of the main silicon-oxygen absorption bond (1070 cm⁻¹) is reduced as the density of the film increases.

In FTIR spectrum of this sample (Fig. 1, spectrum 1) we see only silicon oxide related absorption bands so we can say the a-SiC material is “completely oxidized”. IR absorption cross section of Si-C and Si-O bonds is different but of the same order. From the surface image we see that relative contribution of the volume of island-like regions is quite significant so that we can attribute the absence of the Si-C related absorption in FTIR spectra to the absence of corresponding a-SiC material. Basing on this suggestion we can attribute island-like regions to carbon-enriched highly defective SiO(x) structural fragments.

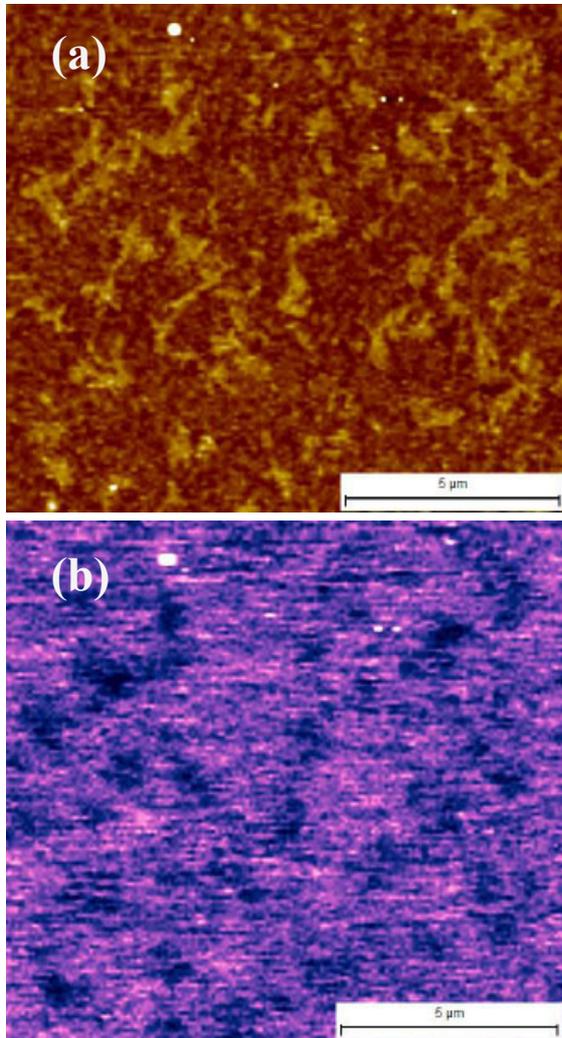
Figure 2 (a) AFM topology (contrast of height in range of 10 nm) and (b) KPFM map (contrast of surface potential in range of 30 mV) of the surface of low density a-SiC:H films after oxidation at 550 °C.

3.1 Nano-scale defects Atomic force microscopy measurements show that surface of as-deposited films is smooth and uniform. But after oxidation of the low density sample (the sample deposited at lowest discharge power, see spectrum 1 in Fig. 1) at 550 °C we observe formation of island-like inhomogeneities (Fig. 2(a)). Such morphological defects were not observed after oxidation at 650 °C. IR spectra of these samples (not presented here) do not differ significantly. The size of island-like morphological

defects ranges from several hundred nm to several μm , and islet defects protrude above the surface of the main body of the films by about 10 nm.

Kelvin probe force measurements exhibit that the surface potential of the defects is significantly lower than that of the surrounding matrix (Fig. 2(b) indicating that electrical properties of the material is also inhomogeneous..

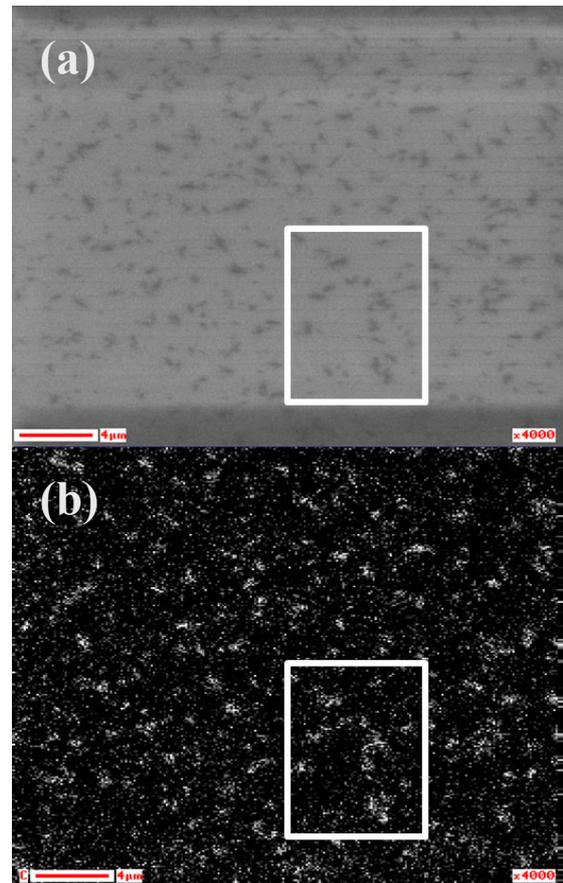
Figure 3 SEM (regime of secondary electron detection) image (a) and carbon distribution map generated by Auger-electron scanning probe (b) of the low density sample after oxidation at 550 °C. Contrast of carbon distribution map corresponds to the range from background signal of the C(KVV) line (black) to maximum of the amplitude of C(KVV) line (white).

Figure 3 shows the SEM image generated by secondary electrons of the surface of the sample after annealing in oxygen at 550 °C (Fig. 3(a)) and the corresponding distribution of carbon on the surface of the

sample (Fig. 3(b)). It is seen that carbon distribution replicates the morphological map, thus indicating that the island-like defects are enriched by carbon in comparison with the surrounding surface. Local nano-probe measurements show that the flat surface contains much more oxygen than island-like defects. Thus island-like defects can be attributed to non-oxidized regions.

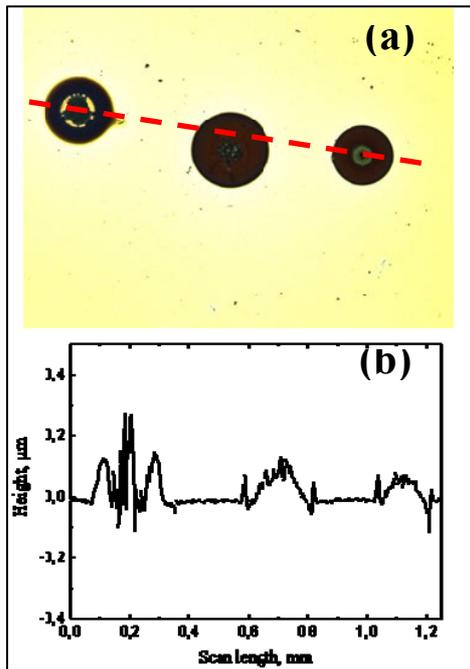
Figure 4 Optical microscopy image of the micro-defects (a) and corresponding surface profile (b).

Figure 4(a) shows a typical optical microscopy image of such spots. Optical profilometry showed that these spots are the projections (Fig. 4(b)) with a complex structure of the edge and the center. Usually these defects are formed around pin-holes or near the edges of the silicon substrate.

When measuring the profile of the distribution of elements, the ion etching conditions were identical so the delayed arrival to a silicon substrate in the case of measurement over the dark spot is obviously due to the greater thickness in this location, which is consistent with optical profilometry data (see Fig. 4(b)).

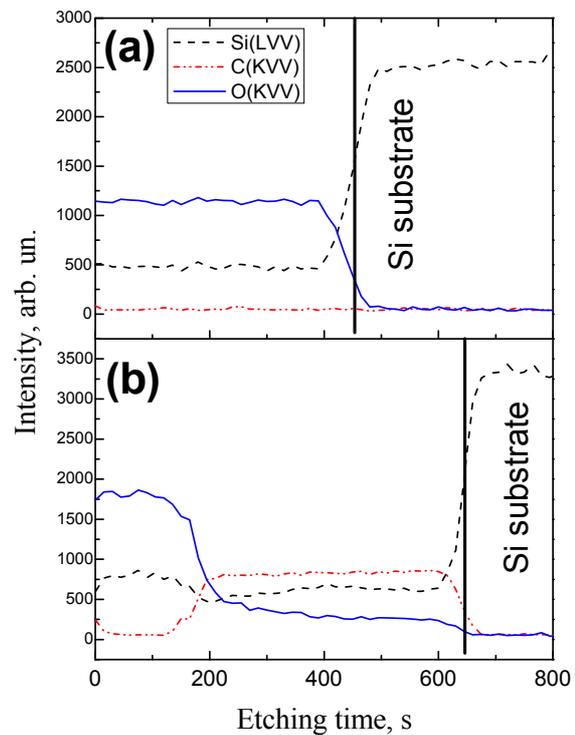
Figure 5 AES depth profile of the distribution of silicon, carbon and oxygen in the region of uniform surface (a) and “dark hole” defect (b).

Nano-probe Auger electron profiles of silicon, carbon and oxygen in the dark spot and in the open surface are shown in Fig. 5. It can be seen that in a homogeneous area of the film the distribution of the elements in depth of the film is homogeneous and corresponds to amorphous silica.

In the dark spot the profile of the composition is represented by two areas: (1) the upper area with a high concentration of oxygen, and (2) the lower area, with high carbon content. The oxygen concentration drops at the boundary and then slowly decreases toward the silicon substrate. The silicon concentration in these two areas differs little. Thus we can conclude that dark spots are represented by a bi-layer: upper layer of silicon oxide and underlying nano-composite layer composed of amorphous silicon carbide and amorphous carbon precipitates.

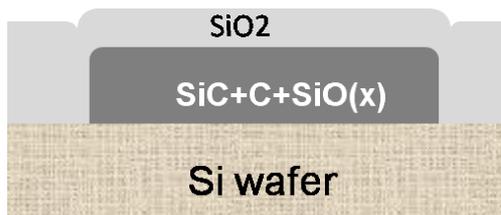
Figure 6 Topological model of the “dark hole” micro-defect.

Summarizing the experimental data, we suggest a topological model of the dark defects as presented in Fig. 6. Significant increase of the thickness in the region of dark spot is probably associated with condensation of large amounts of carbon in the porous SiC matrix.
